Kingston Waterfront Resiliency Project Site Reconnaissance Report

November 16, 2018

Prepared for: City of Kingston, NY

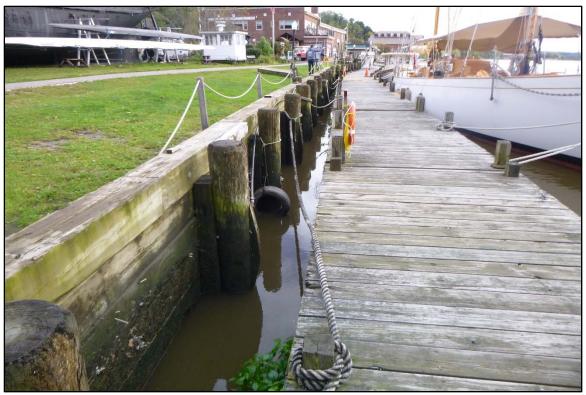
The timber bulkhead adjacent to the Maritime Museum was found to be mostly intact with the exception of areas where the cribbing wall had partially failed allowing fill to leech into the waterway, creating areas of subsidence behind the timber bulkhead. Timber cribbing debris was unexpectedly found throughout the entire site. Dimensioned timber debris was found along the entire shoreline length against the existing mean low water level and extending out to a maximum of 20ft in some locations.

Photo 1: View of Timber Bulkhead at Hudson River Maritime Museum, looking East.

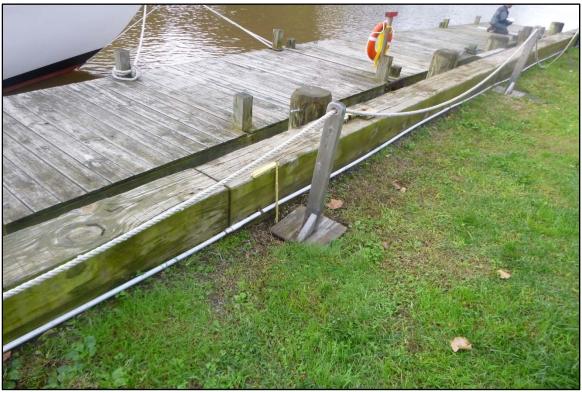
Photo 2: View of area of subsidence behind the timber bulkhead due to fill leeching.

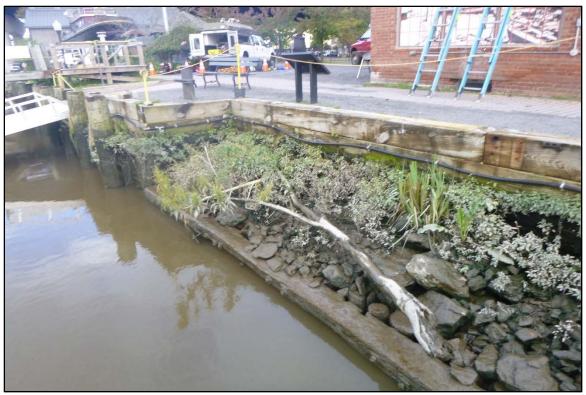
Photo 3: View of Timber Bulkhead behind the Maritime Museum with original failed cribbing in front.

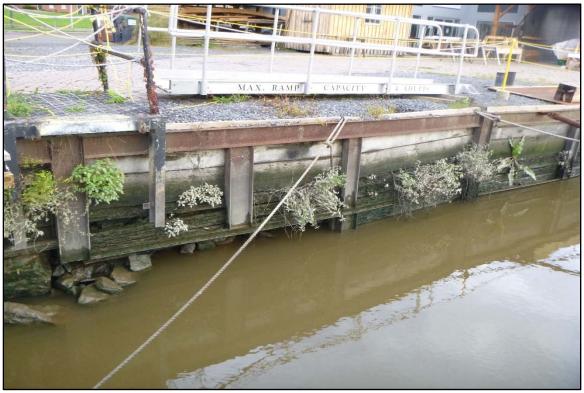
The steel framed bulkhead with timber planks behind the Boat School had areas where fill was leeching as well. Timber elements were deteriorating and displaced due to the upland surcharge pressures.

Photo 4: View of Steel and timber planking bulkhead with failed areas and leeching of fill.

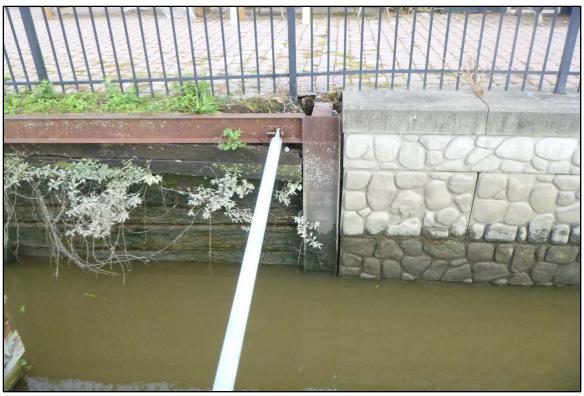
Photo 5: View of Steel bulkhead and Concrete block interface, loss of fill due to failed bulkhead.

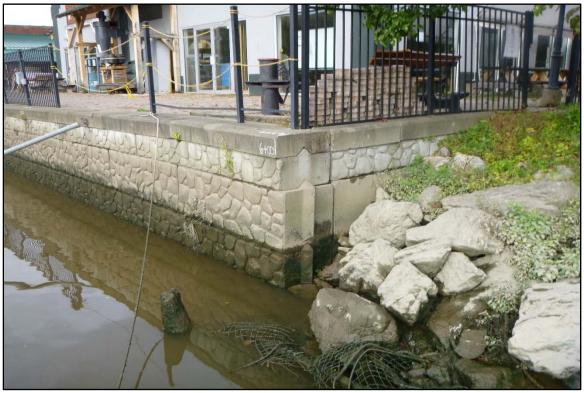
Photo 6: View of interface between Concrete block wall and abandoned ferry landing rip-rap.

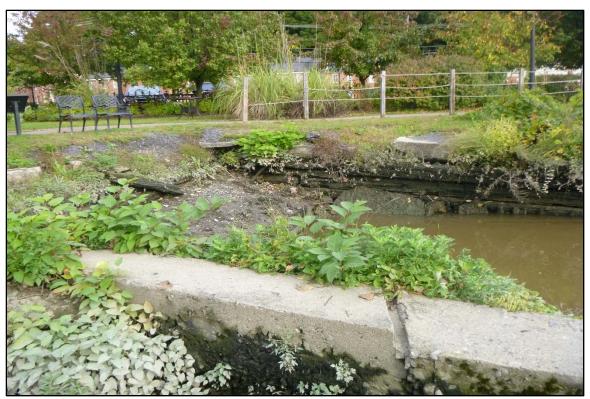
The abandoned ferry slip area between the Boat School and Ole Savannah was found to have a large amount of concrete debris and abandoned timber piles that no longer serve any structural function.

Photo 7: View of Ferry Landing debris and remaining structure.

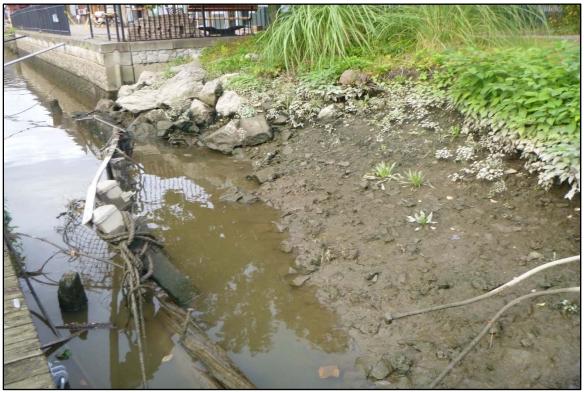
Photo 8: View of Ferry Landing shoreline with failed barrier and timber debris.

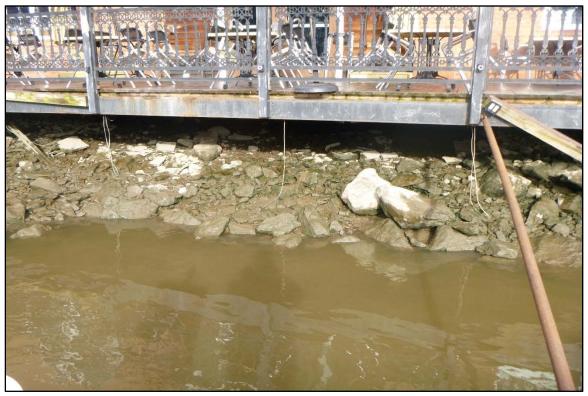
Photo 9: View of Ole Savannah Shoreline with concrete debris and riprap underneath of cantilevered patio.

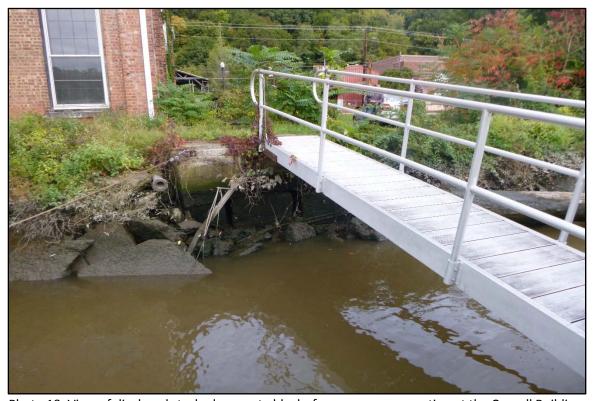
The stacked concrete blocks at the Cornell Building showed similar deterioration to the wall behind the Boat School with the bulkhead being constructed on top of existing timber cribbing. This area showed more severe signs of settlement and displacement of the stacked concrete blocks.

Photo 10: View of displaced stacked concrete blocks for gangway connection at the Cornell Building.

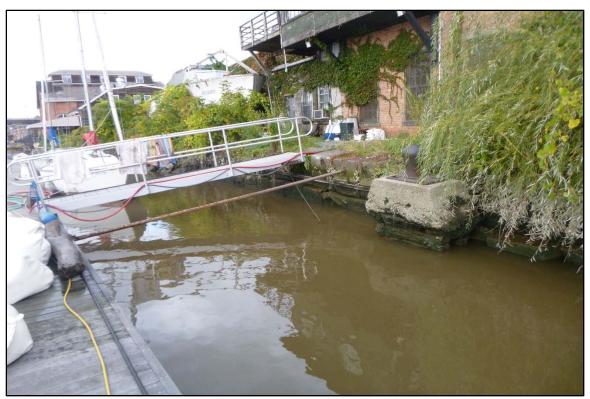
Photo 11: View of displaced stacked concrete blocks for the gangway connection at the Cornell Building.
