# *EXISTING CONDITIONS REPORT*

## RONDOUT LIGHTHOUSE *Kingston, New York*

Re: **Conditions Report for Rondout Lighthouse  
Kingston, NY**

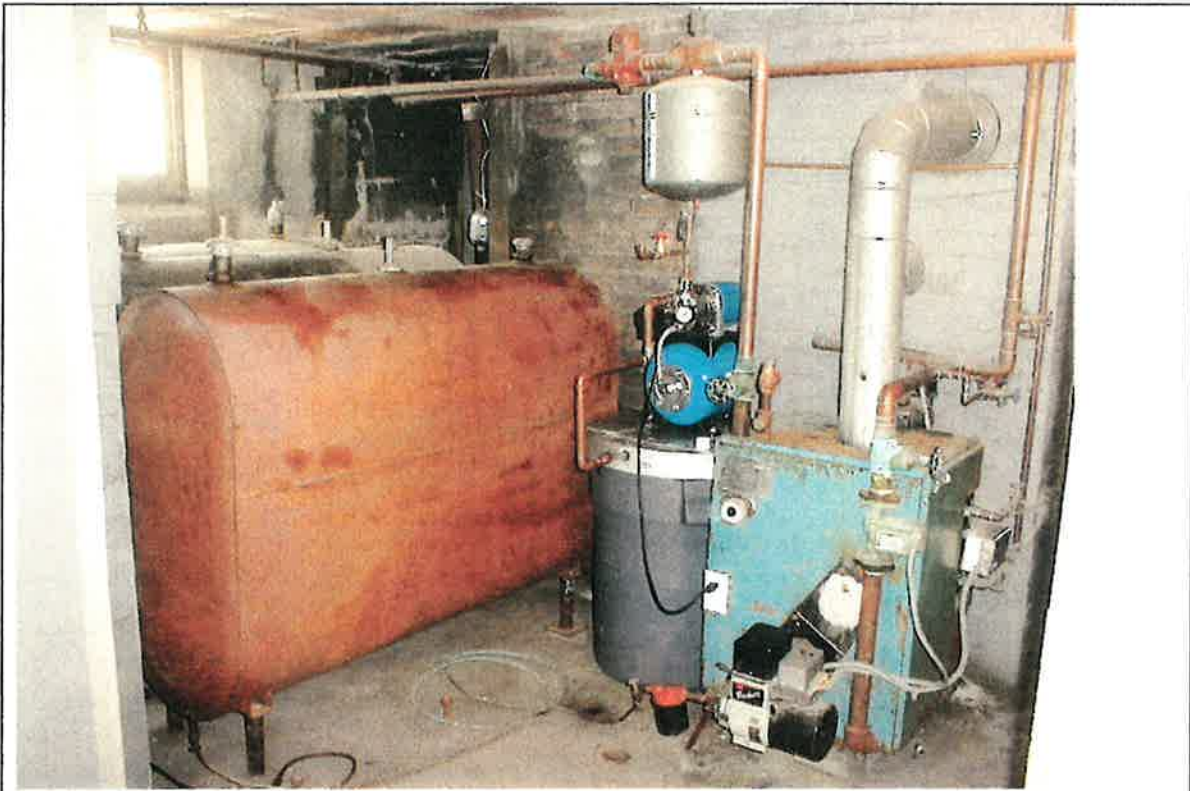
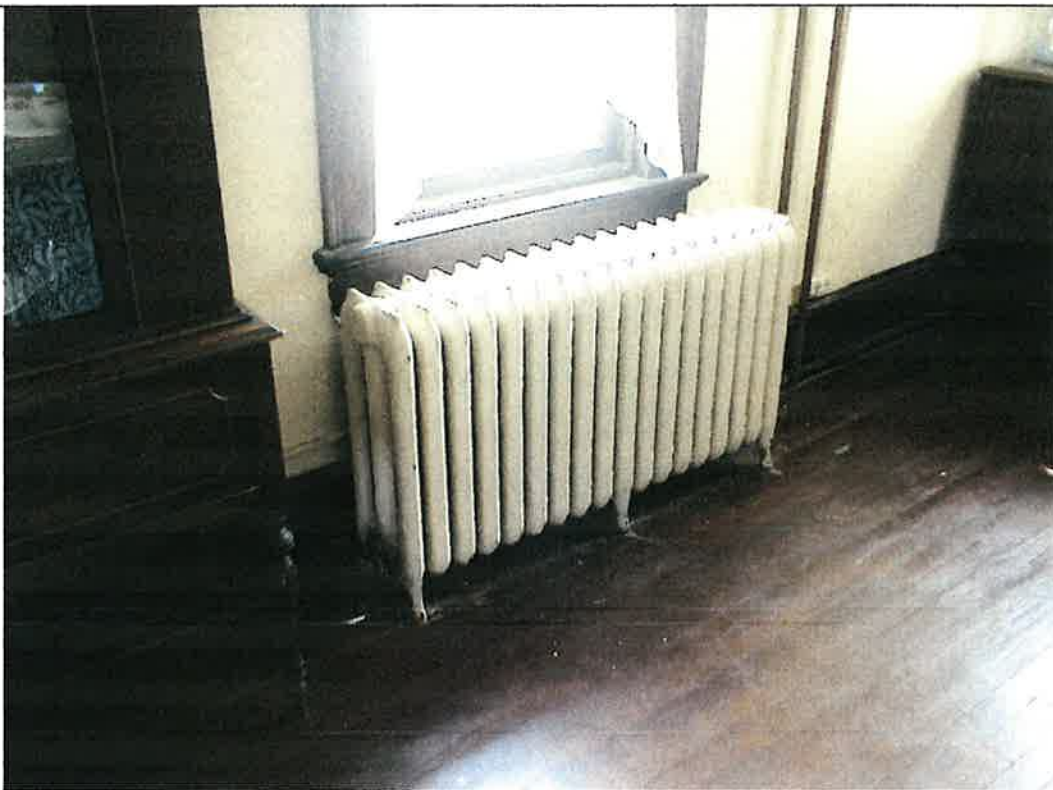
Existing Heating System – Boiler, Oil Storage Tank (top) and typical radiator (above).

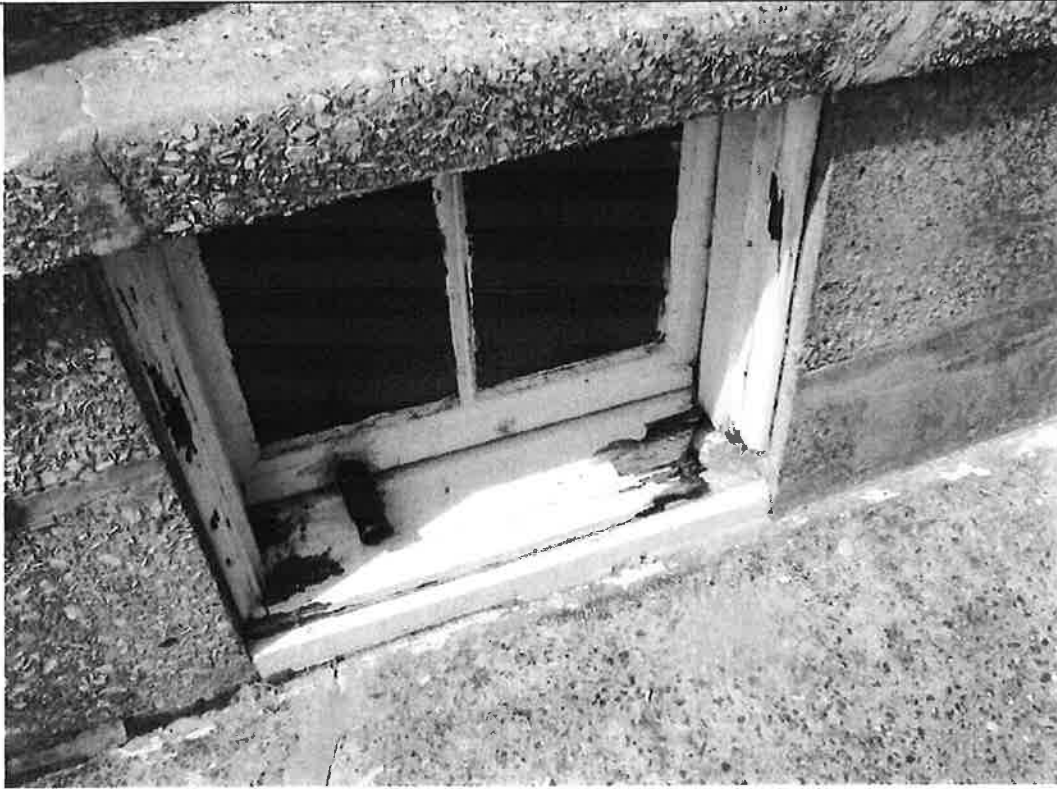
Evidence of rot at wood window frames.

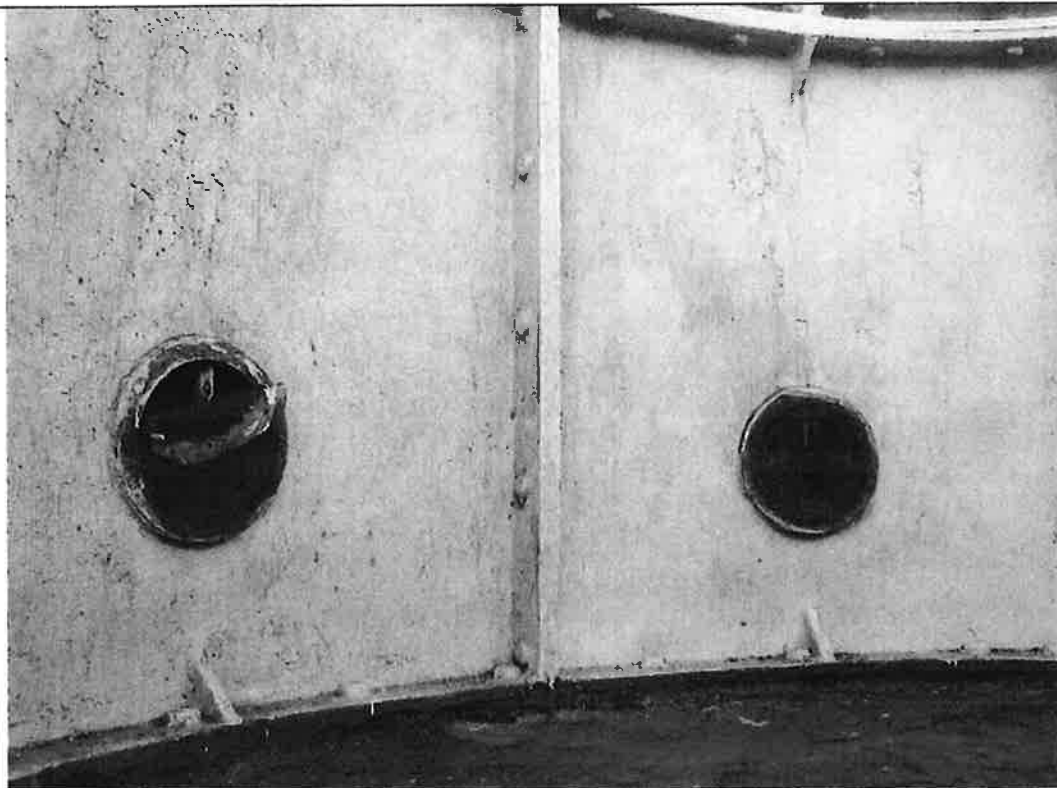
Existing air vents in Beacon -- possible source of moisture infiltration.

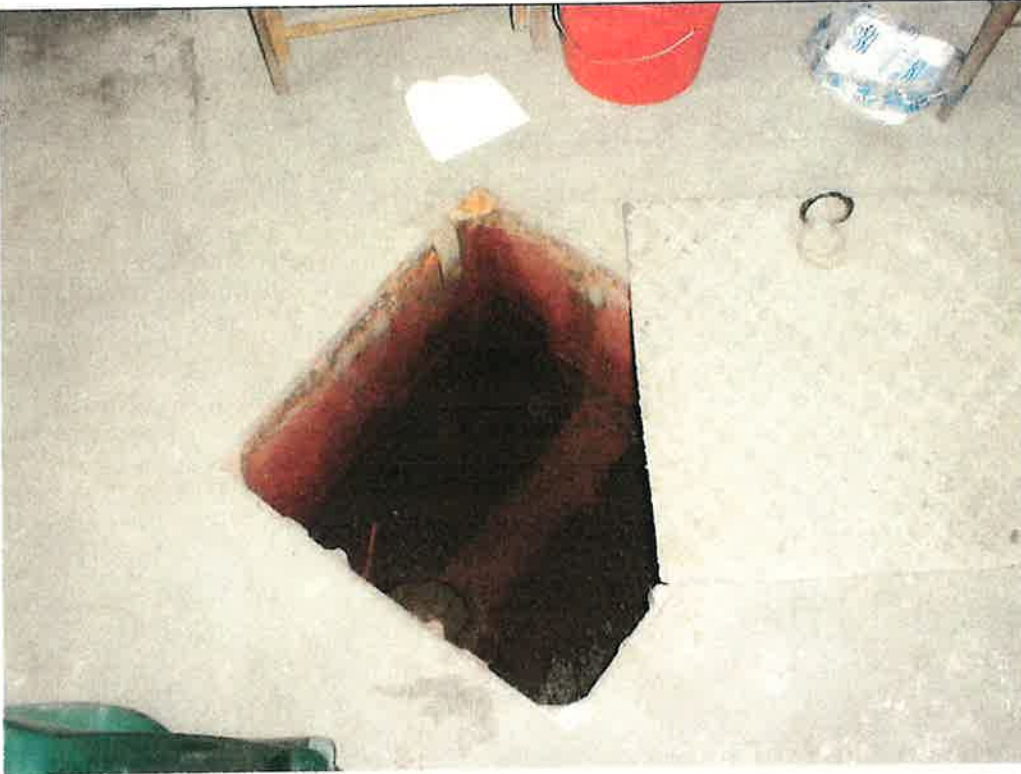
Existing access door in basement floor – original sanitary piping passes through

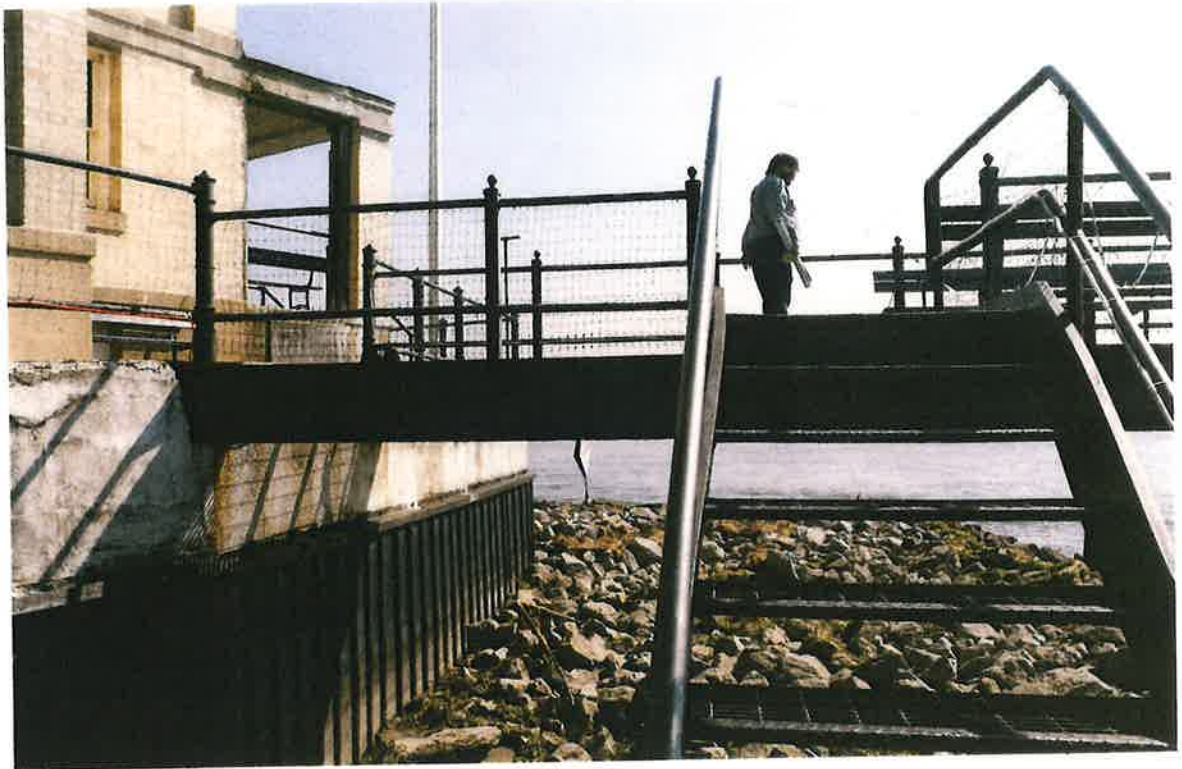
23

The vertical exterior face of the concrete pier from the top of the steel caisson to the underside of the topping walkway slab has been repaired over the years by repairing settlement cracks and reparging the surfaces. The concrete has deteriorated behind the steel caisson. The steel interlocking caisson is generally in fair condition . There are a

few signs of rusting of the thickness of the sheet iron, this condition indicates there are other hidden weak areas. The caisson steel cap has rusting and has rotted and fallen off in several sides. Refer to the structural report (photos 23-30).

Recommendations: Concrete cracks and face surfaces need to be repointed and parged to make the surface as weather tight as possible and possibly coated with a waterproof protection coating. The steel caisson cap should be replaced and the holes in the caissons repaired. **Cost = \$28,000**

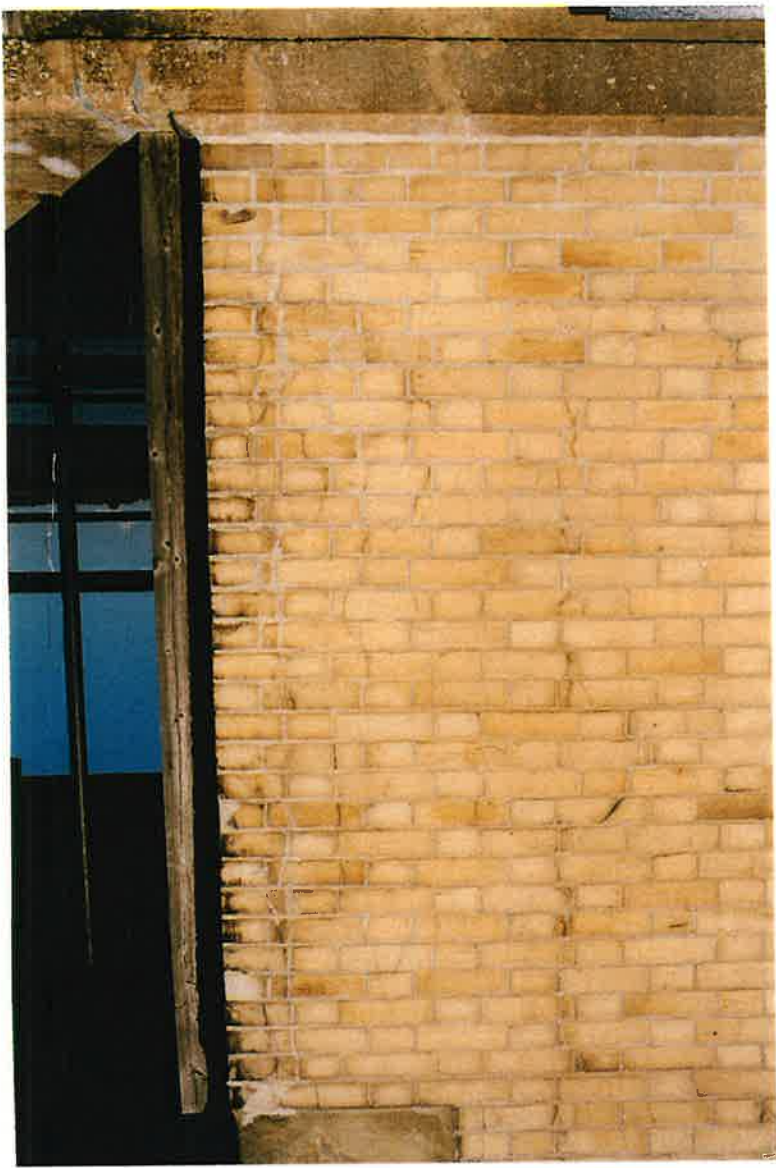
31

The wall is built with a flemish bond brick pattern with clay tile backup. In our last construction campaign the brick work was determined to be only repointed, and to postpone rebuilding of any more complicated conditions. But we are aware of failure of the brick due to building settlement and other movement and thermal action of the solid brick wall without any expansion capability. In addition to the structural cracks, hairline cracks are found in the wall and are concentrated at the corners. The hardness of the brick with tight mortar joints is contributing to the cracking as well. The exposed concrete lighthouse tower top appears in good condition. The exposed concrete surface has eroded due to freeze thaw cycles. Refer to the structural report (photos 31-38).

Recommendations: The movement of the structure is a given to the wood pile pier structure and evidence of settlement will require repairs periodically. At some future date the brick in the areas of greatest concentration of movement will require replacement. Due to the nonstandard size of the brick, it is recommended that a large quantity of the non-standard brick should be ordered and manufactured and purchased for longer term repairs as repair is needed. The original working drawings for the building do not give a precise detail of the construction of the walls. We recommend that a series of probes be made to confirm the construction and a study of crack pattern. An analysis of the brick should be made to determine its structural characteristics. The remaining 20% of the brick wall should be repointed as required to complete the repointing campaign. The exposed concrete top should be studied regarding possibly providing a breathable masonry waterproof coating to protect the surface. **Cost = \$26,000**

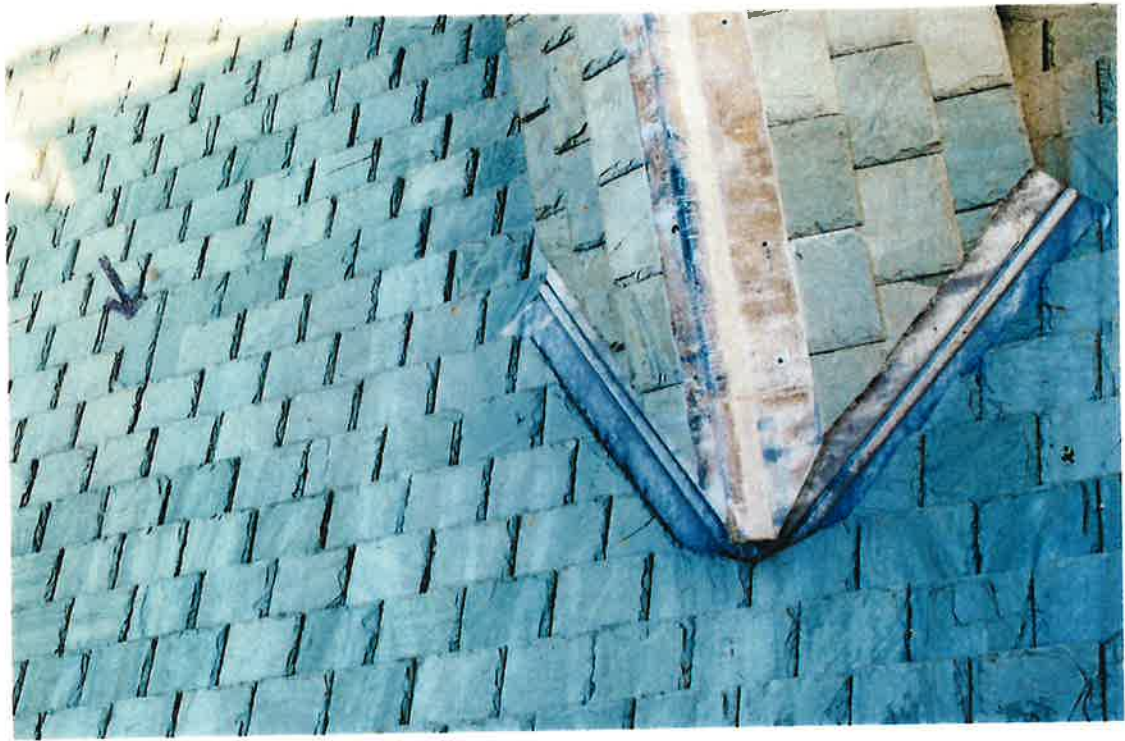
39

The slate roofing was installed in the late 1990's and is in good condition. The lead coated copper built-in gutters and flashings appear to be in good condition. There are two (2) locations where a slate shingles has been lost (photos 39-40).

Recommendations: The slate shingles that have been lost should be replaced. **Cost = \$500**

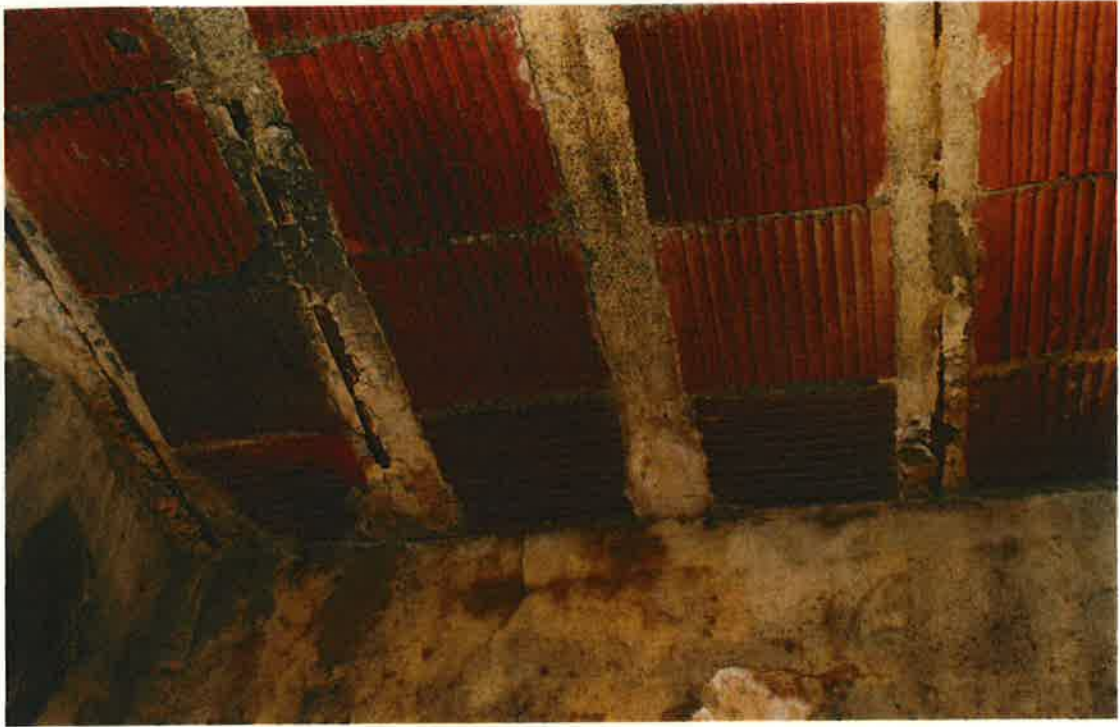
49

The floor system is described in the conditions report. There are various areas where the steel beam edges have been exposed and are rusting and should be studied as to how best to repair (photos 49-50).

Recommendations: Scrape and expose all rusted steel members of the floor system and paint with a protective coating. **Cost =\$5,000**
