**INTENSIVE LEVEL
MIDTOWN EAST SURVEY
City of Kingston**

Intensive Level Building Survey of the Midtown East Study Area
City of Kingston, Ulster County, New York

Survey Methodology Statement

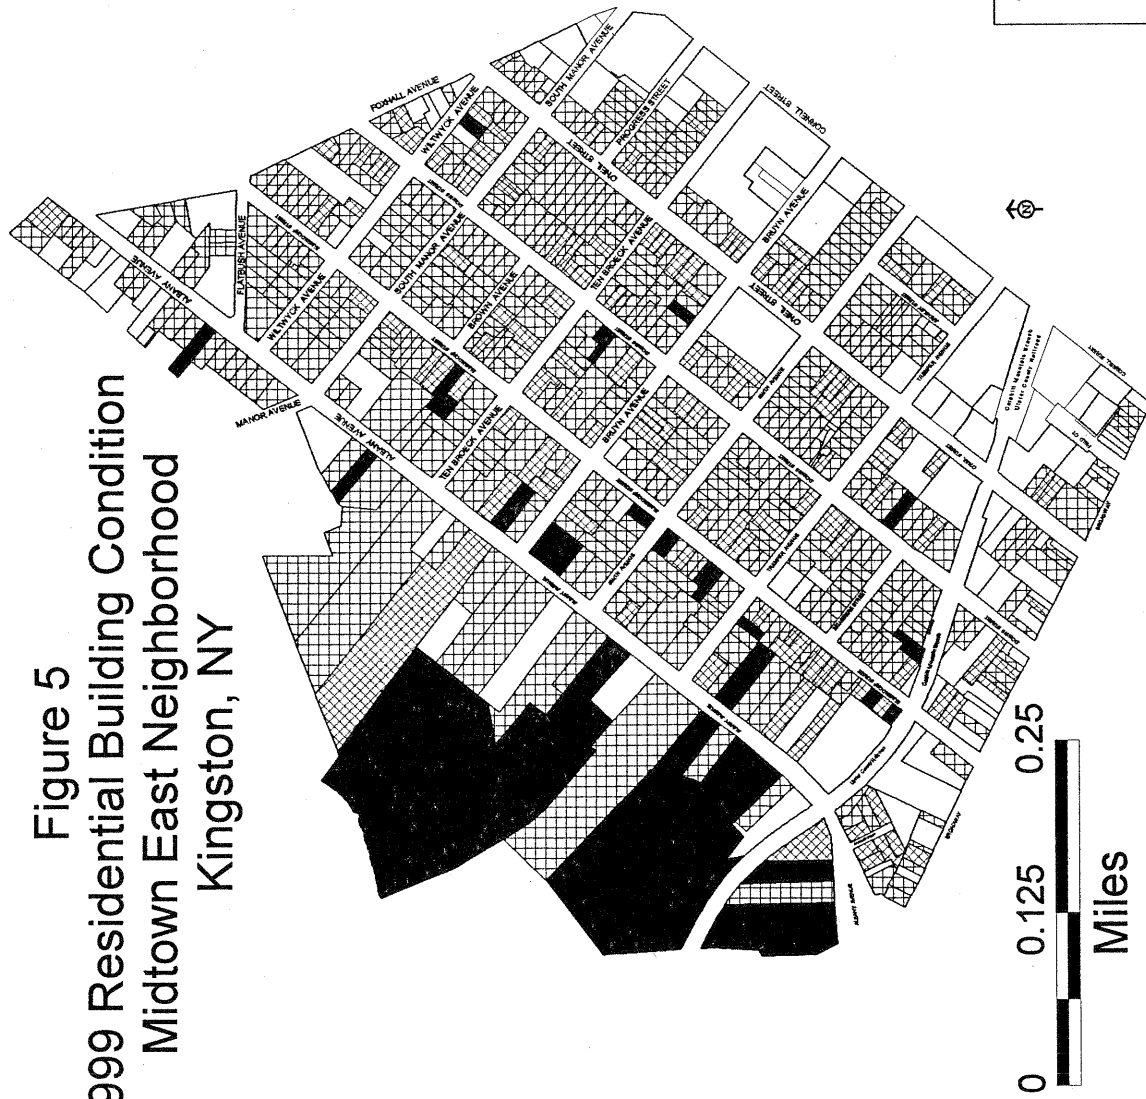
Figure 5
1999 Residential Building Condition
Midtown East Neighborhood
Kingston, NY

■	Poor	(12)
▨	Fair	(129)
▩	Normal	(472)
■	Good	(15)

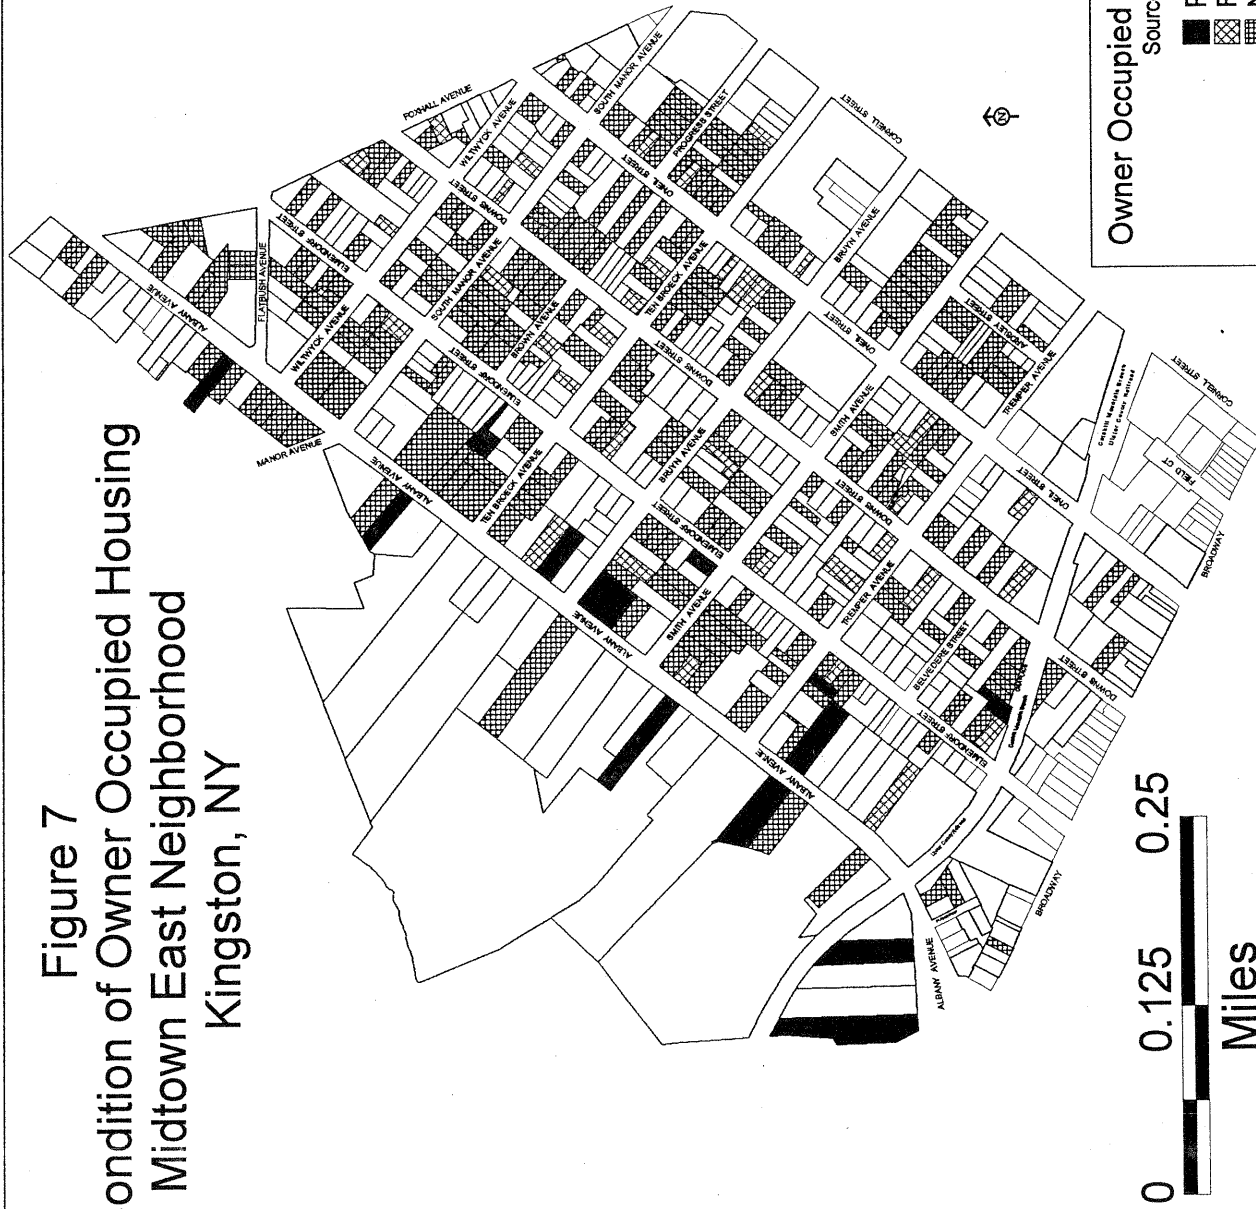
Figure 7
1999 Condition of Owner Occupied Housing
Midtown East Neighborhood
Kingston, NY

■	Poor	(2)
▨	Fair	(36)
▩	Normal	(254)
□	Good	(12)

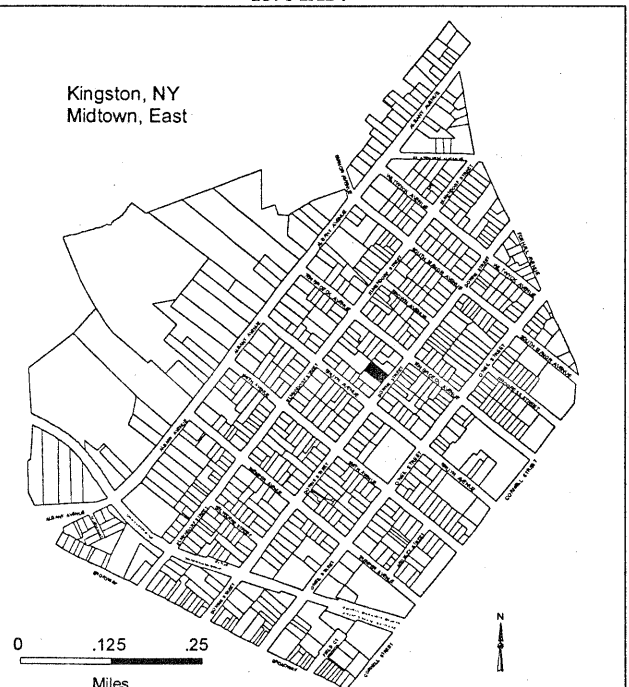
- a. none known. b. zoning c. roads d. developers e. deterioration ☒
f. other: vacant, pigeons inside
