## **FIELD REPORT**

## 106 Green Steet, Kingston NY:

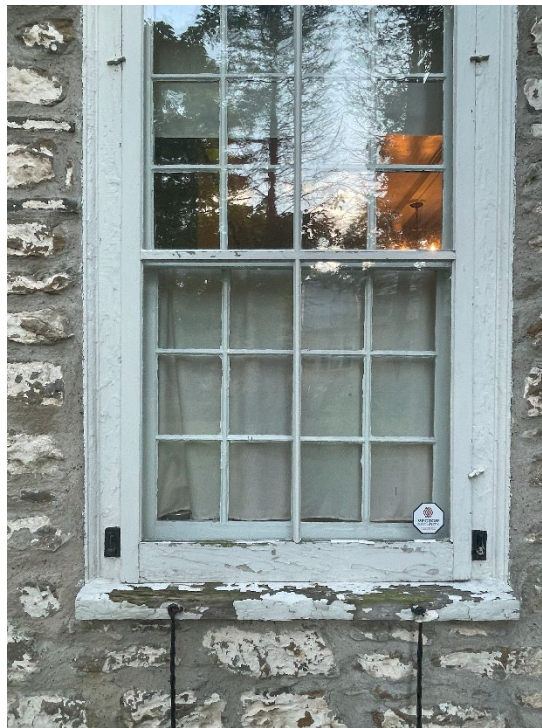
This photo is of a west facing window at 106 Green St. The storm window, added at an unknown date, may have been added during the early 19<sup>th</sup> century. Older photos of the structure show the dwelling had an exterior shutter system that would have helped protect the sashes and would have provided a bit of security and protection against weather elements. At first glance, one would think that this is not worth saving, but that's not the case at all. While the window system is weathered, the wood and glass are both sound. The system that's failing is the paint system.

Also, not visible in this photo, are any gaps that may exist due to the jamb being out of square. Those gaps are easily remedied by adding bronze weatherstripping and by making a few minor adjustments to the sashes. Another attribute in regards to increasing the life span of this window system is to remove the current paint, sanding the old growth wood to release the tannins and treat the wood with a treatment of boiled linseed oil prior to painting. This will help protect the wood fibers, increase the rot resistance. Applying finish coats of linseed oil paint will also assist in increasing the lifespan of the windows.

Based on the historical findings on this property and the observed condition of the existing windows, it is noted that these windows should remain in place and not be replaced. The sample of the replacement window that was reviewed at the onsite meeting on 2/19/25, is not a historically accurate replica of the existing windows and would change the look of the home and significantly change the historic value of the house. The existing windows contain characteristics in the glass and the structural elements of the wood sash that lend to the historic architectural value of this building and other similarly aged homes located in Kingston NY.
