Re: Demolition of Herzog's Warehouse Building at 9-17 North Front Street

Re: Asbestos Abatement Air Sampling, Monitoring: 9 Front St. (Herzog's Wearhouse)

An clearance air sampling, lab evaluation, and visual clearance inspection by a NYSDOL Licensed project monitor determined the satisfactory abatement of Asbestos Containing Material located on the 1st, and 2nd floors of Herzog's Wearhouse, 9 Front St., Kingston, NY.

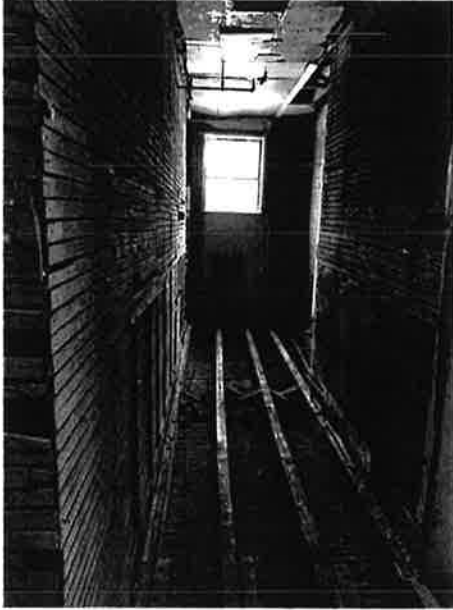
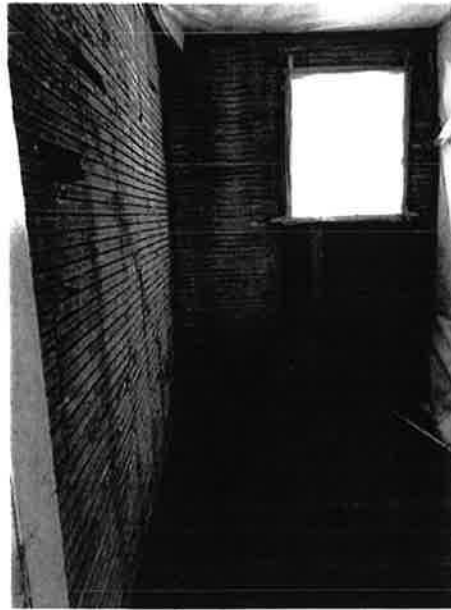
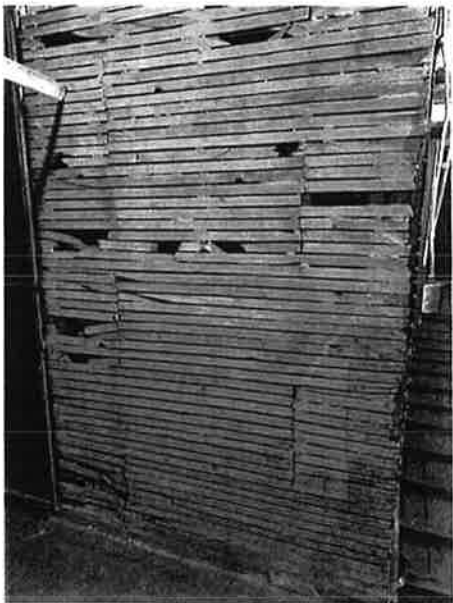
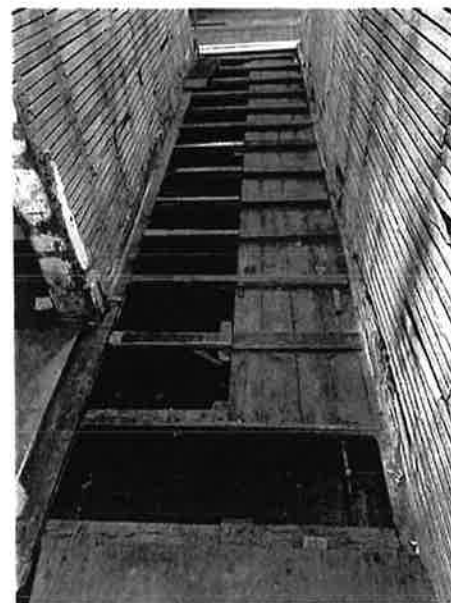
2nd floor Work Area (Post-Abatement)

Along with this, as per NYS CR56, the project required a final visual inspection of the work area by a licensed Project Monitor, to ensure no presence of the identified ACM following removal. The work area passed a visual inspection, and is clear of all identified ACM.

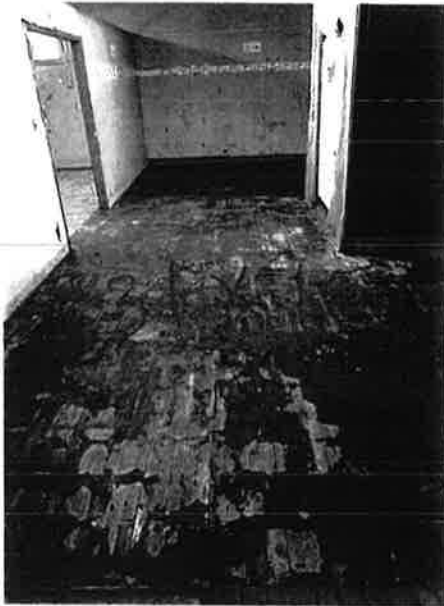
1st floor Work Area (Post-Abatement)

(Left): 31x15 9x9 tile on top of Non-ACM Tar-paper Mastic

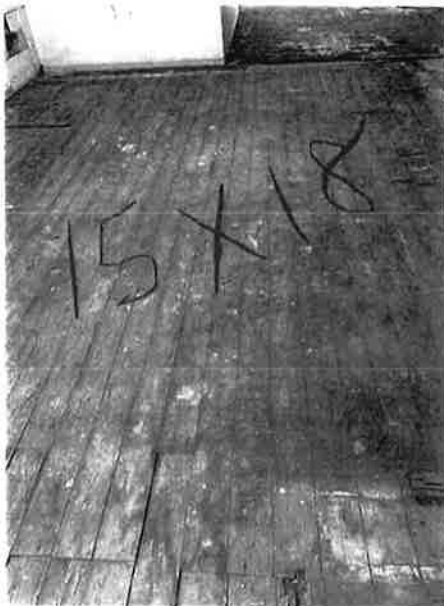
(Left) 15x18 Mastic on top of nailed plywood
