Cooper Lake Dam Rehabilitation Public Presentation

Mescal Hornbeck Community Center, Woodstock

November 18, 2019

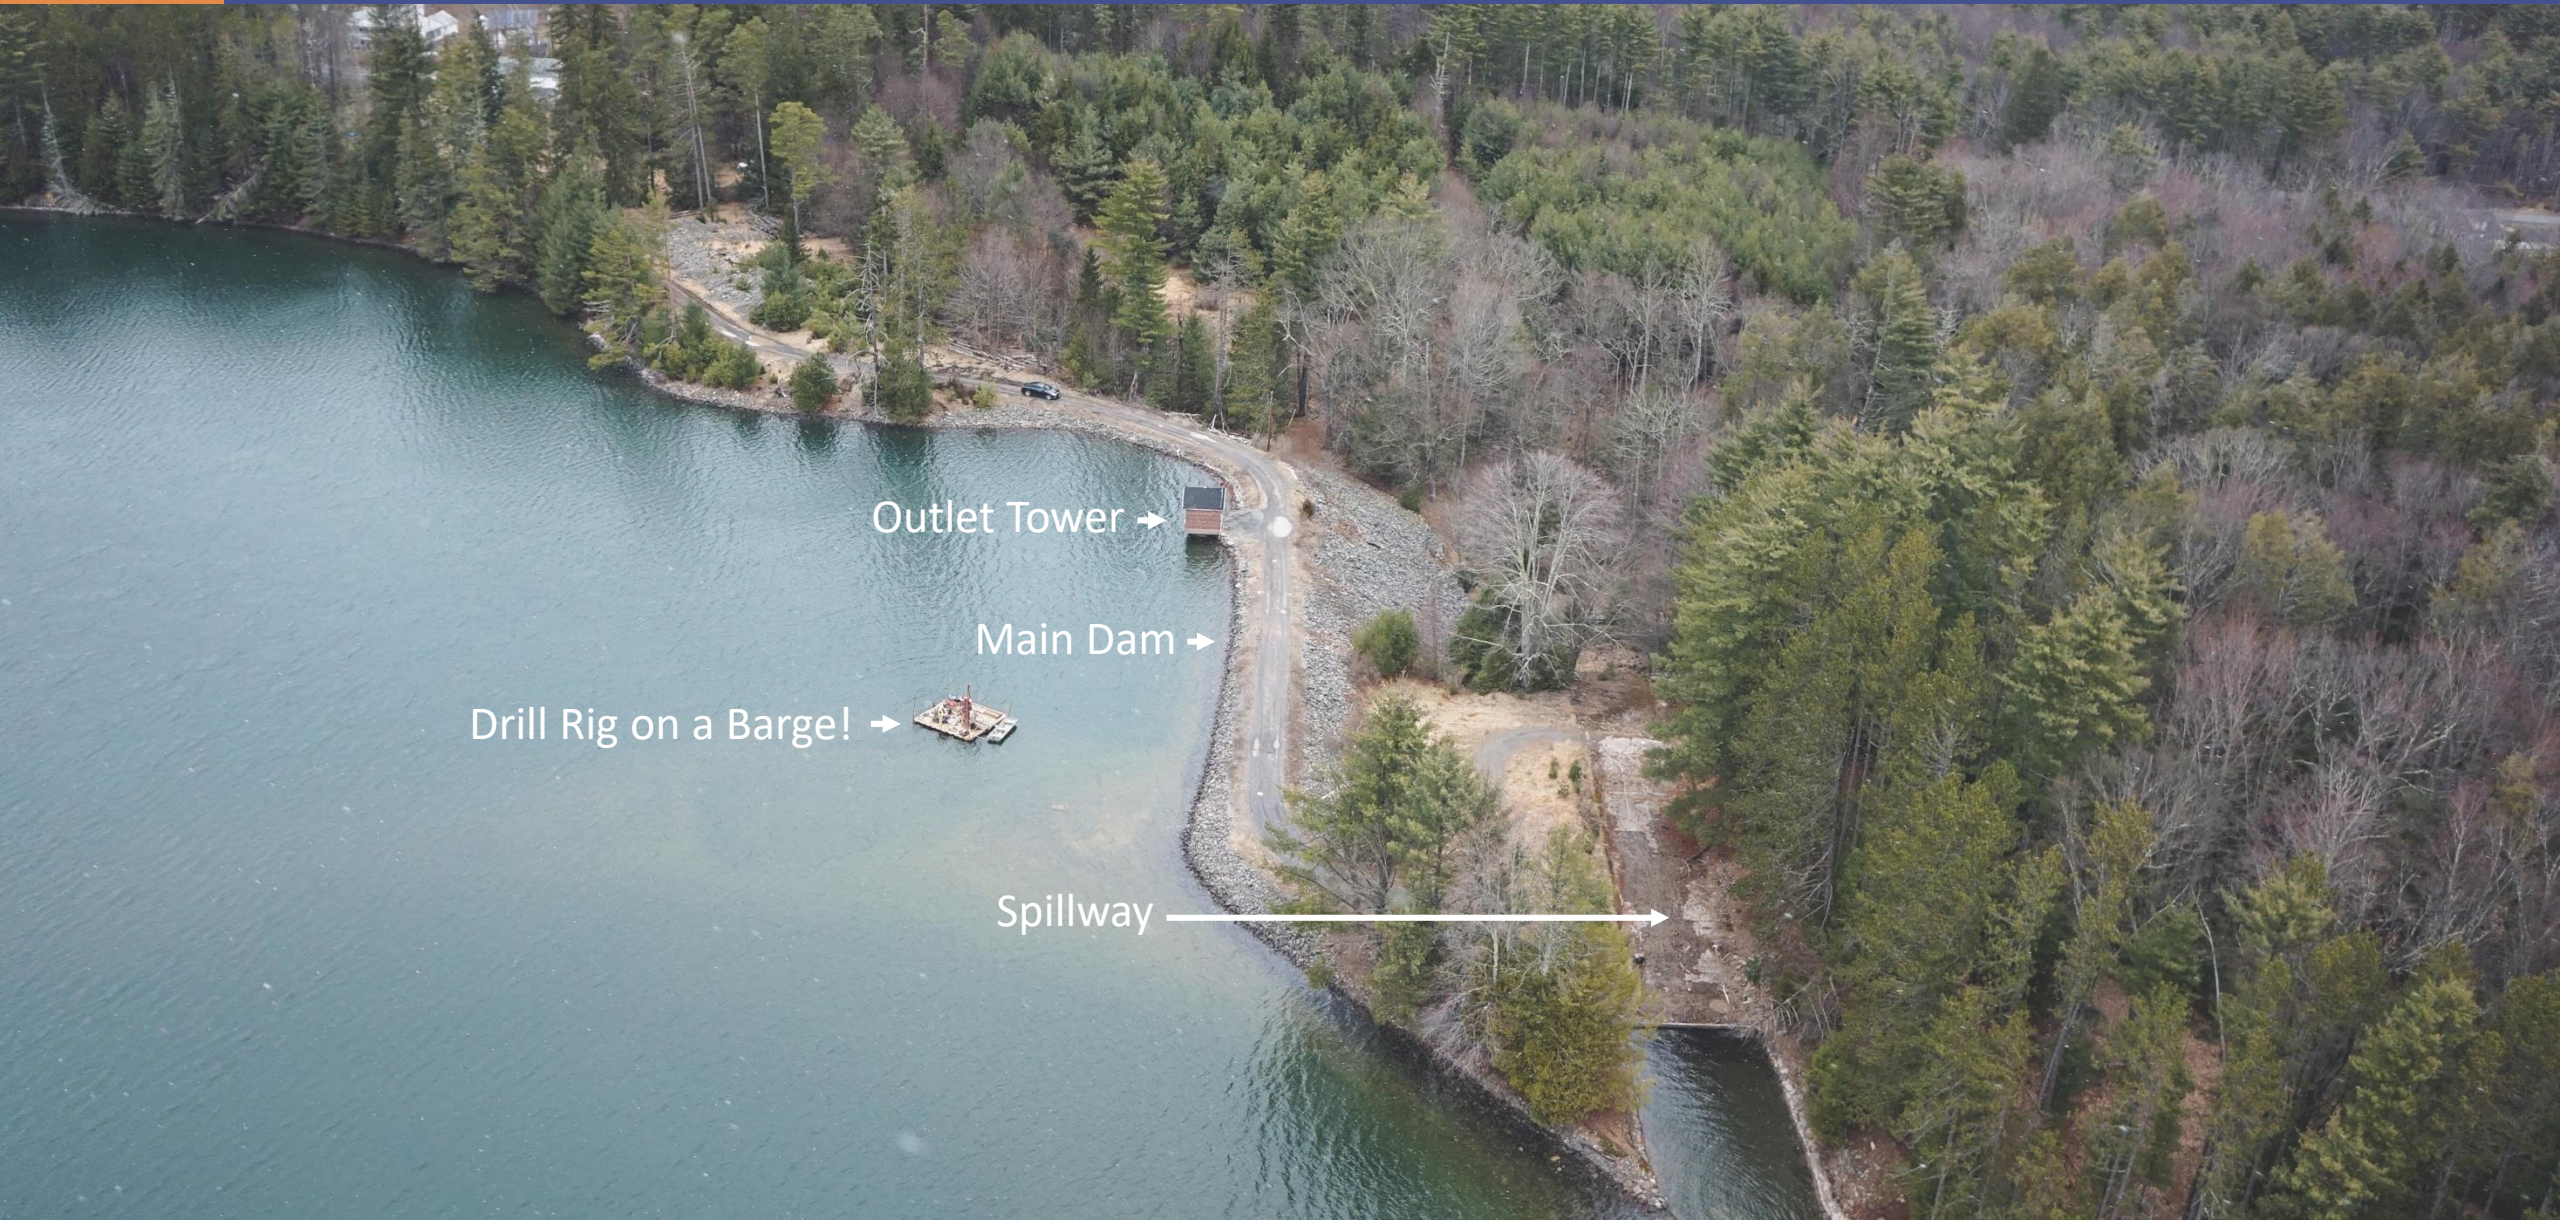
Cooper Lake Dam

Outlet Tower →

Main Dam →

Drill Rig on a Barge! →

Spillway →

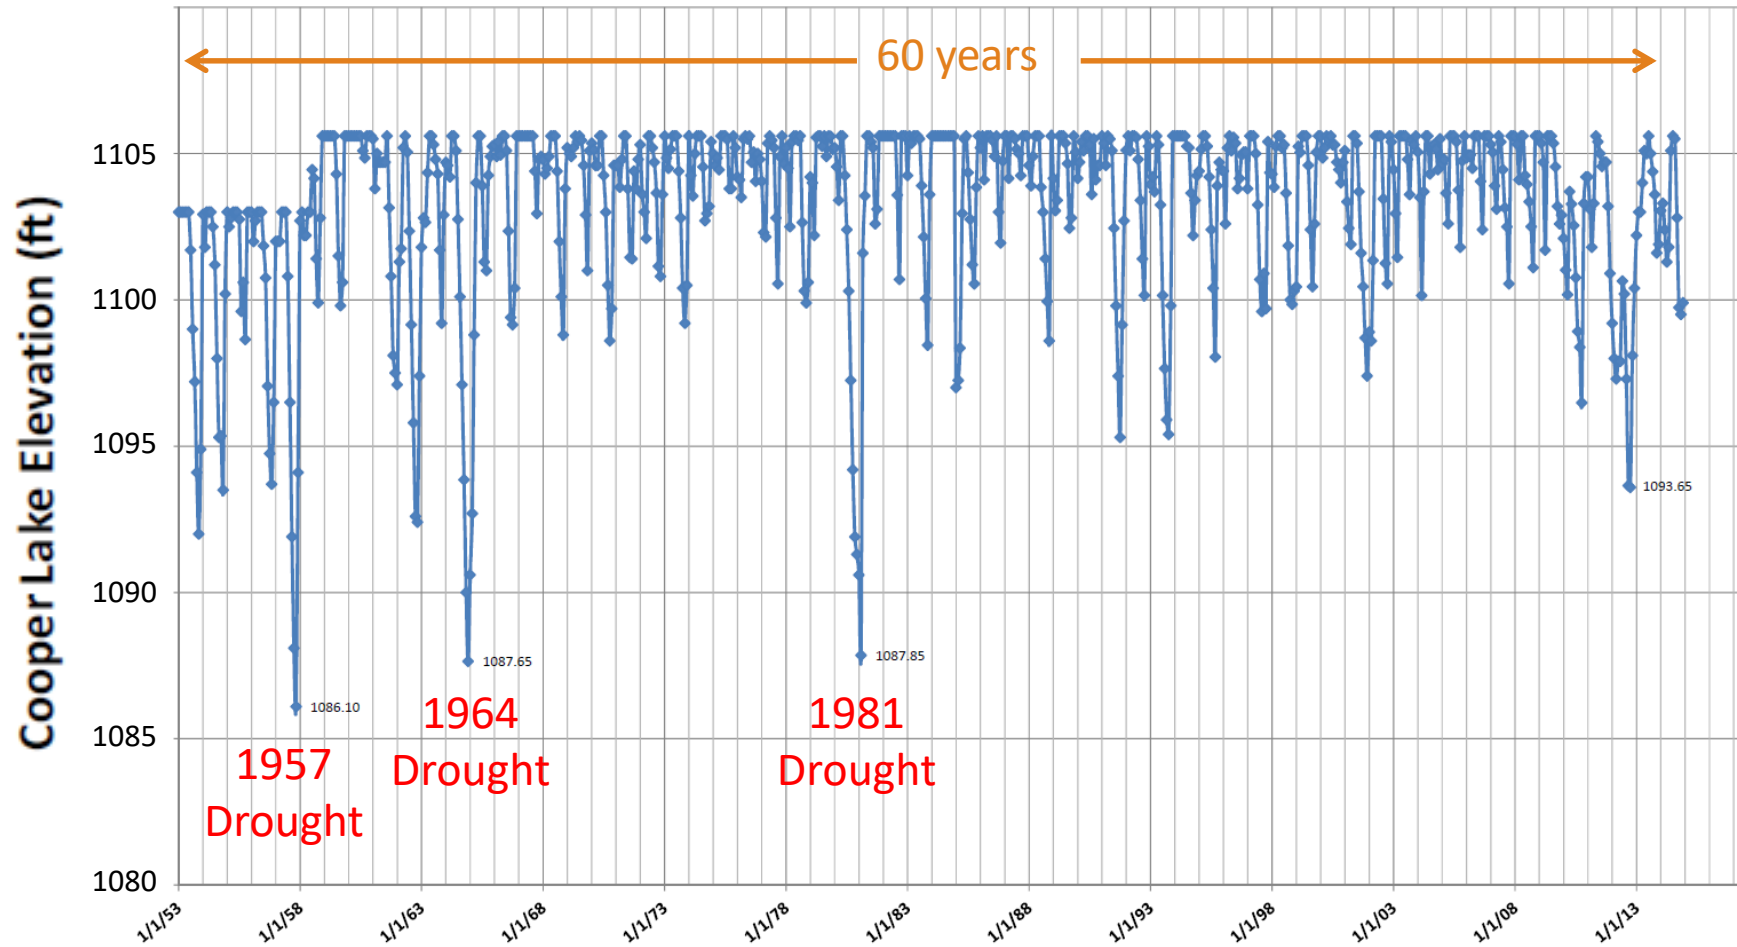
Cooper Lake – Historical Elevations

Note: Bottom of Reservoir Approx. 1066 ft

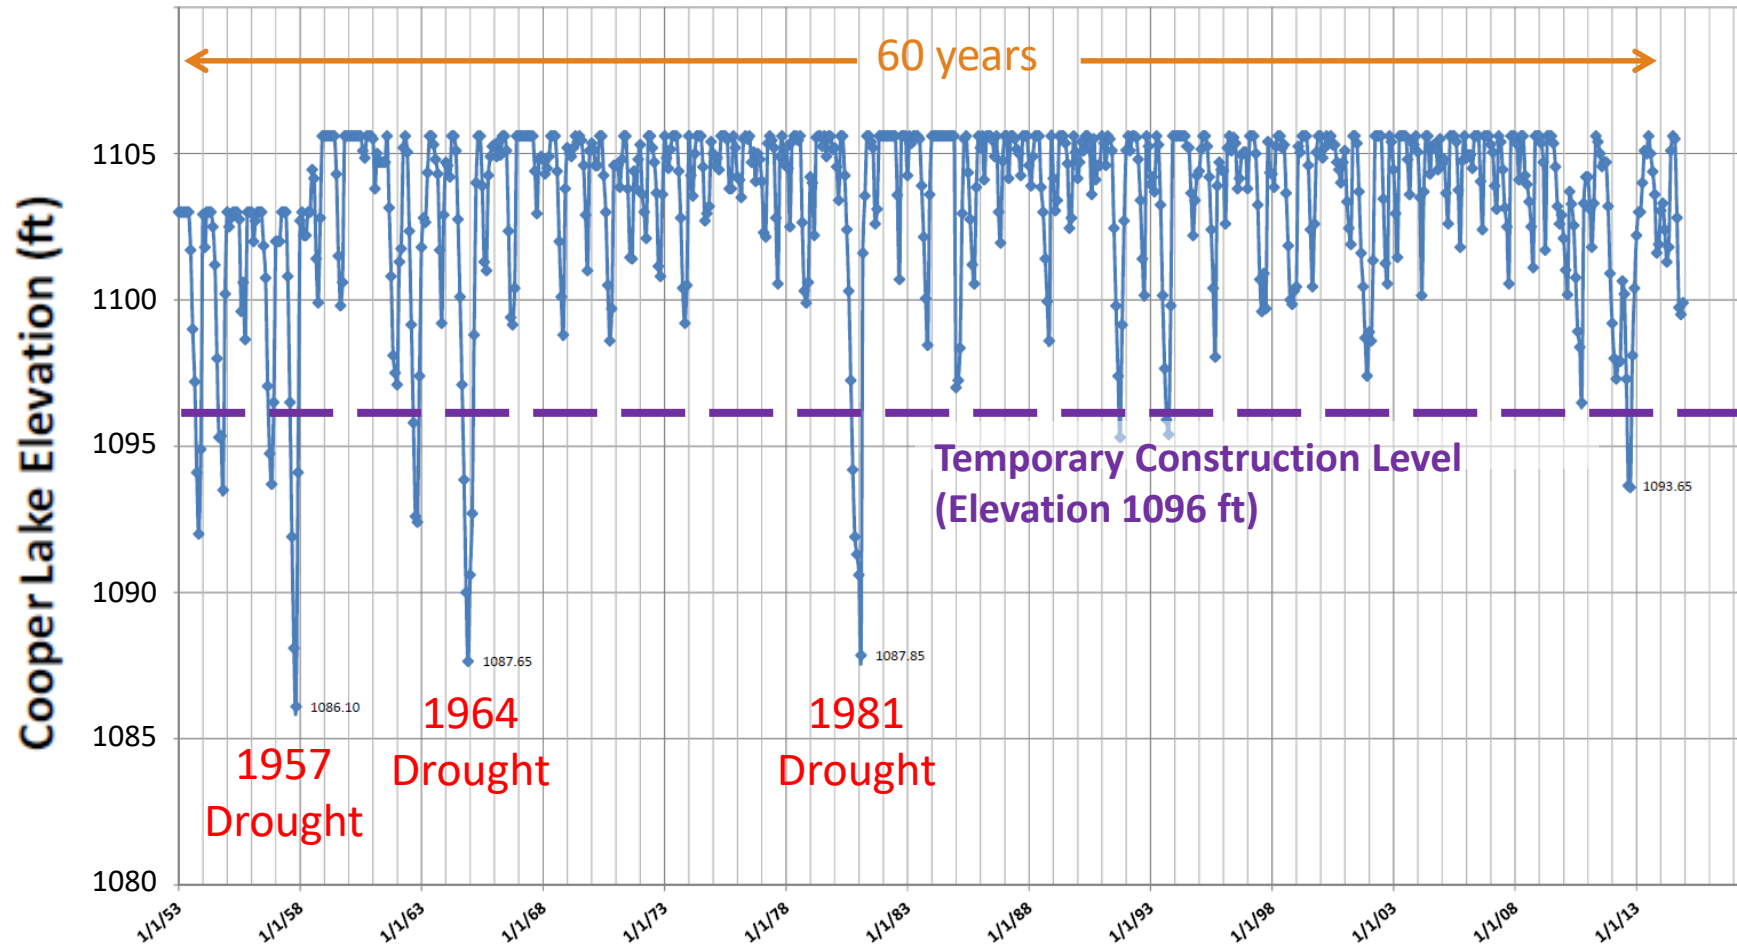
Cooper Lake – Temporary Construction Level

Note: Bottom of Reservoir Approx. 1066 ft

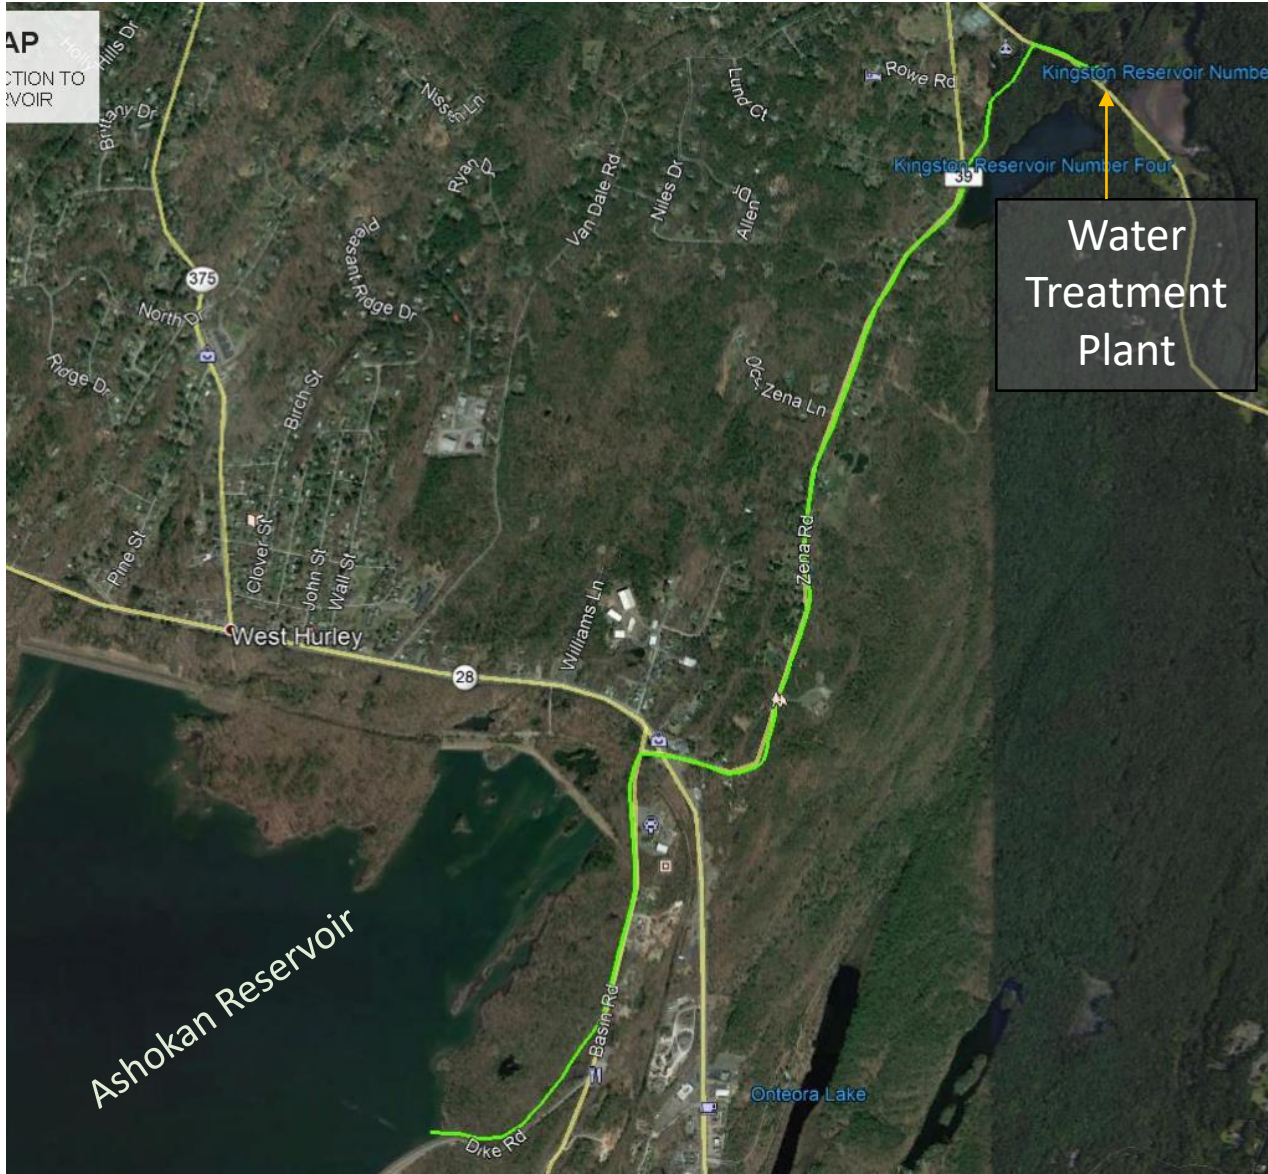
Temporary Ashokan Reservoir Connection Map

Permanent

- Connection Chambers
- Electrical Service
- Road Crossing Sleeves (3)

Temporary (if needed)

- Pumps at Ashokan
- Overland Water Main
12-Inch HDPE ~16,000 ft
