KINGSTON HISTORIC BLUESTONE SIDEWALK SURVEY

PROJECT REPORT

John H. Braunlein

November 30, 2013

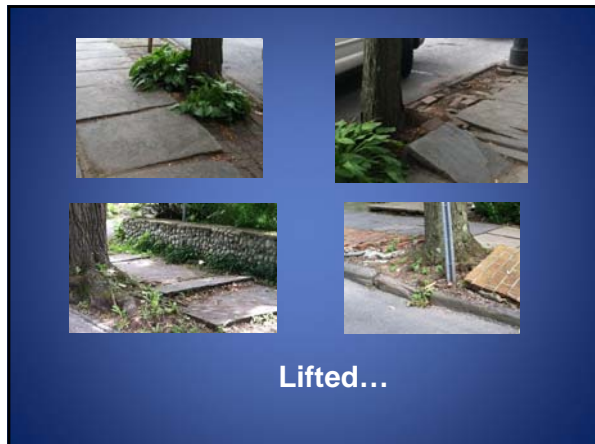
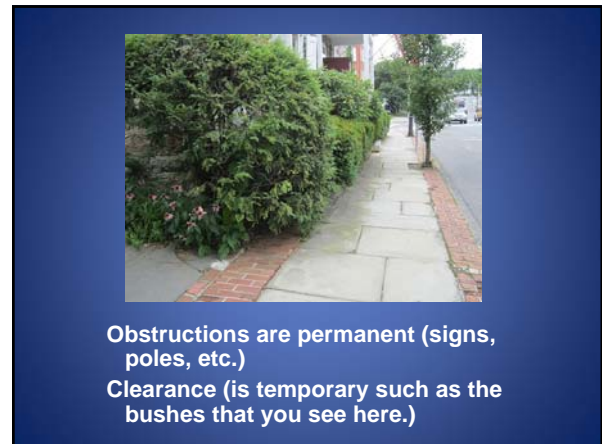
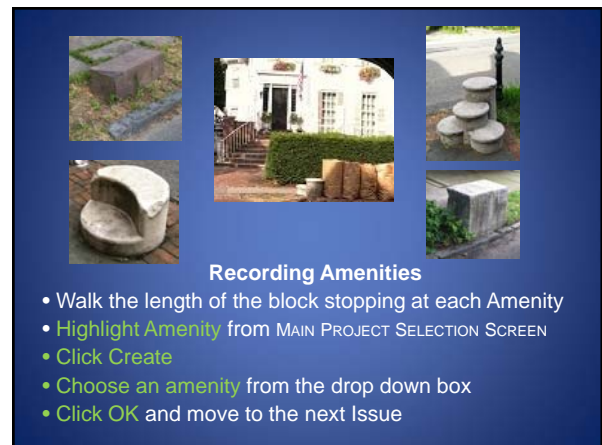
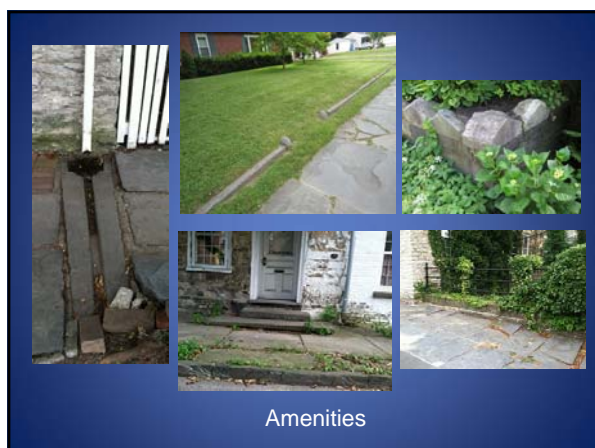
Issues

Cracked, broken, delaminated...

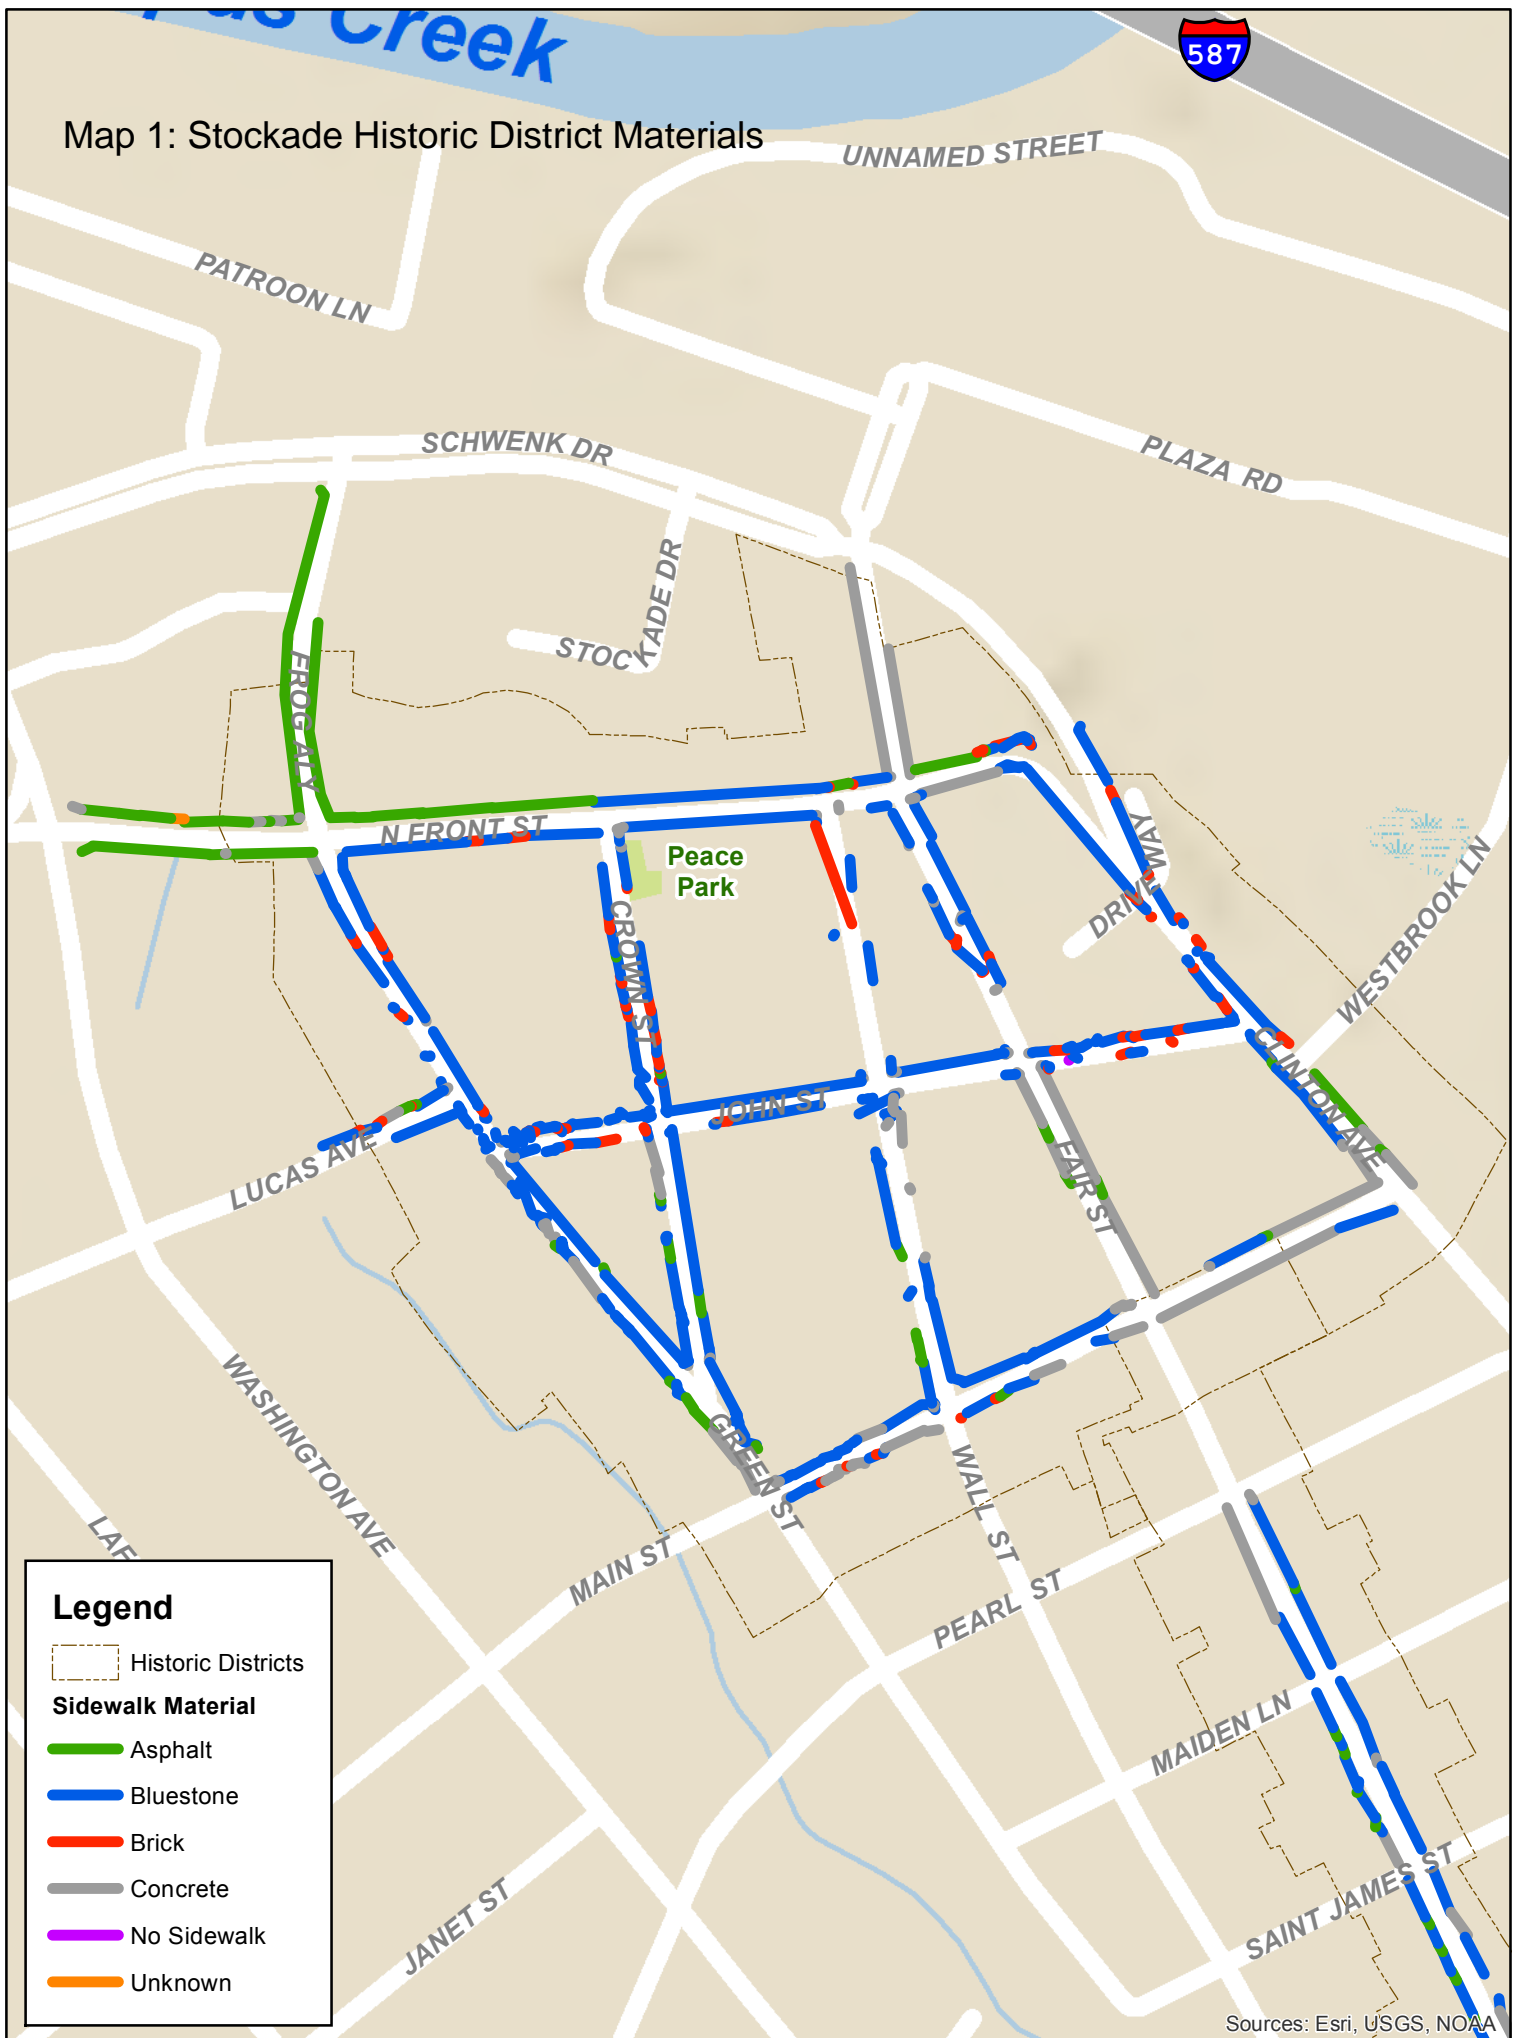
Map 1: Stockade Historic District Materials

Sidewalk material in the Stockade District is 58% bluestone, followed by 16% concrete and 15% asphalt. The bluestone consists of both historic material and modern flags. More than 57% of the Stockade District sidewalks are in poor or fair condition. Comparing the maps showing conditions and materials, we see that 63% of those rated poor or fair are made of bluestone, although we cannot tell whether they are historic or modern materials, and the data does not correlate condition issues to the presence and condition of street trees. Fully 82% of condition issues are cracking/delaminating (49%) and lifting (33%); the former typical of modern materials, the latter usually correlated to street trees that are over age, of species with shallow roots known to interfere with sidewalks, and have been installed according to outdated protocols and/or have been poorly maintained.

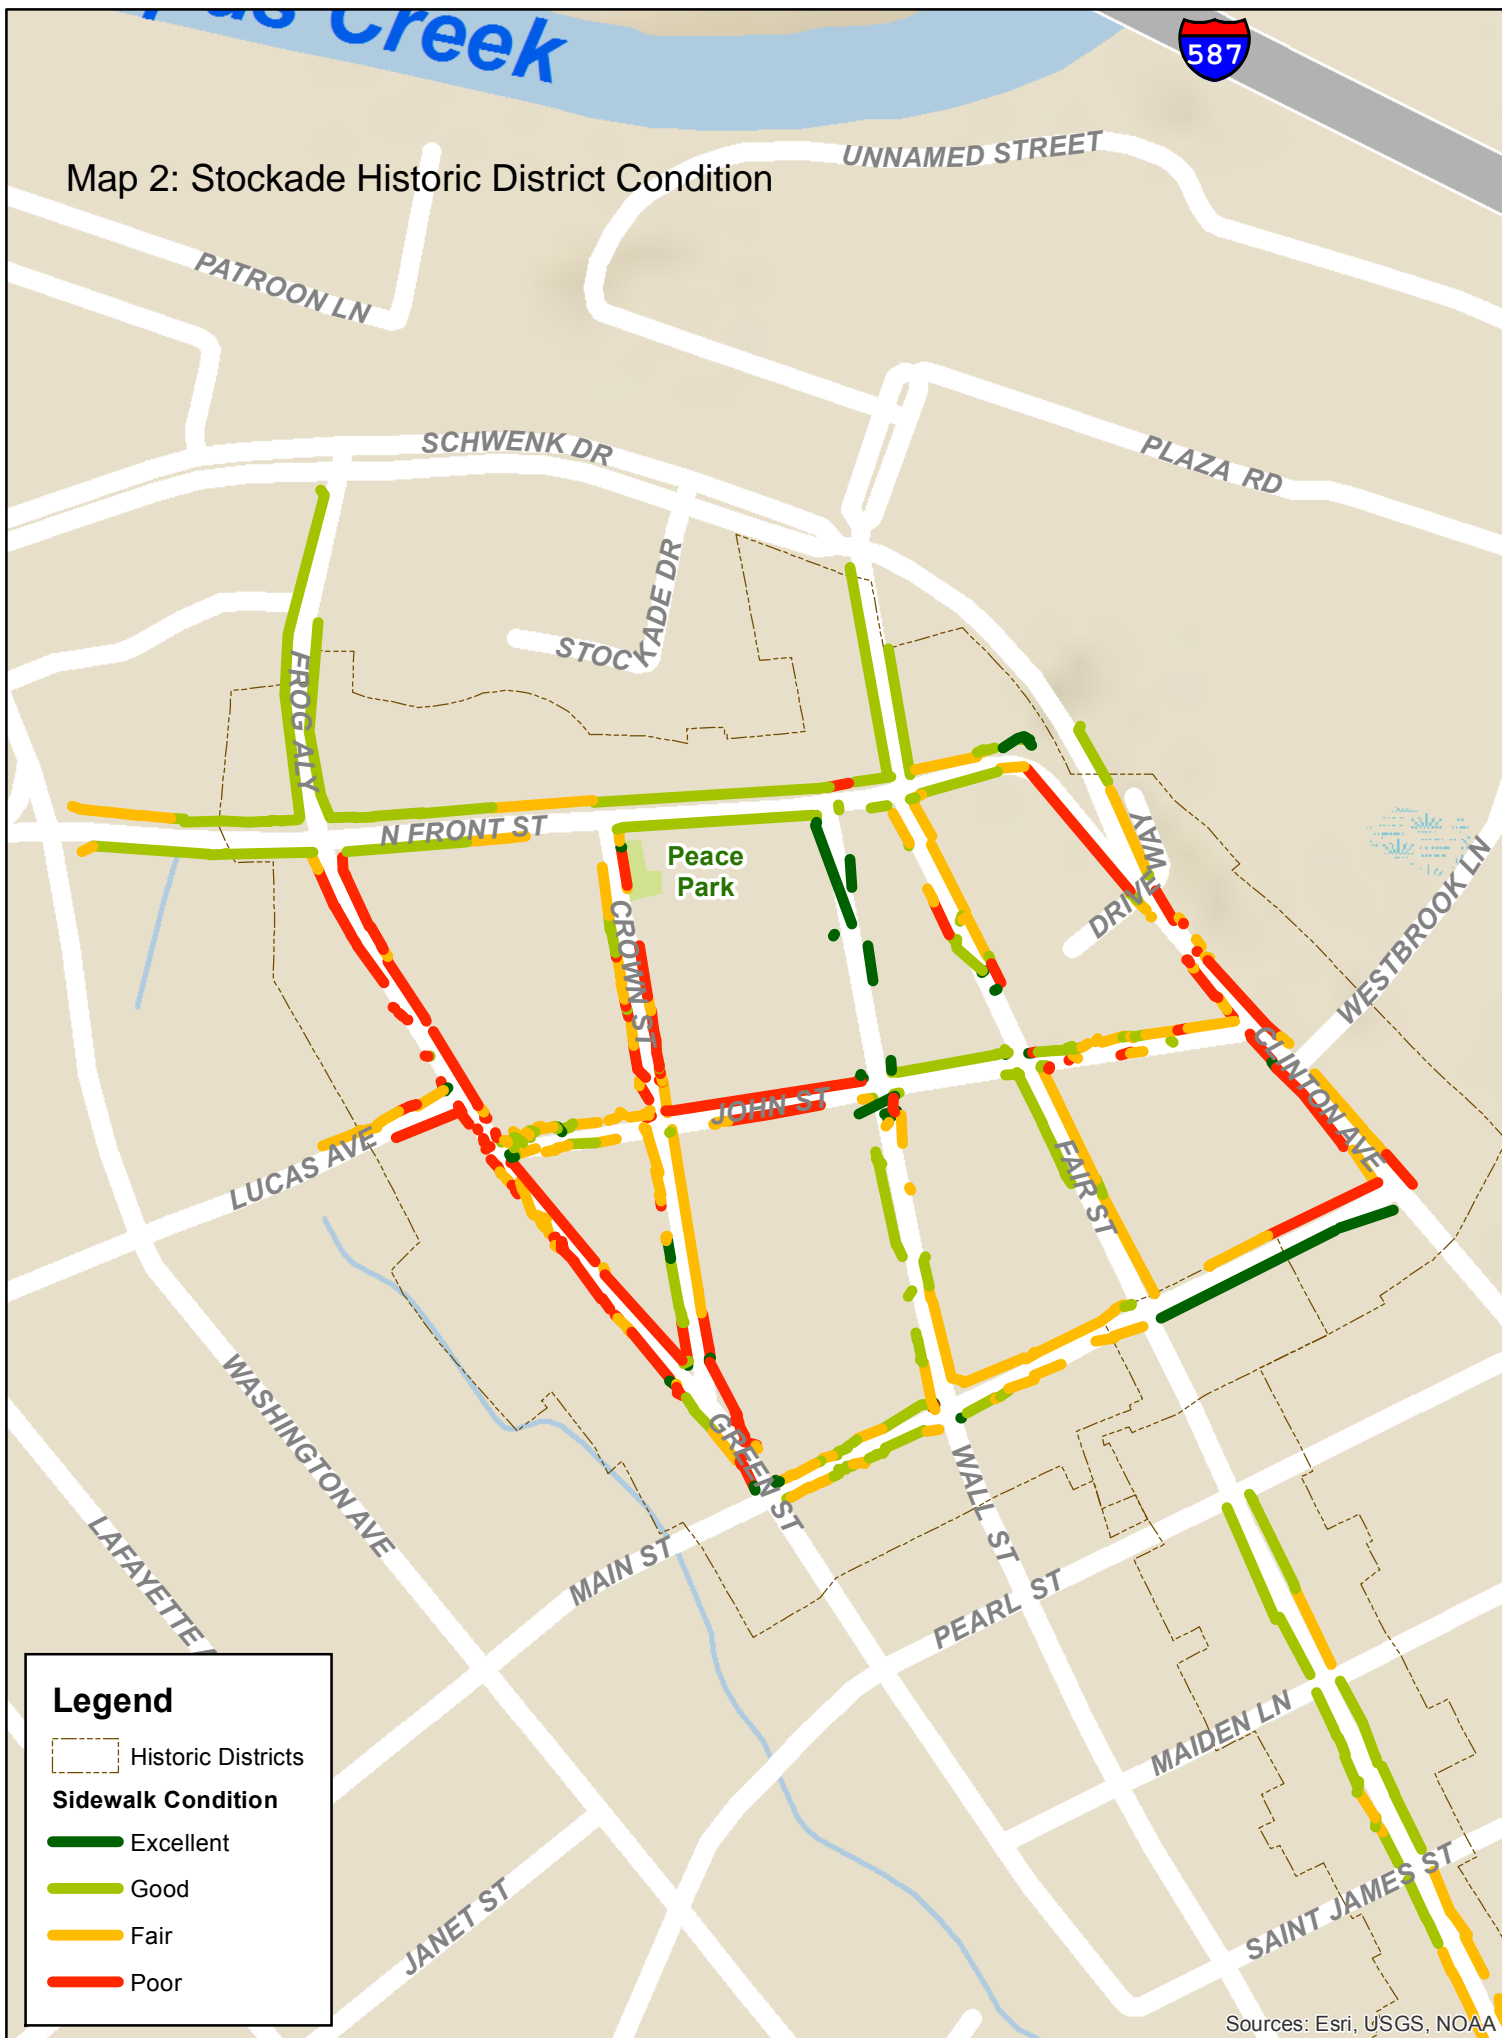
Map 2: Stockade Historic District Condition

Significantly, the bluestone sidewalks along Clinton Avenue, Crown Street, and much of John Street – that include some of Kingston’s most historic architecture – are in very poor condition; the sidewalks on Green Street – an 18th-century streetscape of stone houses -- are in deplorable, often hazardous condition. In addition to extensive cracking and delamination, a large number of the stones are lifted, some as much as 4” to 6”, one even 10”, making this area especially treacherous. Typical of such compromised areas, most street trees are species inappropriate for street use, and are much older than the fourteen-year life span now recommended for trees in urban streetscapes. Further, they have been installed without accommodation to train roots to the bedrock below and in buffers steadily encroached by street widening over the years.

Street, in particular, have already been cited, but there are numerous areas -- especially in the Stockade and Rondout Districts -- equally deserving attention. It is recommended that the hazardous areas documented in this survey be studied and a plan developed and implemented to correct these conditions.
