**INTENSIVE-LEVEL HISTORIC RESOURCES
& BUILDING SURVEY
WILBUR & PONCKHOCKIE NEIGHBORHOODS
CITY OF KINGSTON, ULSTER COUNTY, NEW YORK
RFPK #22-11**

EXECUTIVE SUMMARY

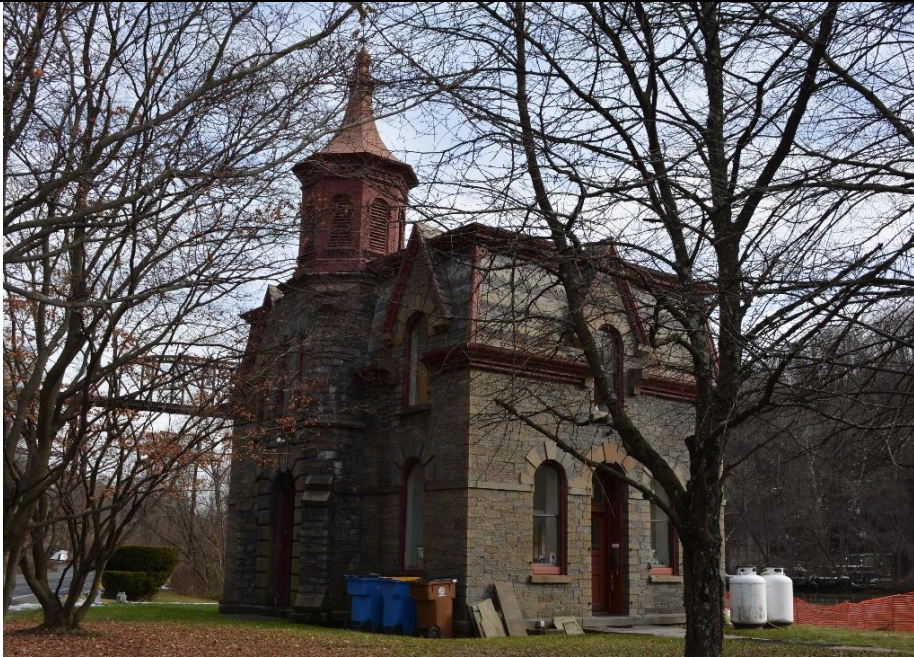
Photo #:	Address / Block & Lot:	Year Built:	Eligibility Recommendation:
1	532-574 Abeel St / 56.57-3-11.210	1870	ALREADY LISTED ON NRHP

<p>Description: Second Empire building with exterior comprised of bluestone. It is three bays wide and two bays deep. The entrance located on the first floor consists of an archway and two buttresses. The second floor has narrow arched windows with voussoirs. There is a capped tower in an octagonal cupola.</p>

532-574 Abeel Street (Photo 1): (built 1870, per NRHP nomination) – This building is the former Fitch Bluestone Company Office (see Illustration 1). This Second Empire style office building, constructed of locally quarried, rusticated, ashlar-cut bluestone in irregular sizes, was added to the National Register of Historic Places in 2016. The NRHP nomination notes that the building is locally significant under both Criterion A, commerce & industry, and Criterion C, architecture.

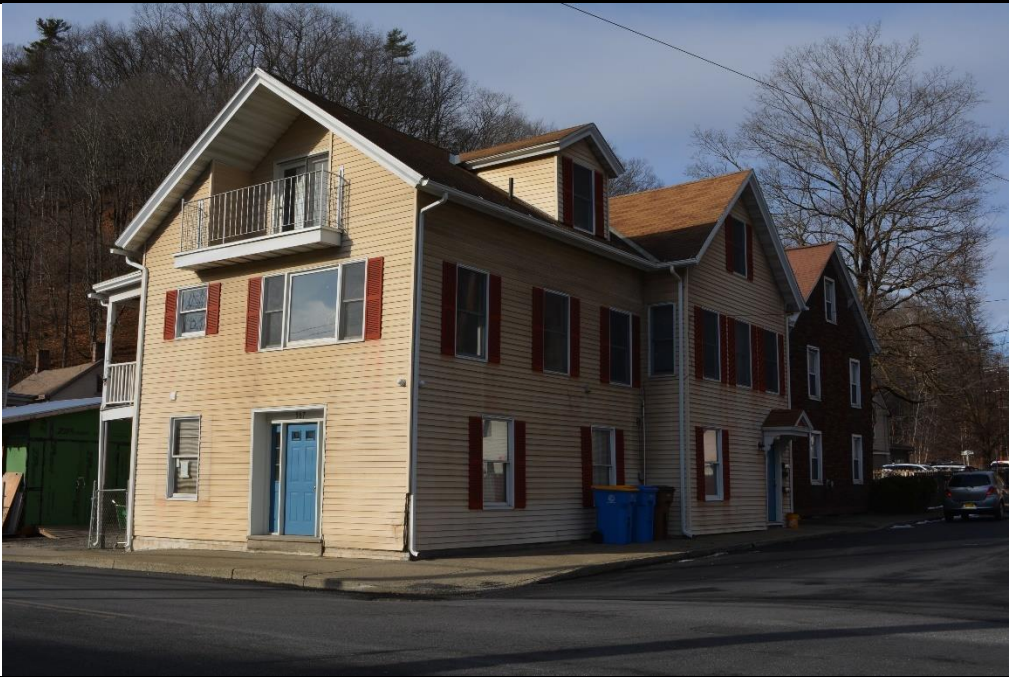
Description: A vernacular/National style building with vinyl exterior, a cross-gabled roof form and asphalt roofing material. It is six bays wide and two bays deep on the first floor. Lacks integrity.

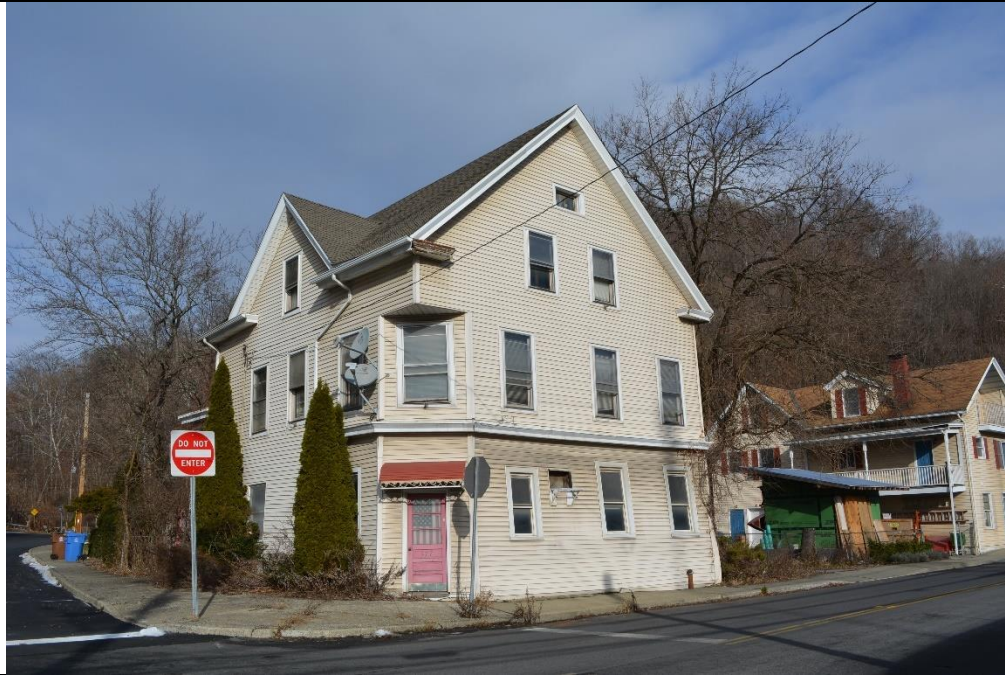
Description: A vernacular/National style building with vinyl siding, cross-gabled roof form and asphalt roof. Corner entrance. Roughly 4 bays wide & deep. Possibly shown on 1870 Beers map. Replacement windows and doors – lacks integrity.

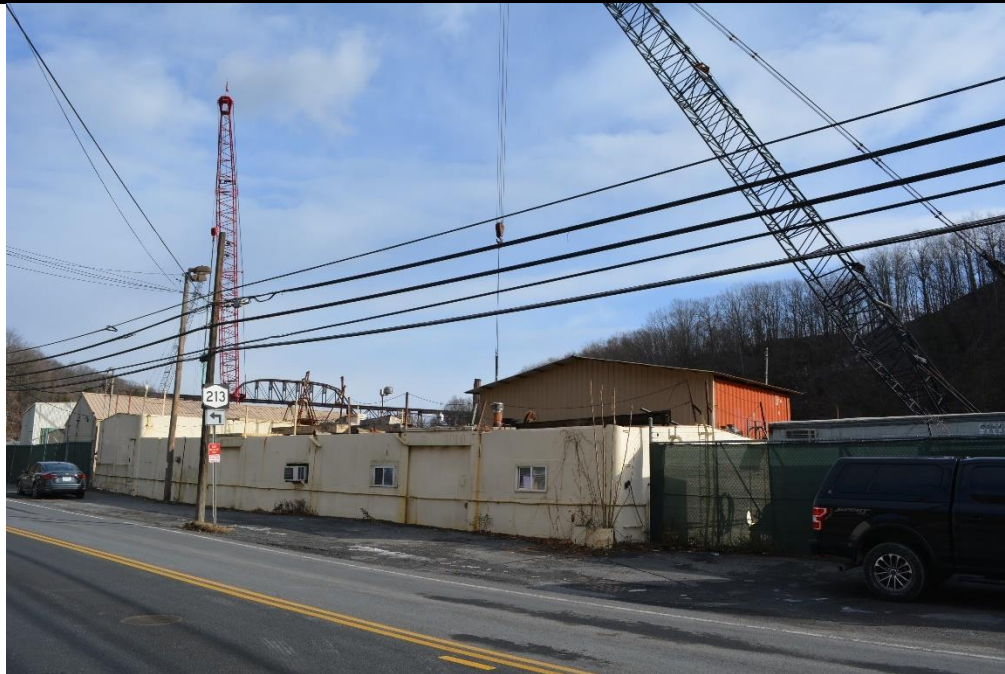
Photo #:	Address / Block & Lot:	Year Built:	Eligibility Recommendation:
6	582-598 Abeel St / 56.57-3-10	1950	NOT ELIGIBLE:

Description: Astylistic utilitarian steel manufacturing buildings. These two are repurposed superstructures of covered steel barges of a type that operated around NYC in the mid-20th Century

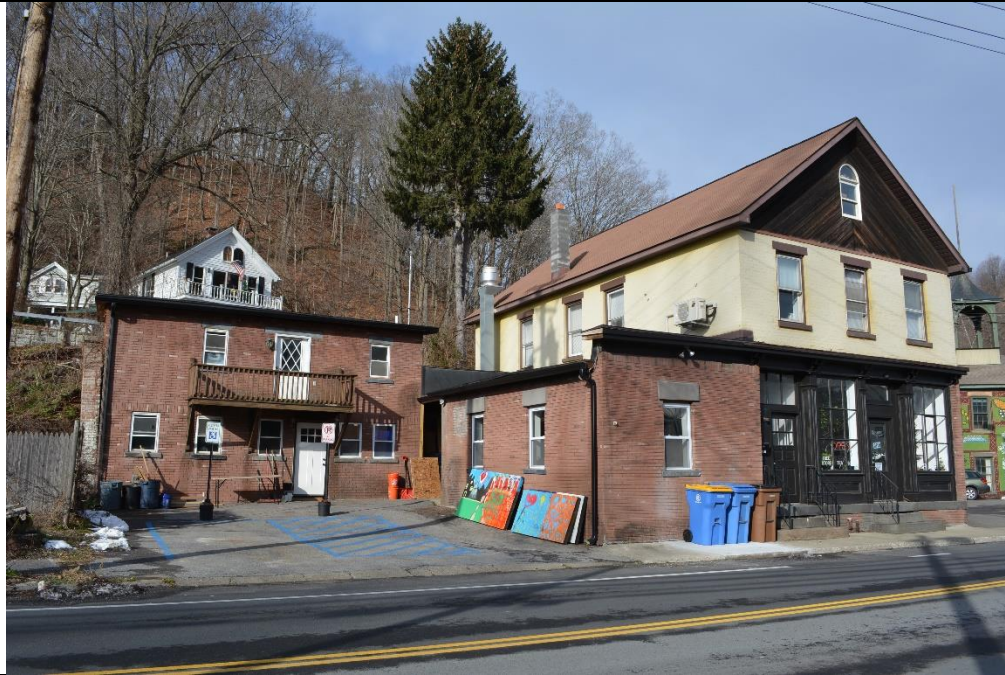
Description: A vernacular/National style building with a brick exterior, wood front gable, asphalt roof. Glass window storefront and entrance door, the second-floor has three bays wide. There is an attached first floor brick extension on the southern side of the main building.

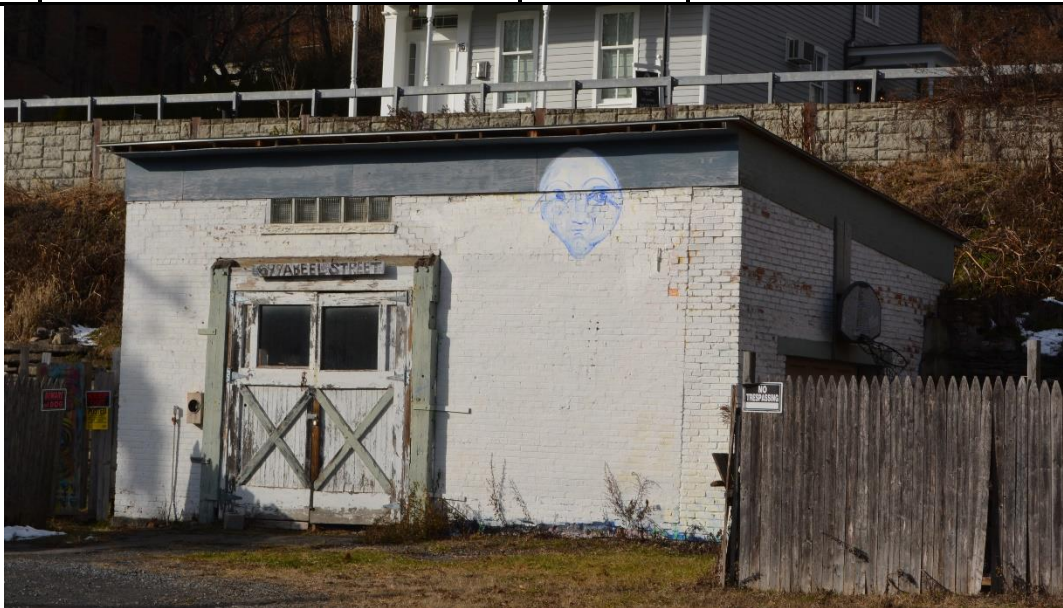
Photo #:	Address / Block & Lot:	Year Built:	Eligibility Recommendation:
8	599 Abeel St / 56.57-2-10	c. 1870	HD, NON-CONTR

Description: Astylistic utilitarian brick rectangular garage with wooden door entrance and metal roof, likely a remnant of a larger blacksmith shop, now belonging to 1984-built house (next page). Lacks integrity.

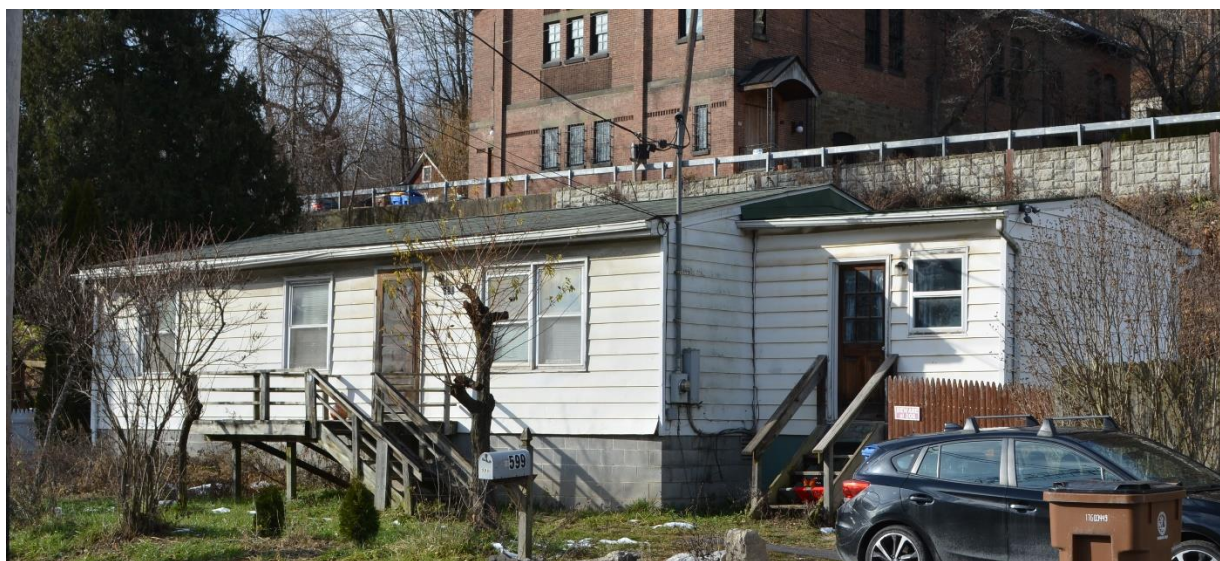
Photo #:	Address / Block & Lot:	Year Built:	Eligibility Recommendation:
9	599 Abeel St / 56.57-2-10	1984	NOT ELIGIBLE, NON-CONTR

Description: A contemporary building with metal siding and asphalt roof material.

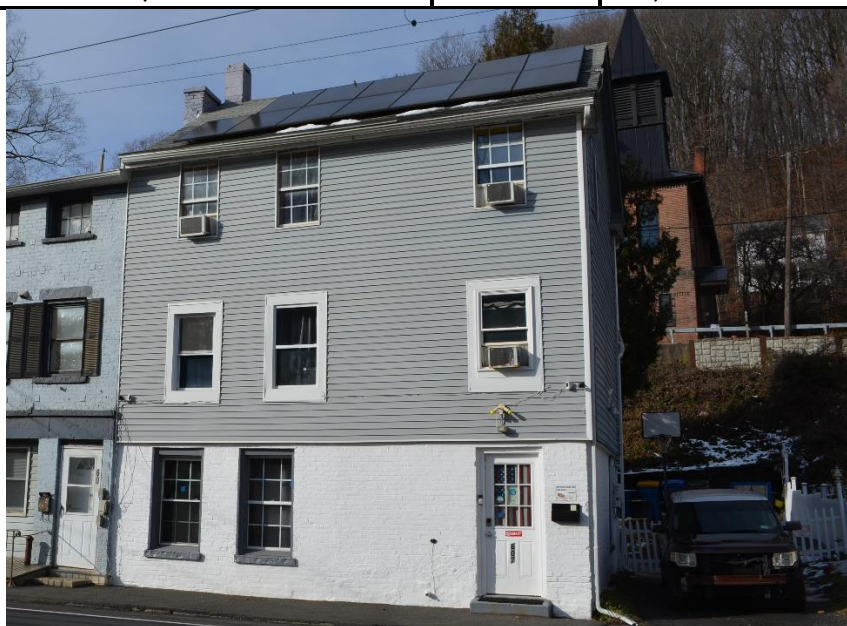
Photo #:	Address / Block & Lot:	Year Built:	Eligibility Recommendation:
10	607 Abeel St / 56.57-2-9	1856	HD, CONTR

Description: Three story vernacular/National style building with side gabled roof. The first floor is brick with 3 bays; the second and third floor clad in vinyl. The roofing material is asphalt with solar panels. Replacement windows & doors.

607 Abeel Street (Photo 10): (c. 1856, per tax records) – This and the adjacent building at 609 Abeel Street may be depicted on the 1858 French map as well as the 1870 Beers map, although the 1870 map shows a narrow space between the buildings here. The 1887 Sanborn shows the buildings as they appear today. Both buildings are side-gabled, nearly a full three stories tall (this one is slightly taller than its neighbor), and they appear to share a wall. This building has vinyl siding in the upper stories of the visible façades as well as replacement windows, doors, and soffits. This building would be a contributing property in this potential historic district, but likely does not maintain sufficient integrity to justify individual NRHP listing.

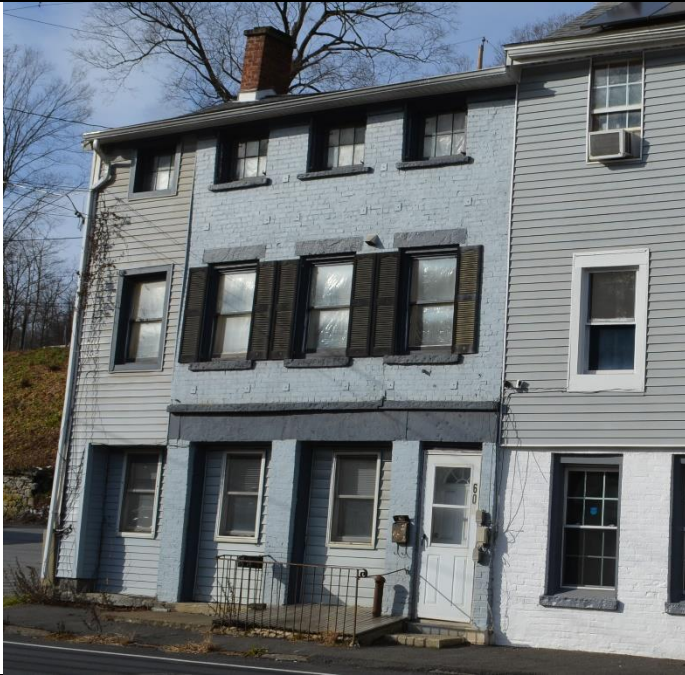
Photo #:	Address / Block & Lot:	Year Built:	Eligibility Recommendation:
11	609 Abeel St / 56.57-2-8	1856	HD, CONTR

Description: A three story vernacular/National style building predominately brick with vinyl siding mix, four bays wide with asphalt roof. Several replacement windows & doors.

609 Abeel Street (Photo 11): (c. 1856, per tax records) – Enough of the historic, primary façade remains visible here, showing the building's vernacular interpretation of the Federal style (potentially also called a "National" style per McAlestar). As with the neighboring building at 607 Abeel, vinyl siding covers many portions of this brick edifice, including bays at the first floor, the southern quarter of the front façade, and the visible south side façade. Several windows and doors appear to be replaced. This building would be a contributing property in this potential historic district, but it may not maintain sufficient integrity to rise to the level necessary for individual NRHP listing.

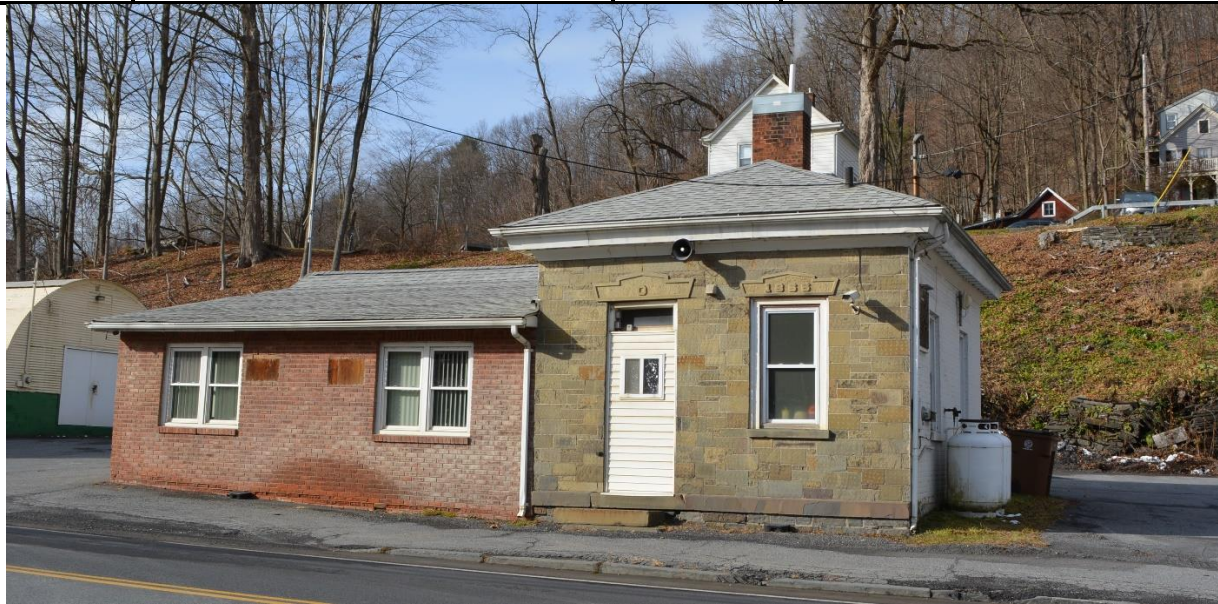
Description: A vernacular/National style building, one story stone-front/brick-side building, two bays wide with newer 20 th century addition. Window lintel on south façade is engraved with 1866. The brick addition is four bay width and shed like structure. Replacement windows & doors.

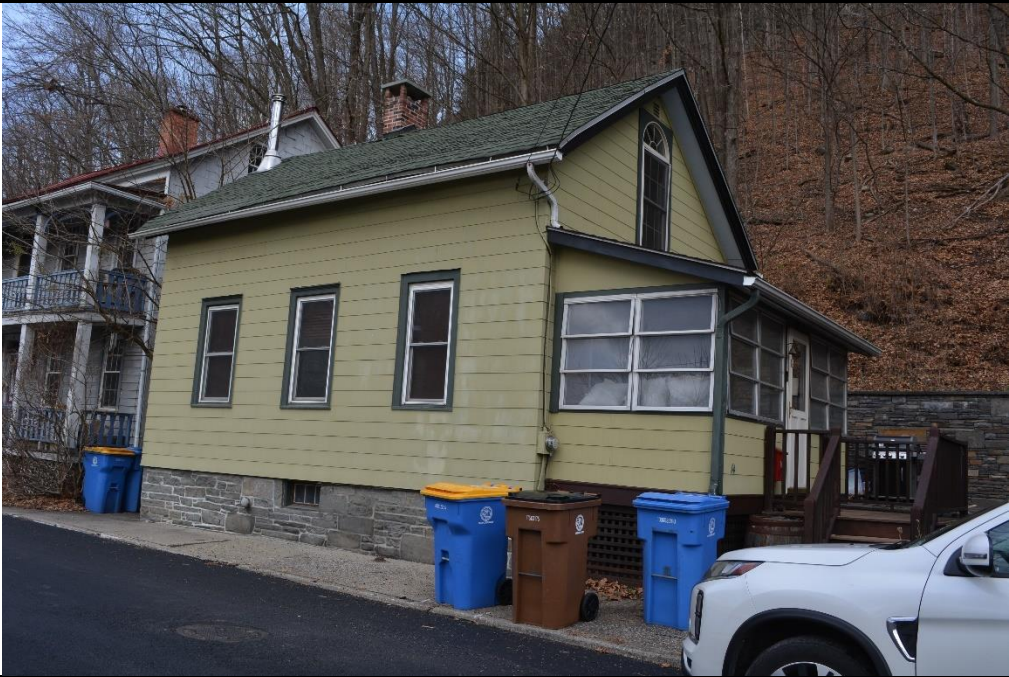
Description: A two-story, vernacular/National style house with enclosed porch, stone foundation, replacement siding and asphalt roofing material. Replacement windows & doors. Lacks integrity.

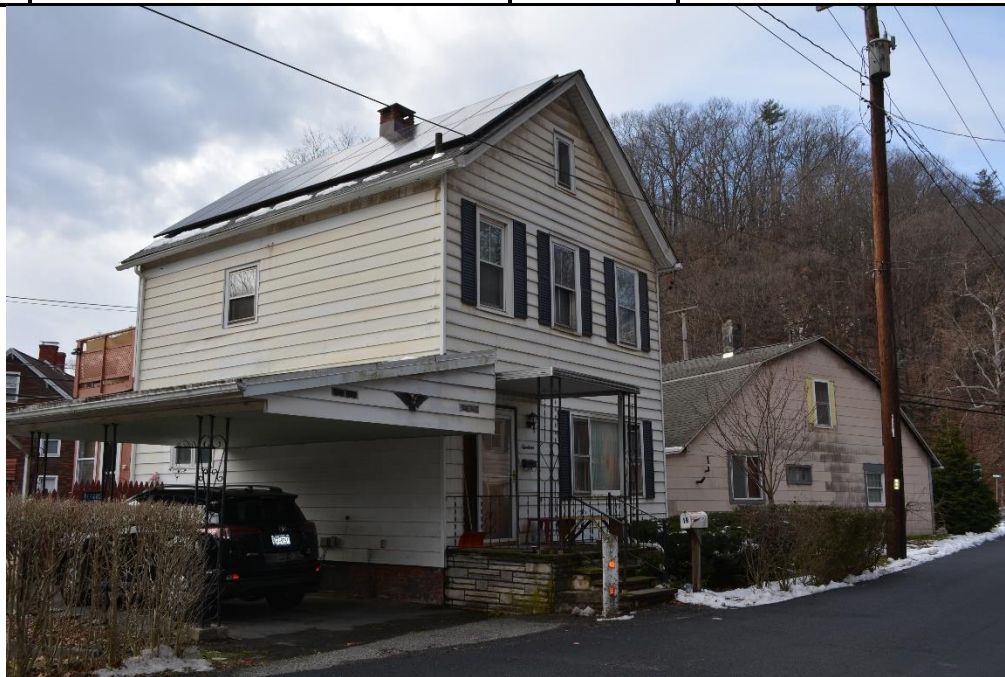
Description: A front-gabled, two-story, vernacular/National style building with metal siding and asphalt roof with solar panels. Three bays wide. There is an attached car port. Replacement windows & doors. Lacks integrity.

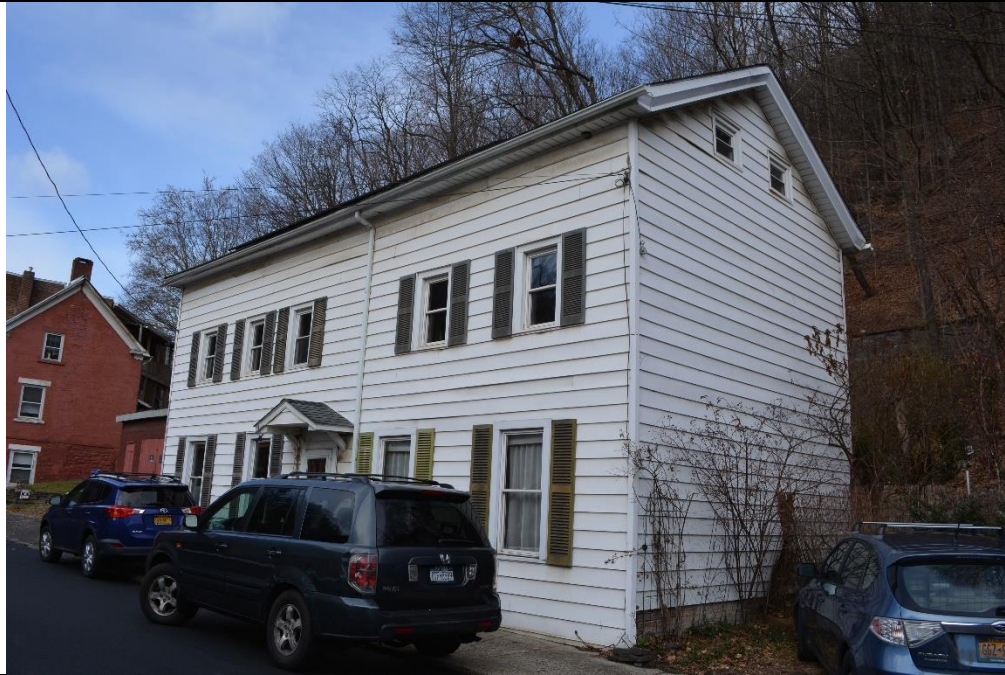
Description: A two-story vernacular/National style building with metal exterior, side gabled roof with solar panels. It is roughly five bays wide. Replacement windows & doors. Lacks integrity.

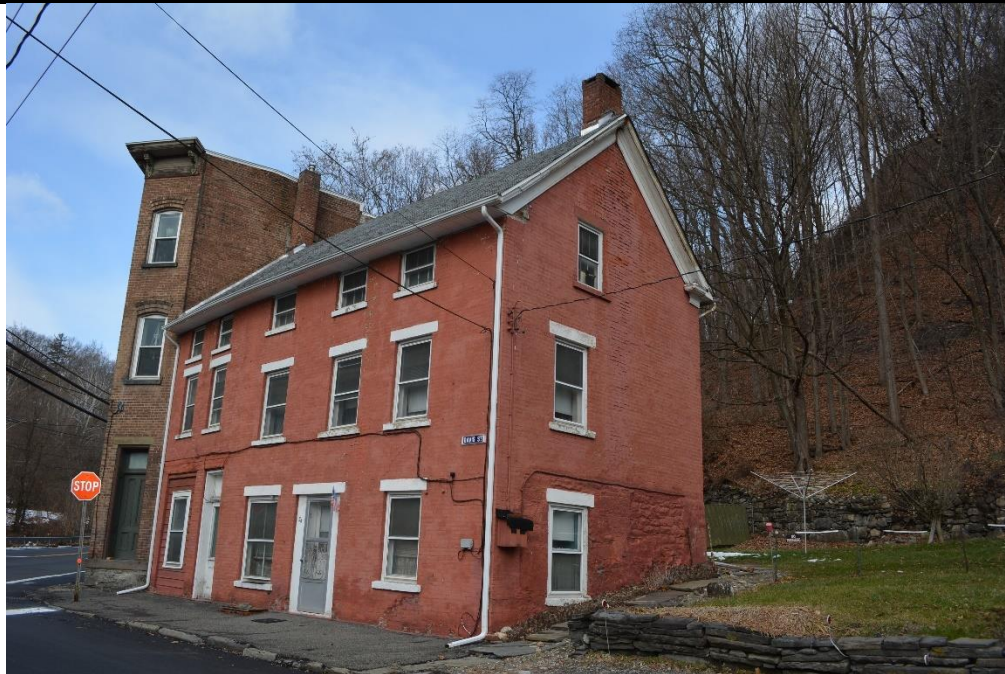
Photo #:	Address / Block & Lot:	Year Built:	Eligibility Recommendation:
18	34 Davis St / 56.49-3-3	1840	IND, HD

Description: A side-gabled, three story, Federal style brick building with asphalt roof, five bays wide. Some stone present for foundation.

34 Davis Street (Photo 18): (c. 1840, per architectural style) – This building is clearly shown on the 1870 Beers map as the A. Phelan Saloon, but it is unclear if the building shown on the 1858 French map is the same as this building. The vernacular interpretation of the Federal architectural style suggests that this is an older building, and the partial stone foundation on the east façade may be a hint that this building, or portions of it, date to the first half of the 19th century. This side-gabled building is nearly three stories tall. The western quarter or so of the building, which connects to the adjacent building at 26 Wilbur Avenue, has two closely spaced bays with a door

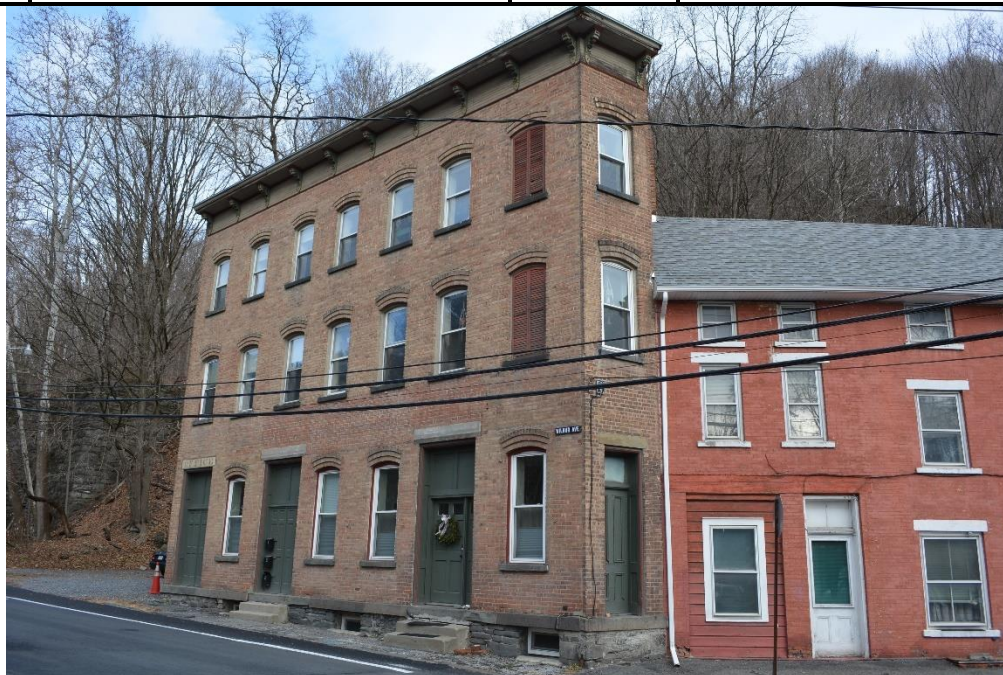
Photo #:	Address / Block & Lot:	Year Built:	Eligibility Recommendation:
19	26 Wilbur Ave / 56.49-3-2	1880	IND, HD

Description: A three-story, Italianate, brick commercial building with wedge-shaped plan. Stone foundation, flat roof, seven bays wide. There are 3 entrances to the southwest and another entrance to the southeast.

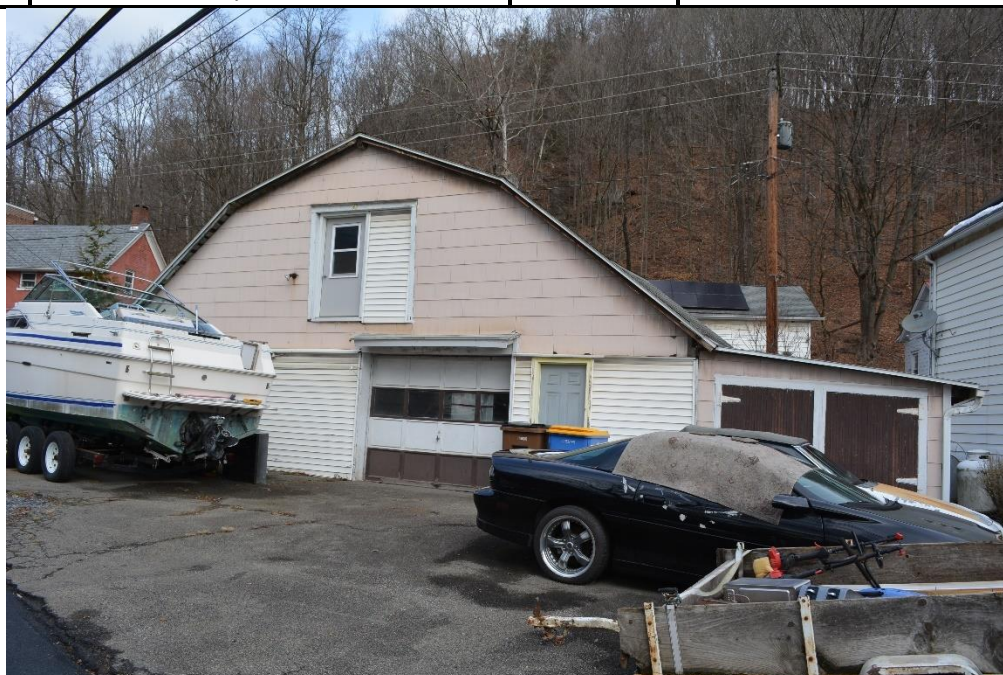
Photo #:	Address / Block & Lot:	Year Built:	Eligibility Recommendation:
20	16 Wilbur Ave / 56.57-2-34	1890	NOT ELIGIBLE:

Description: A gambreled, Dutch Colonial Revival style fibrous siding garage (wagonhouse per 1899 Sanborn map). Altered fenestration. Lacks integrity.

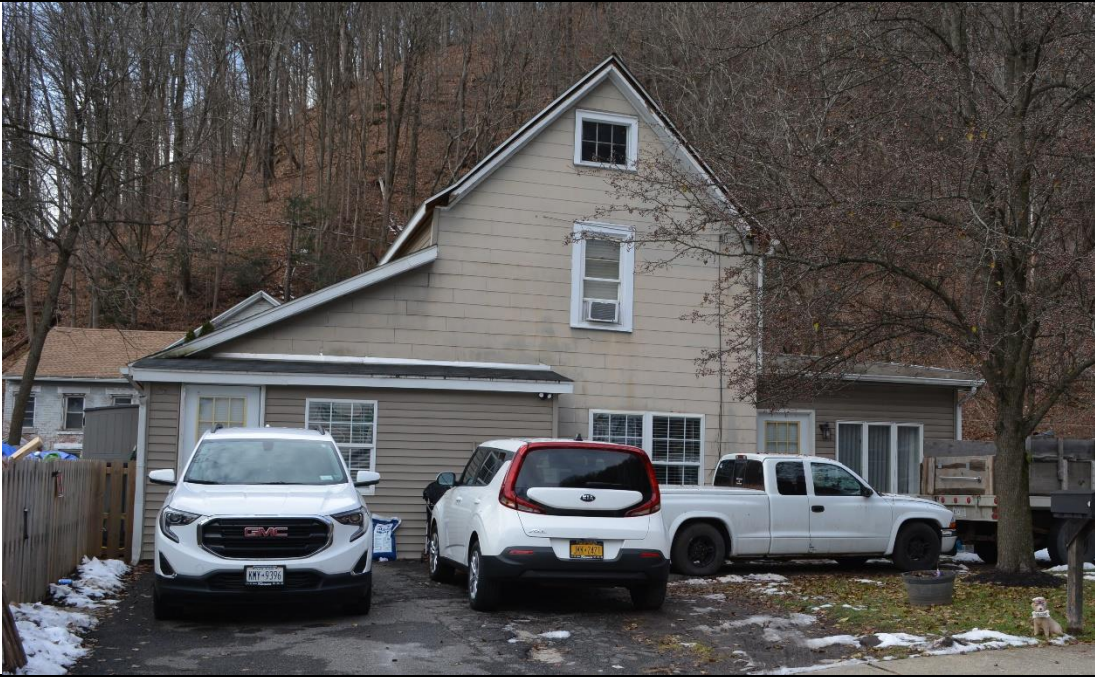
Description: A vernacular/National style building with asphalt roof and additions. Replacement siding and windows. Lacks integrity.

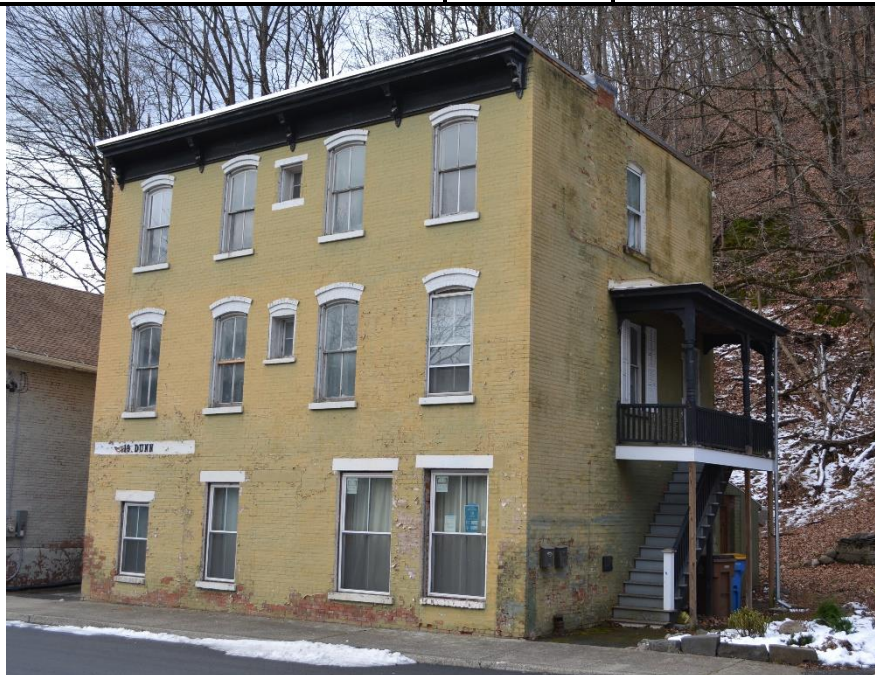
Photo #:	Address / Block & Lot:	Year Built:	Eligibility Recommendation:
23	19 Dunn St / 56.57-2-26.100	1875	IND, HD

Description: A three-story brick Italianate style building with flat roof, roughly four bays wide. Many of the original lintels are still present. Altered fenestration (perhaps historic) and side entrance.

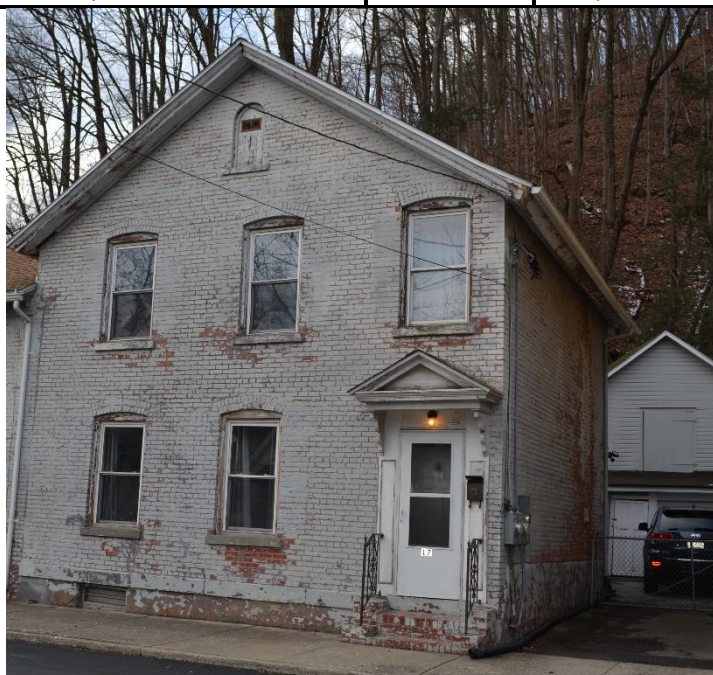
Photo #:	Address / Block & Lot:	Year Built:	Eligibility Recommendation:
24a	15-17 Dunn St / 56.57-2-25.100	1880	IND, HD

Description: A front-gabled, two-story brick Italianate building, three bays wide. A front entrance with closed pediment gable roof above, arched lintels, stone sills. Conjoined with earlier neighboring building (next page).

17 Dunn Street (Photo 24a): (c. 1880, per tax records) – This front-gabled, two-story building is not shown on the 1870 Beers map; an empty lot is shown instead. This building is depicted in the 1887 Sanborn map. The front façade is three bays wide, with brick stoop and a door, under a small, closed pediment roof supported by brackets, very near the northern corner and two one-over-one windows more or less equally spaced in the remainder of the wall (note: brick lines around the center window may indicate a repair or alteration here). There are three windows in the second story, but here the center window is not directly in-line with the window below. Window openings in the first and second stories have elliptical arch tops formed by two courses of bricks, flush with the plane of the wall. A small, semi-circular topped window opening is centered in the attic gable. A stone watertable separates the foundation from the brick of the front façade. All windows have stone sills that project from the plane of the façade. Historic wood soffits remain in place, but windows and the door are relatively new. This building shares a wall with the adjacent building at 15 Dunn Street and the two buildings are painted the same color, but stylistic differences make it clear that these buildings were not built at the same time. The building at 17 Dunn Street would be a contributing property within the proposed historic district. Although perhaps not as compelling as other buildings that are individually eligible for NRHP listing, this one may nonetheless prove to be individually eligible through a more thorough investigation.

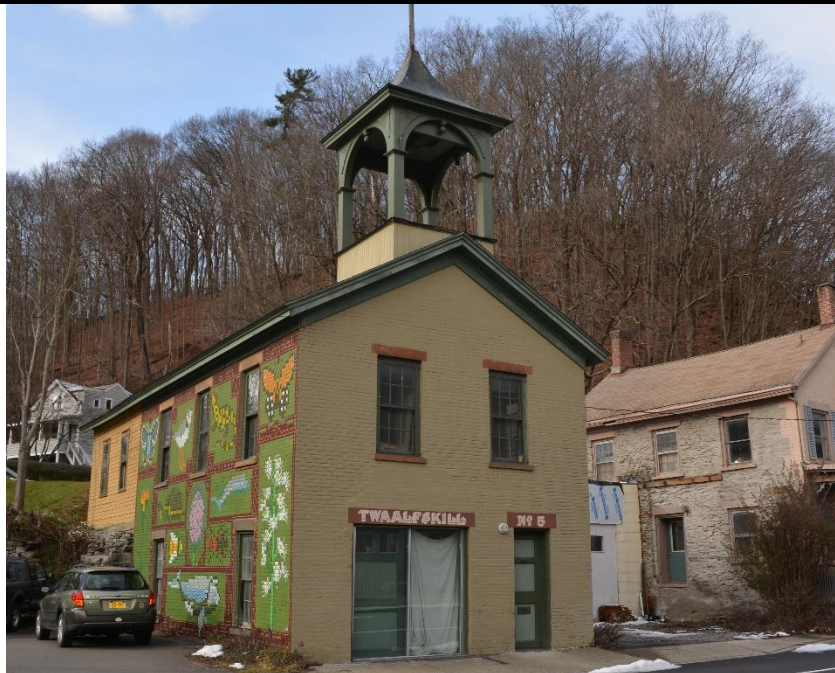
Photo #:	Address / Block & Lot:	Year Built:	Eligibility Recommendation:
26	3 Dunn St / 56.57-2-12	1870	IND, HD

Description: A two-story, front gabled, brick vernacular/National style firehouse, with bell tower, two bays wide and five bays deep. Wood portion at rear. There is a vehicle door located on the front.

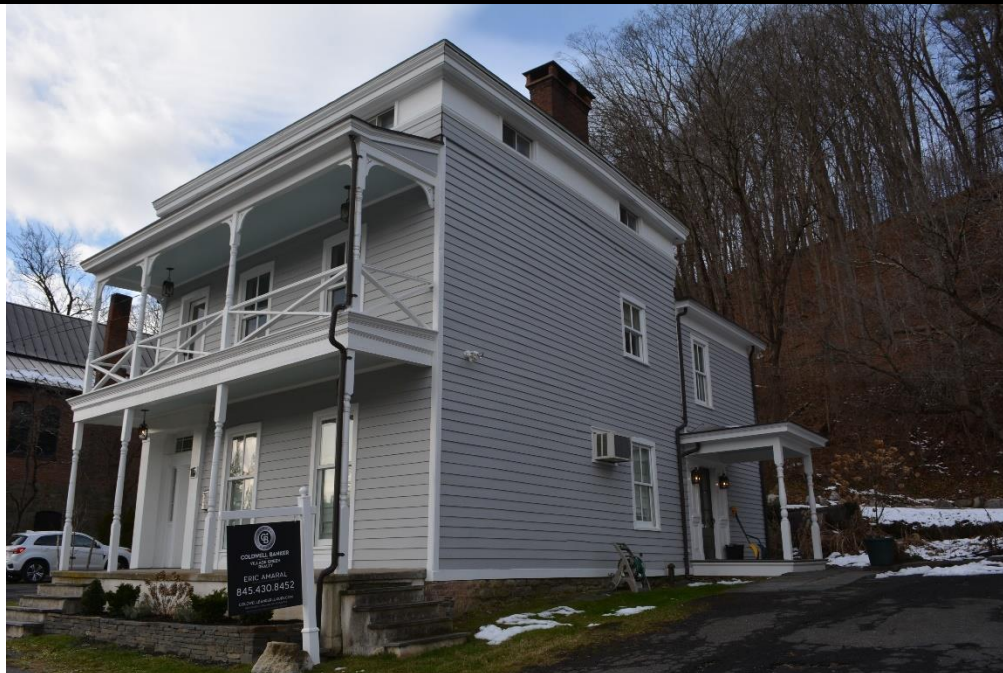
Photo #:	Address / Block & Lot:	Year Built:	Eligibility Recommendation:
28	11 Fitch St / 56.57-2-15	1870	NOT ELIGIBLE or CONTR

Description: A two-story, Italianate, wood house, three bays wide. There is a covered porch on the second floor. Altered fenestration.

15 Fitch Street (Photo 28): (c. 1870, per architectural style) – This Italianate style house with simple hipped roof, previously listed as 11 Fitch Street, appears to maintain a high degree of integrity with wood clapboard siding and wood windows. There is evidence of altered fenestration on the north side (two historic window openings have been expertly covered and a thru-wall air conditioning unit has been installed). The covering over of windows may be a historic change, but the concrete front porch deck is likely not historic. This house underwent some maintenance and possible rehabilitation work within the last few years. This house could be considered contributing within the expanded boundaries of the proposed NRHP district, noting that its wood exterior sets it apart from other buildings within the district.

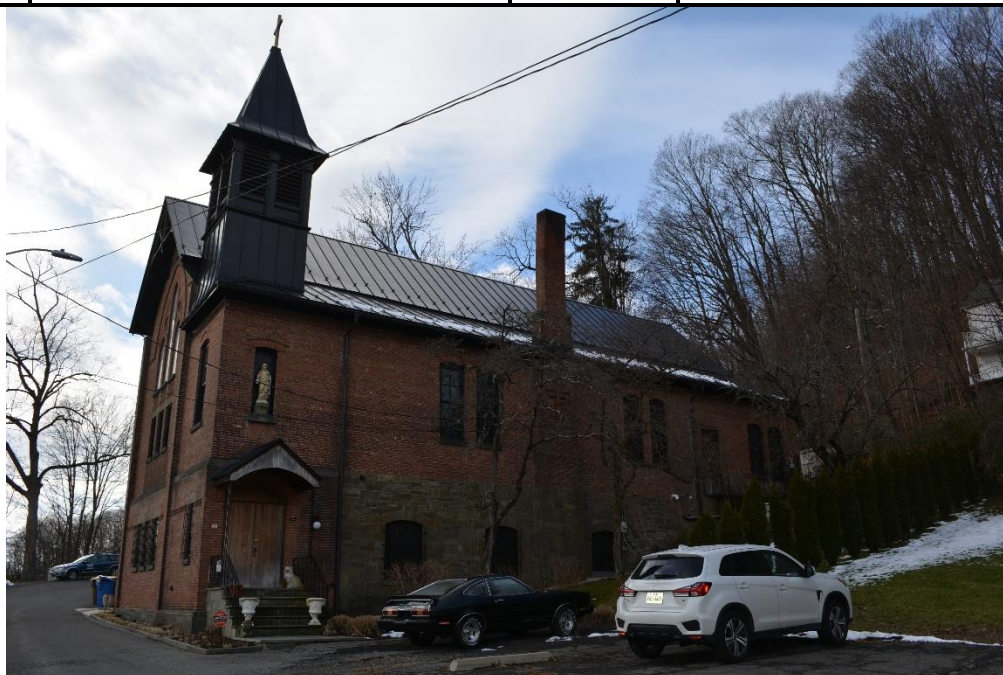
Photo #:	Address / Block & Lot:	Year Built:	Eligibility Recommendation:
29	23 Fitch St / 56.57-2-16	1884	IND or CONTR

Description: A Gothic style brick church with bluestone in lower portions. Rehabilitated and adapted for use as a residence/studio. Standing seem metal roof replaced asphalt shingles.

23 Fitch Street (Photo 29): (c. 1884) – The former Church of the Holy Name, later Sacred Heart of Jesus Church, previously listed as 21 Fitch Street, was dedicated on November 1, 1885 (St. Mary St. Peter). This building is described in Section 4.1.3 below; however, it is also eligible for individual listing in the NRHP under Criterion C, architecture.

23 Fitch Street (Photo 29): (c. 1884) – The former Church of the Holy Name, later Sacred Heart of Jesus Church, previously listed as 21 Fitch Street, was dedicated on November 1, 1885 (St. Mary St. Peter). The building is an excellent example of a Gothic Revival church building with extensive use of bluestone in the lower portion of the predominantly red brick exterior. Many of the historic stained-glass windows appear to remain in place as well. Although the building underwent a significant rehabilitation beginning around 2017 following several years of use in the production of textiles, it is still likely eligible for individual NRHP listing. The most recent work included significant changes to the interior as well as the installation of a standing-seam metal roof. Illustration 13 is provided to assist with any such future determination of eligibility in which interior work may be considered rehabilitations involving tax credits (note that the ceiling has been lowered). This building would certainly be considered as contributing within the expanded boundaries of the proposed NRHP district; however, adding only this building to the proposed district is inelegant and ill-advised because this portion of Fitch Street lacks any public right of way that connects directly to the proposed district. A potential solution is to expand the proposed district boundary to include Fitch Street and the houses at 11 Fitch Street and 1 Fitch Street, thereby solving this problem of physical and accessible continuity. These neighboring houses have wood exteriors, which set them apart from other buildings within the expanded district and, as a result, diminish the robustness of the aesthetic cohesiveness of the proposed district.

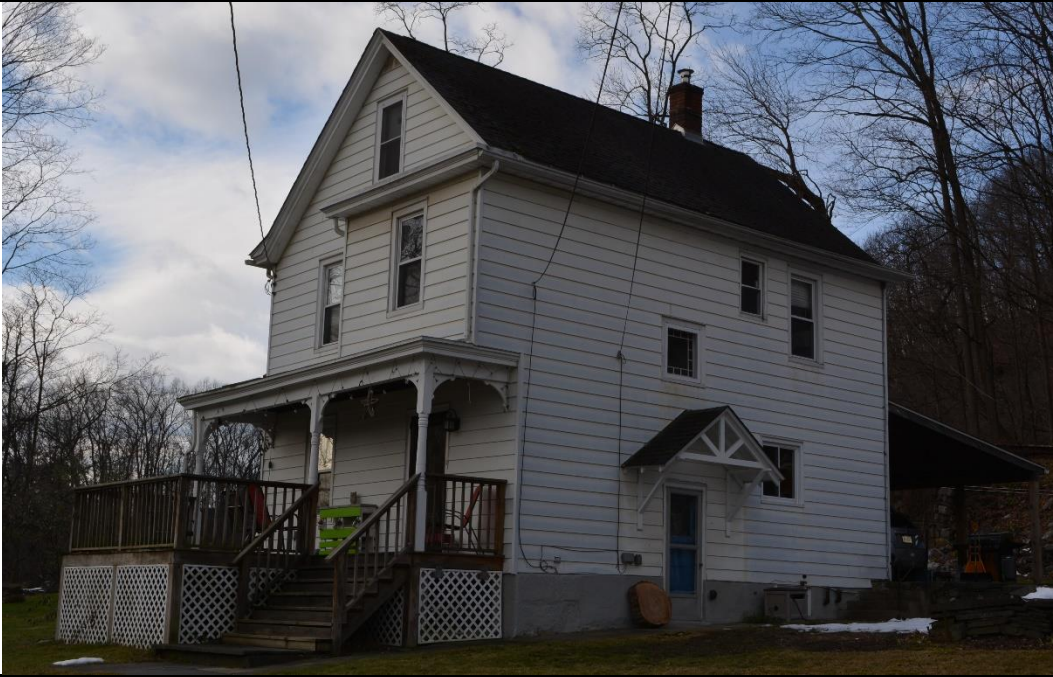
Description: A front-gabled, three-story vernacular/National style house, metal siding, two bays wide. A covered porch on the first floor, front, and entry roof on the side of the building. Replacement windows, doors, siding, and possible altered form. Lacks integrity.

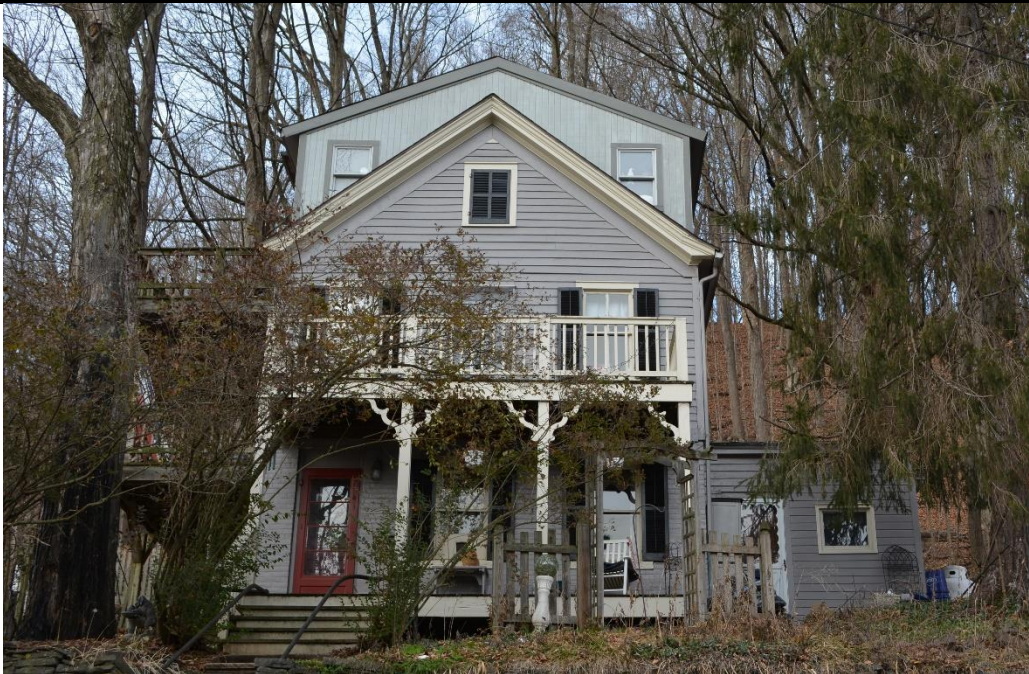
Description: A front-gabled, two-story, vernacular/National style house, three bays wide. Full-width front porch, with walk-out portion at 2nd story. Side porches and raised roof/dormers results in lack of integrity.

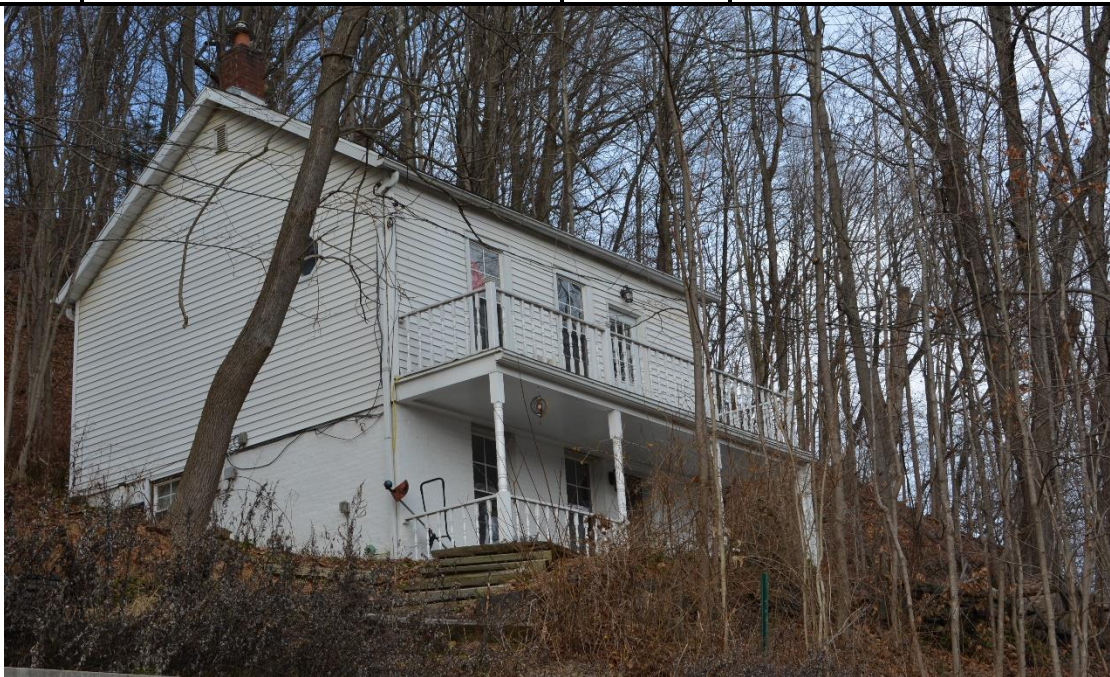
Description: A side-gabled, two-story vernacular/National style house, roughly three bays wide. There is a covered porch on the first floor and open porch on the second floor. Brick first floor, vinyl above, replacement windows & doors. Lacks integrity.

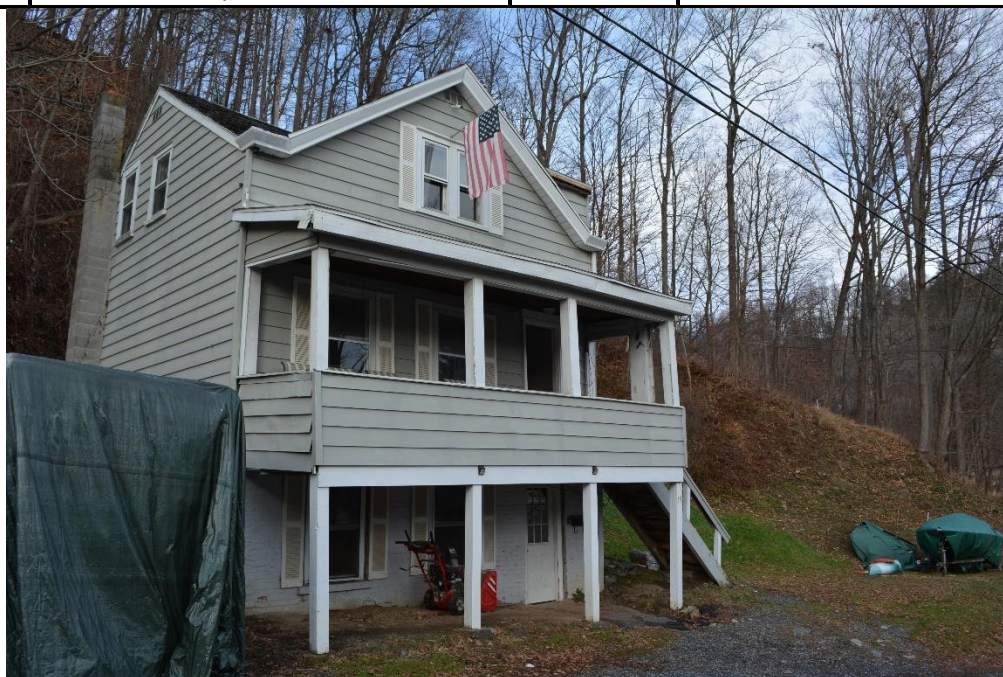
Description: A Gothic Revival house, three bays wide, with metal siding (brick basement/lower level). Full-width front porch. Replacement windows, siding, doors. Lacks integrity.

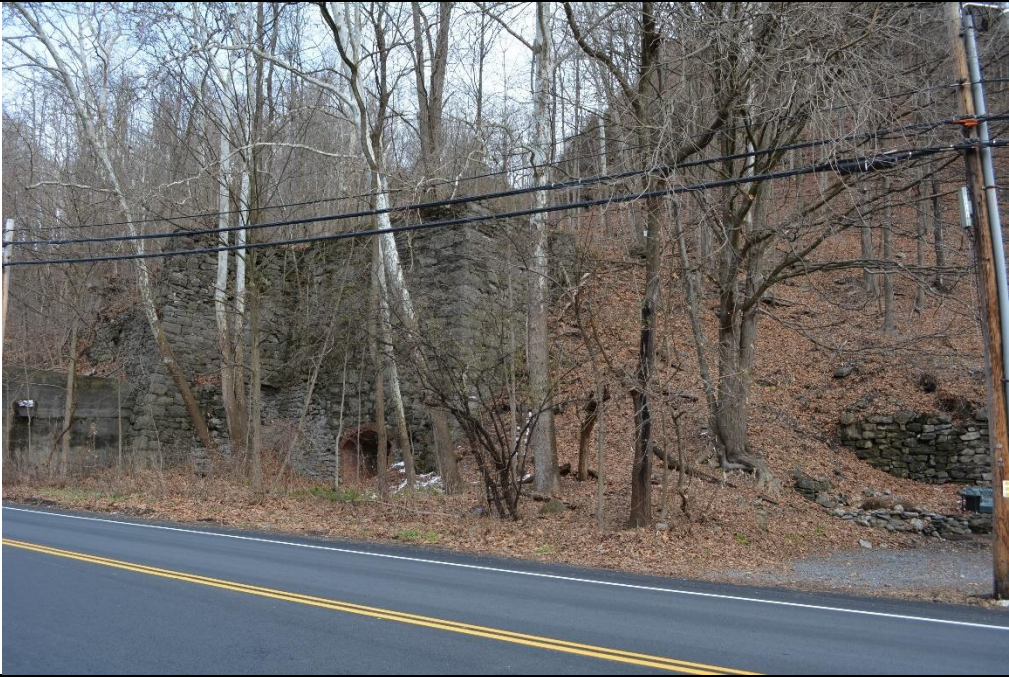
Description: Stone kiln ruin.

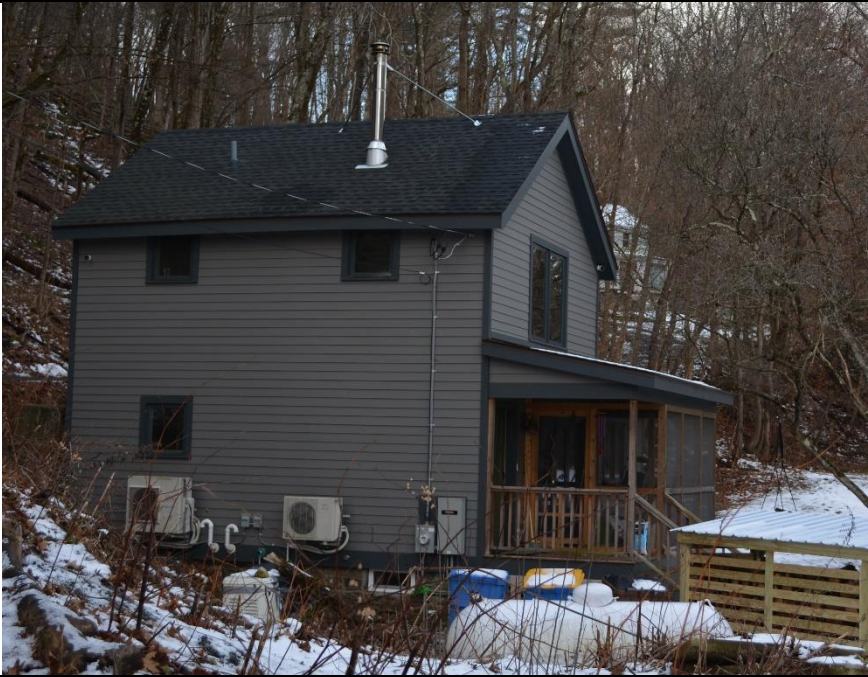
Photo #:	Address / Block & Lot:	Year Built:	Eligibility Recommendation:
35	36 Rodney St / 56.49-4-12	1880	NOT ELIGIBLE:

Description: A vernacular/National style wood house, front gabled with an enclosed porch. Extensive replacement materials. Lacks integrity.
