**INTENSIVE-LEVEL HISTORIC RESOURCES
& BUILDING SURVEY
WILBUR & PONCKHOCKIE NEIGHBORHOODS
CITY OF KINGSTON, ULSTER COUNTY, NEW YORK
RFPK #22-11**

EXECUTIVE SUMMARY

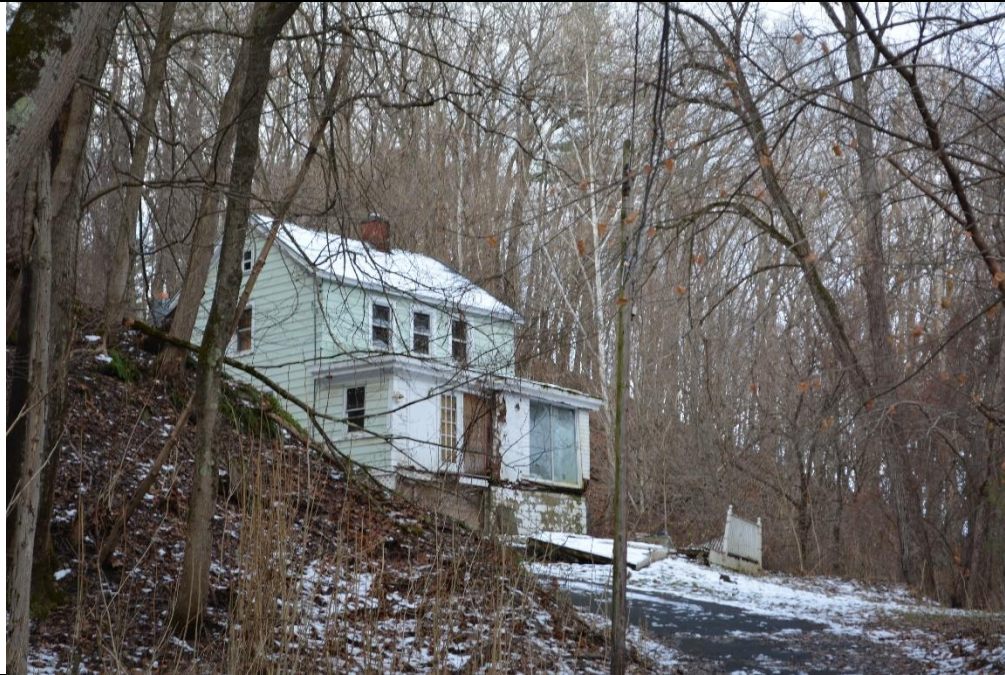
Description: A side-gabled, two-story, vernacular/National style house with enclosed porch. Replacement windows & doors. Lacks integrity.

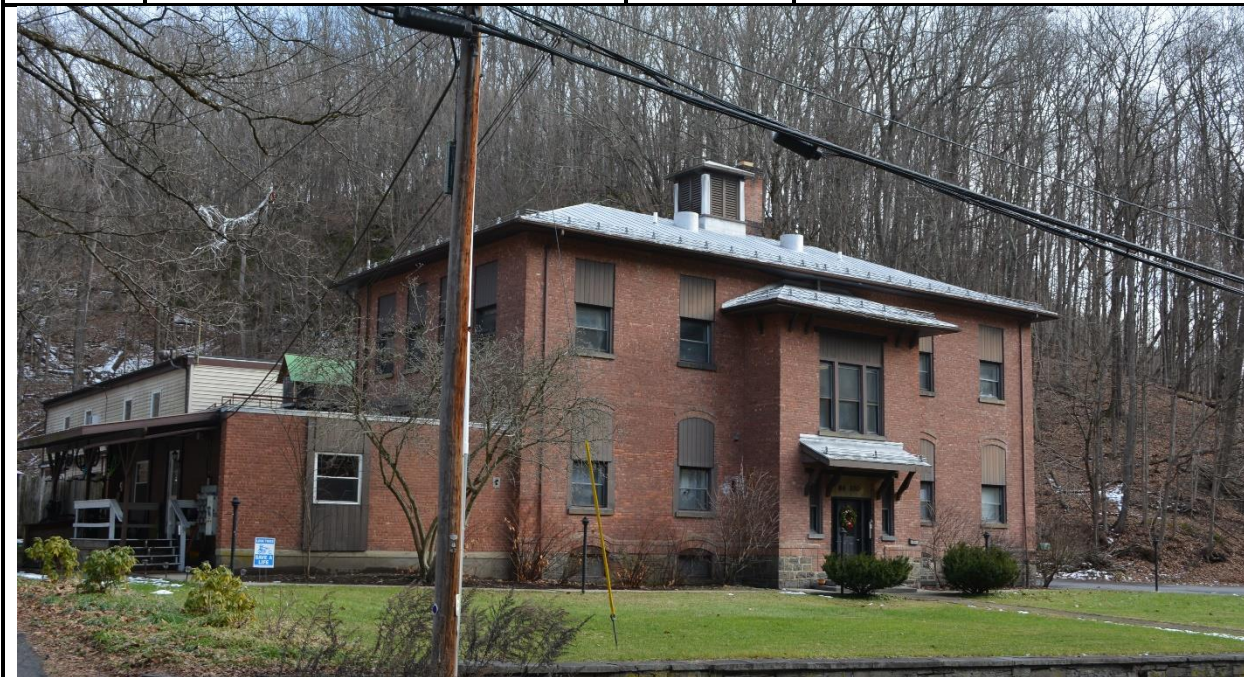
Description: Italianate brick school building, five bays wide. Standing seem metal roof. Additions and altered fenestration (smaller replacement windows).

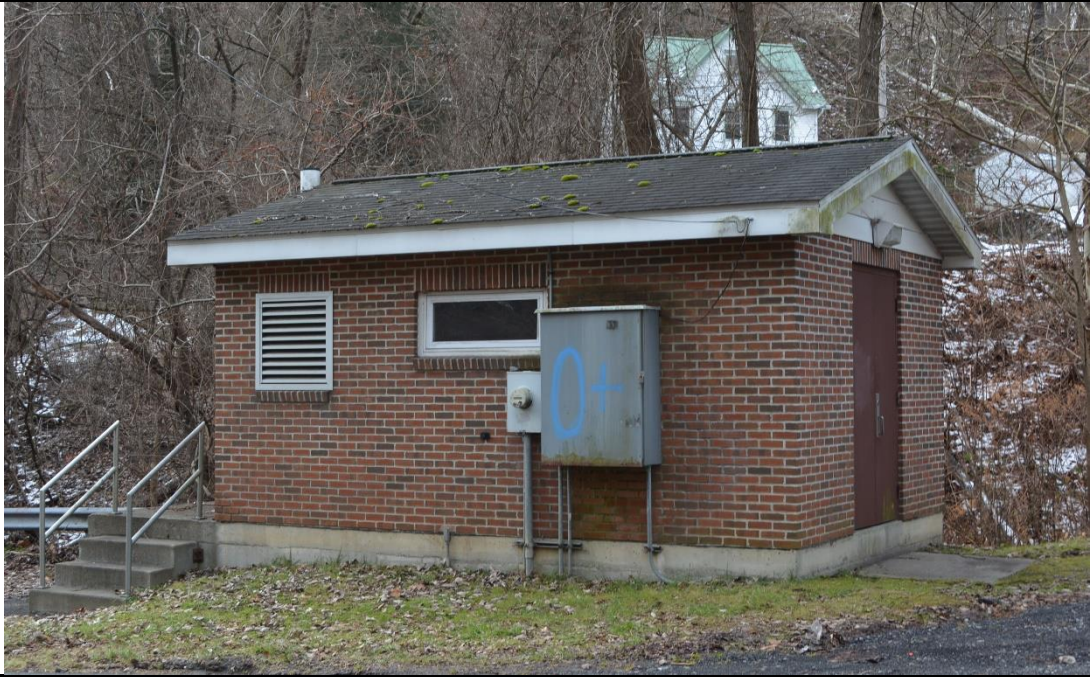
Photo #:	Address / Block & Lot:	Year Built:	Eligibility Recommendation:
38	97 Wilbur Ave / 56.49-1-13.100	1998	NOT ELIGIBLE:

Description: A contemporary brick water pump utility shed.

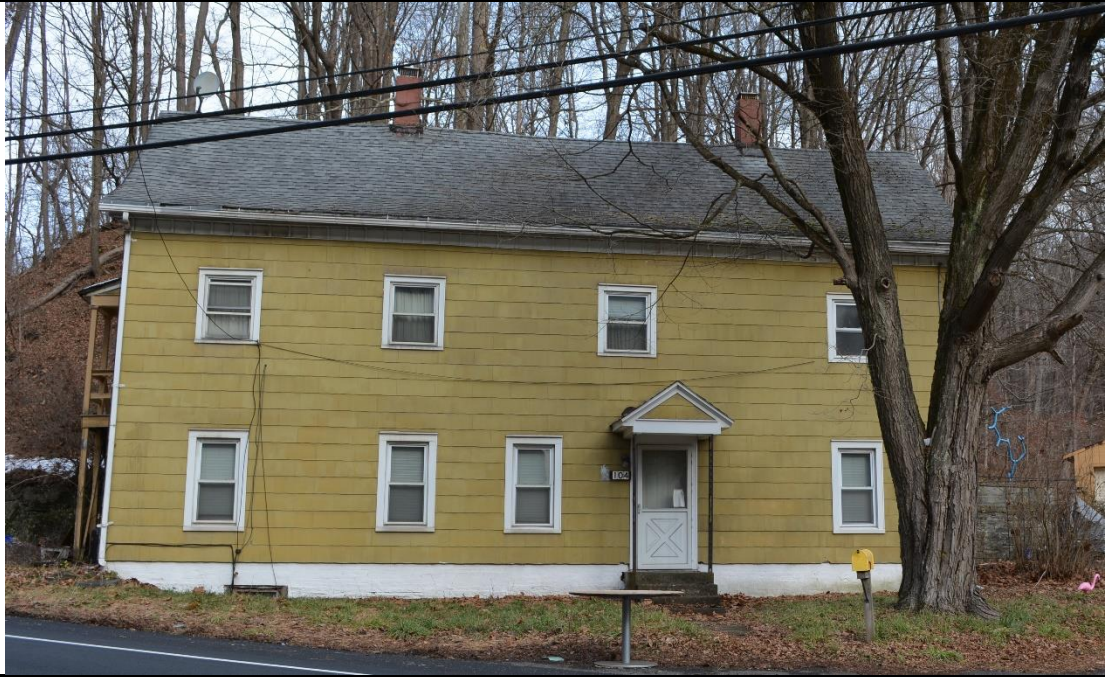
Description: A two-story, side-gabled, vernacular/National style building clad in shingles, cement foundation. Replacement siding, windows, and doors. Lacks integrity.

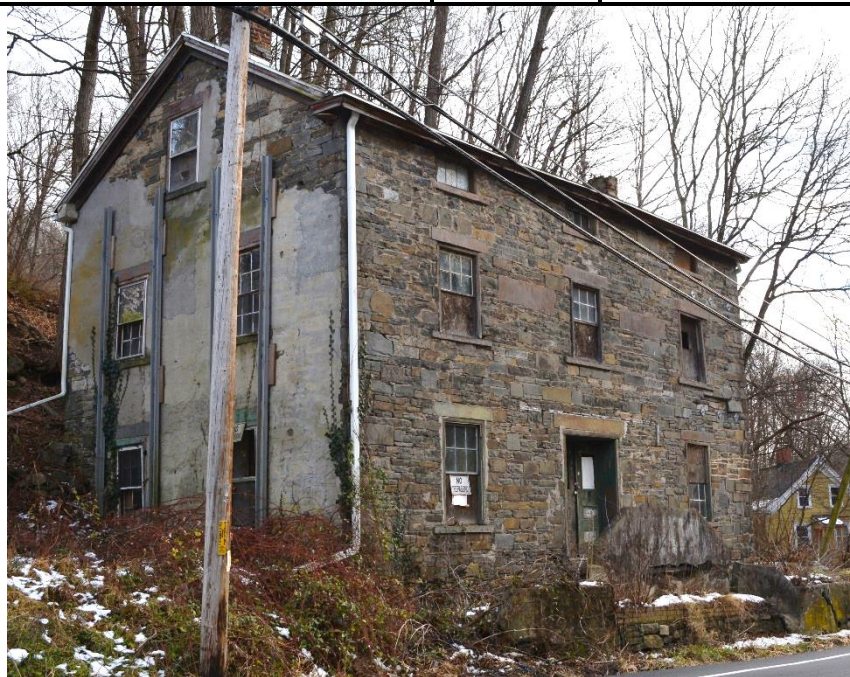
Photo #:	Address / Block & Lot:	Year Built:	Eligibility Recommendation:
40	116 Wilbur Ave / 56-49-2-17	1850	IND

Description: A two-story, side-gabled, vernacular or Federal style building with bluestone exterior, three bays wide, two bays deep. There are 6-over-6 historic windows and double wooden entrance door. Stone lintels and sills. Unique.

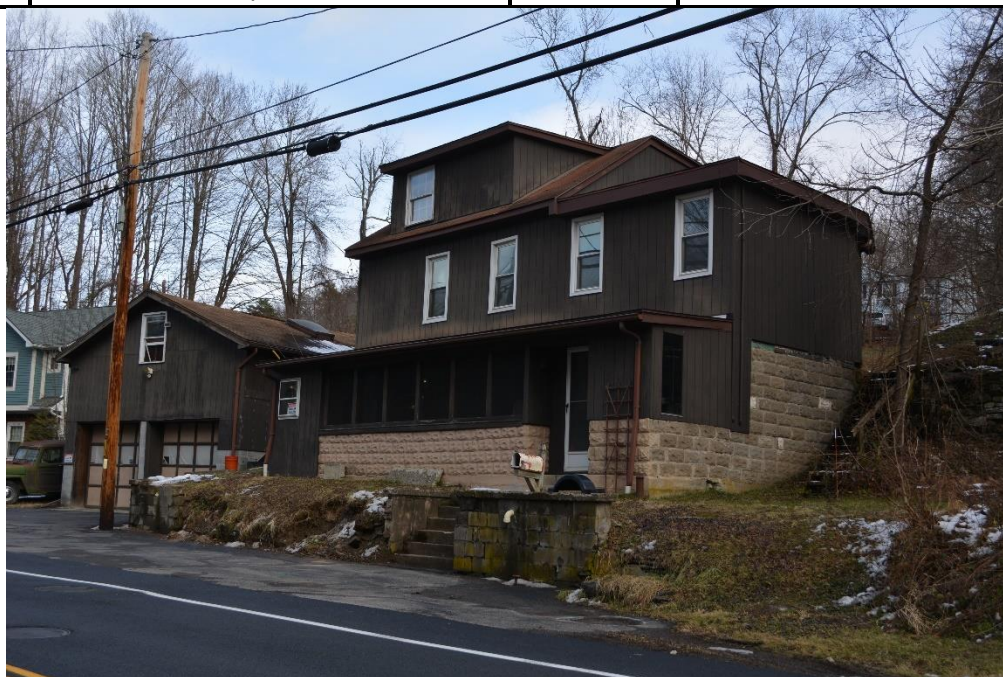
Description: A Contemporary style building with a cement block foundation, wood exterior, enclosed porch on the first floor. Extensive alterations and replacement materials. Lacks integrity.

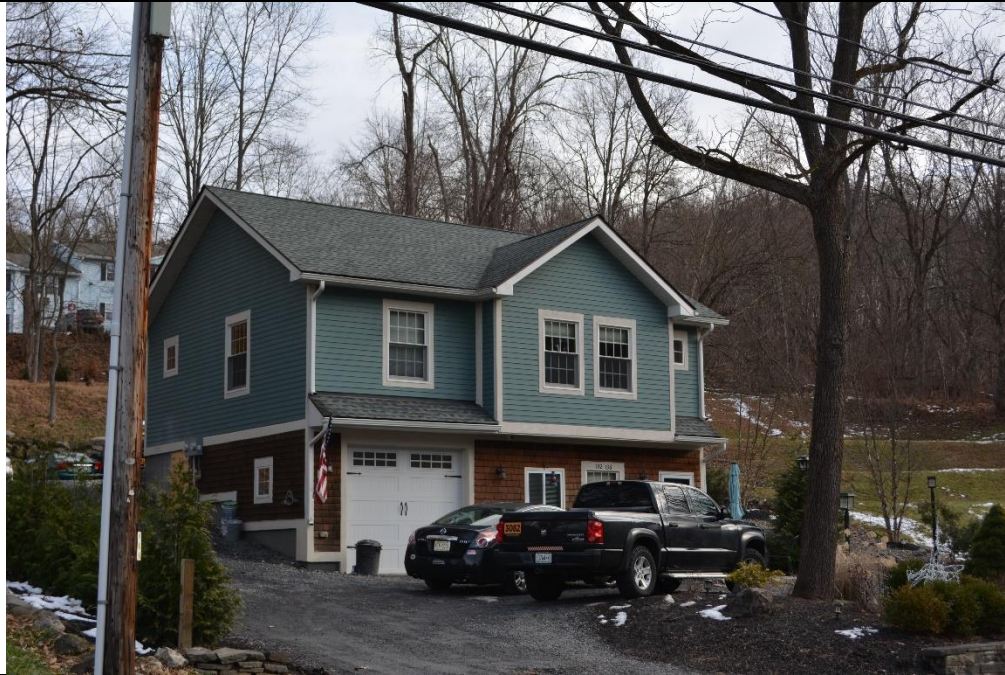
Photo #:	Address / Block & Lot:	Year Built:	Eligibility Recommendation:
42	136 Wilbur Ave / 56.49-2-14	2015	NOT ELIGIBLE:

Description: A two-story, cross-gabled, contemporary style building with poured cement foundation and wood exterior. Less than 50 years old.

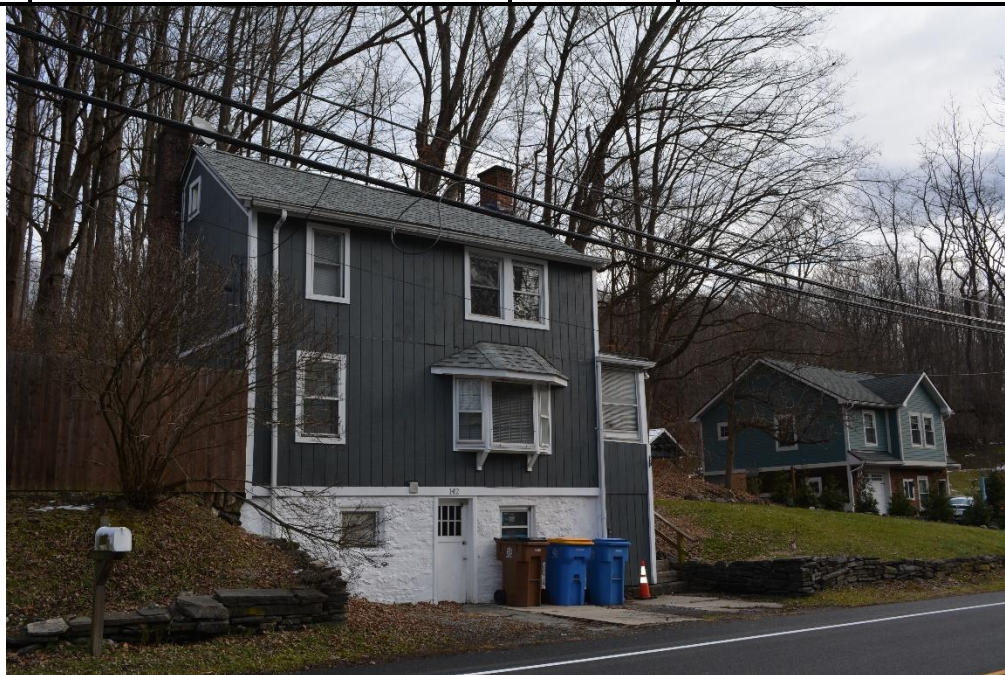
Description: A side-gabled vernacular/National style wood house with stone foundation and asphalt roof. Replacement siding & windows, altered fenestration. Enclosed porch or addition. Lacks integrity.

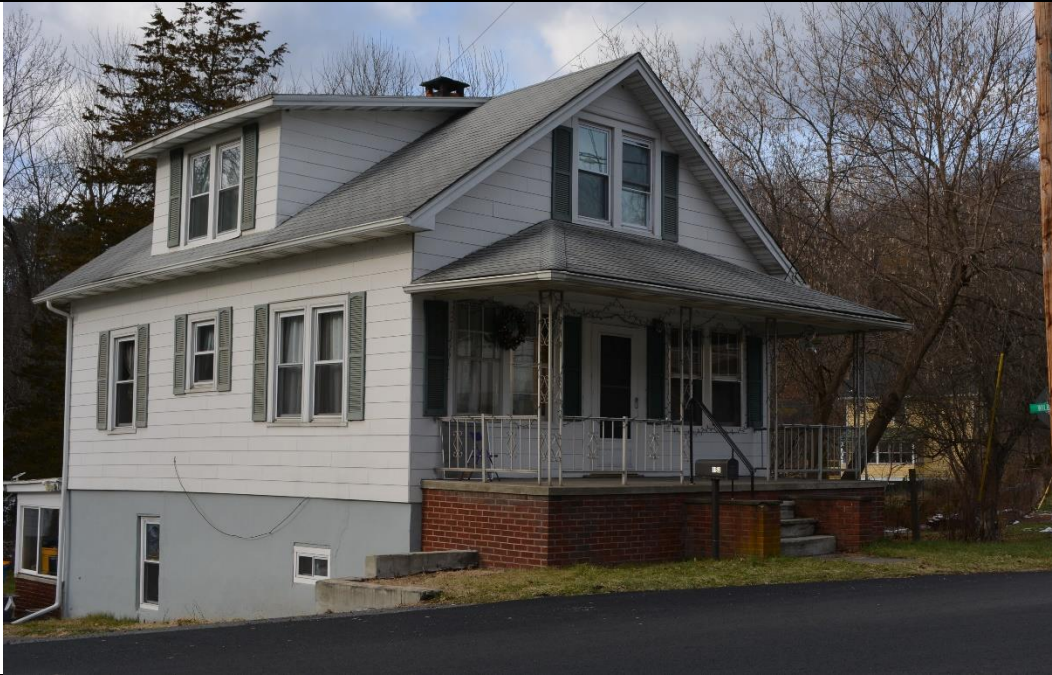
Description: A two-story, front-gabled, Colonial Revival style house with a cement foundation and asphalt roof with side dormer; three bays wide & deep and six bay deep. Extensive use of replacement materials. Lacks integrity.

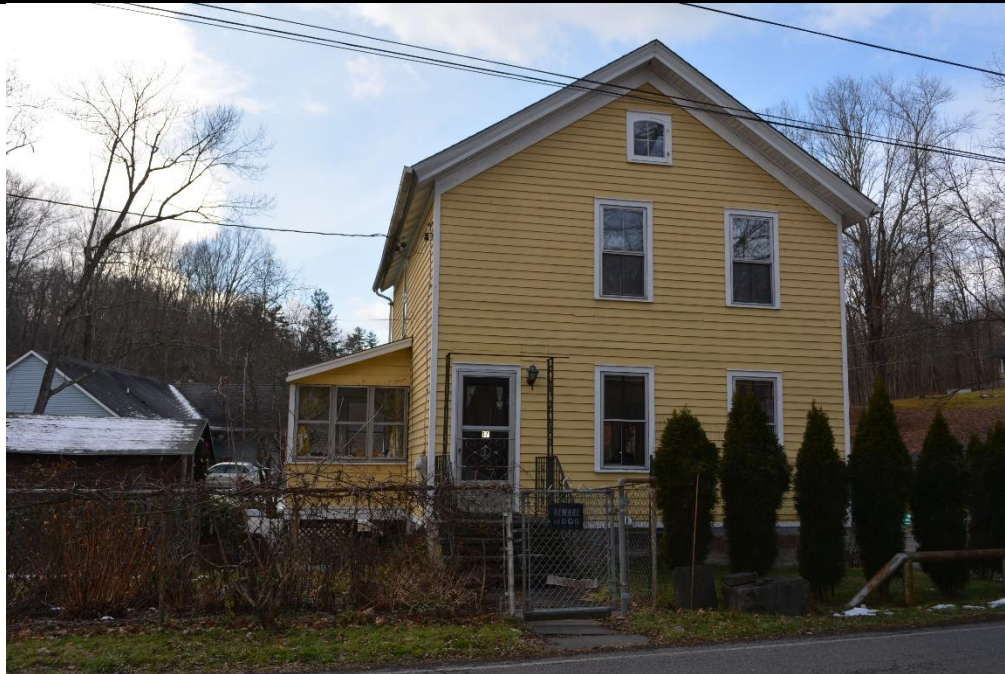
Photo #:	Address / Block & Lot:	Year Built:	Eligibility Recommendation:
45	17 S Wall St / 56.49-1-17	1878	NOT ELIGIBLE:

Description: A two-story, vernacular/National style house with front gabled roof, brick foundation, wood exterior siding, asphalt roof and three bay width. There is an enclosed porch off the southeast exterior. Altered fenestration, replacement soffits.

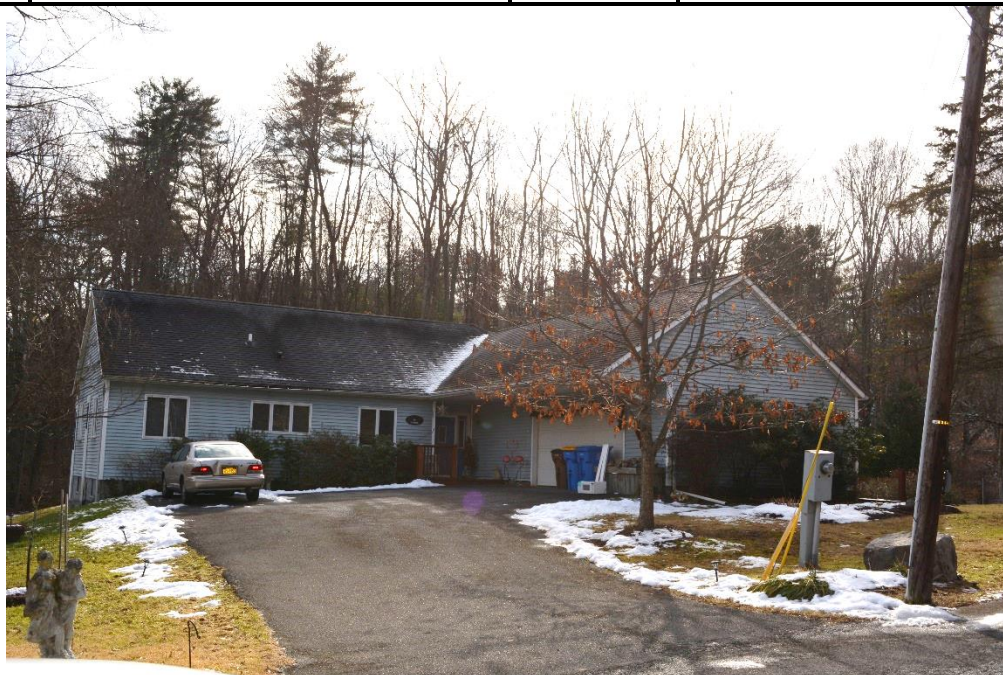
Photo #:	Address / Block & Lot:	Year Built:	Eligibility Recommendation:
46	16 Brook St / 56.49-1-18.100	1989	NOT ELIGIBLE:

Description: A one-story, contemporary style home with an asphalt cross-gable roof and cement foundation. Less than 50 years old.

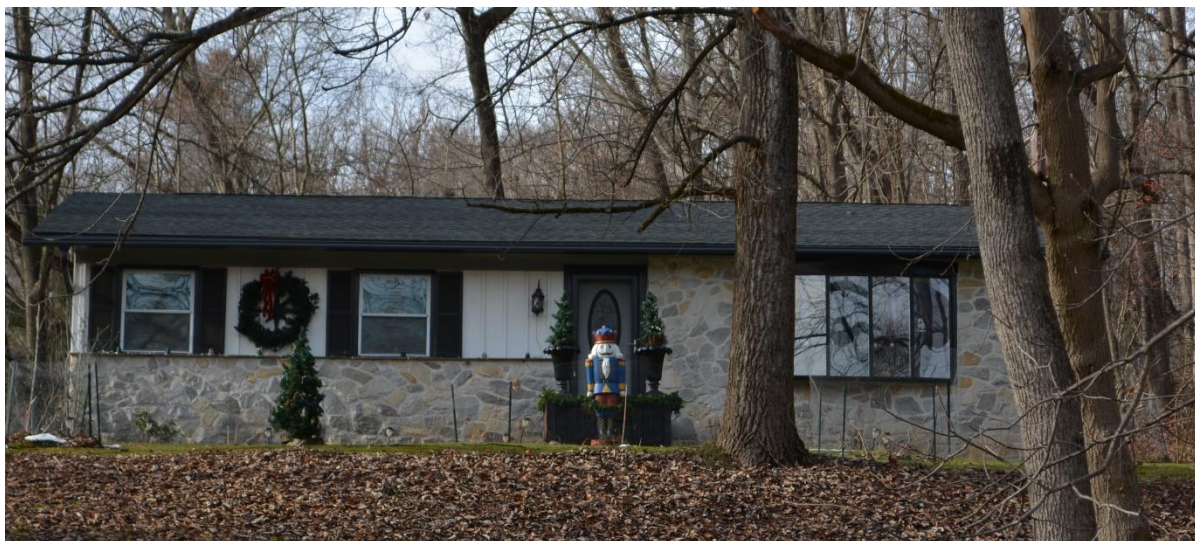
Photo #:	Address / Block & Lot:	Year Built:	Eligibility Recommendation:
47	1 Brook St / 56.49-1-5	1964	NOT ELIGIBLE:

Description: A one-story, Contemporary style, side-gabled building with cement foundation, asphalt roof and four bay width. Stone veneer and board-&-batten style siding. Altered fenestration (oriel window replaced), replacement door. Lacks integrity.

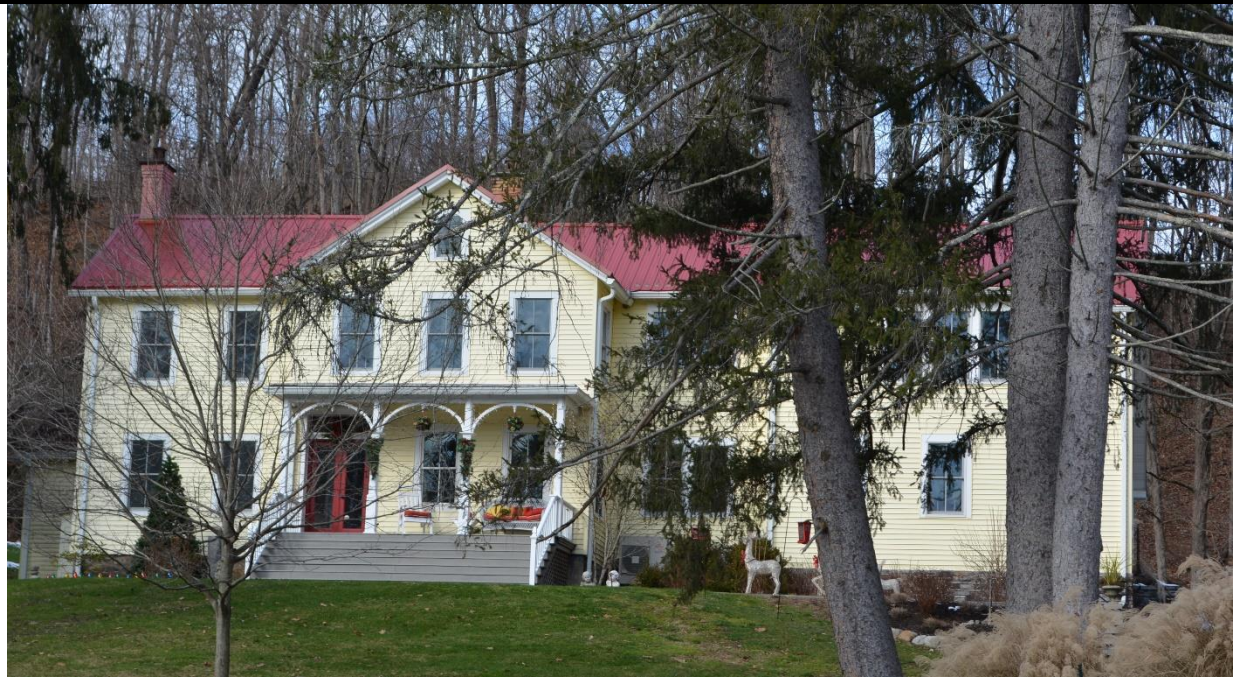
Description: A two-story Italianate style house. Large & recent addition at side (right side of photo). Metal roof. Lacks integrity (scale & location of addition).

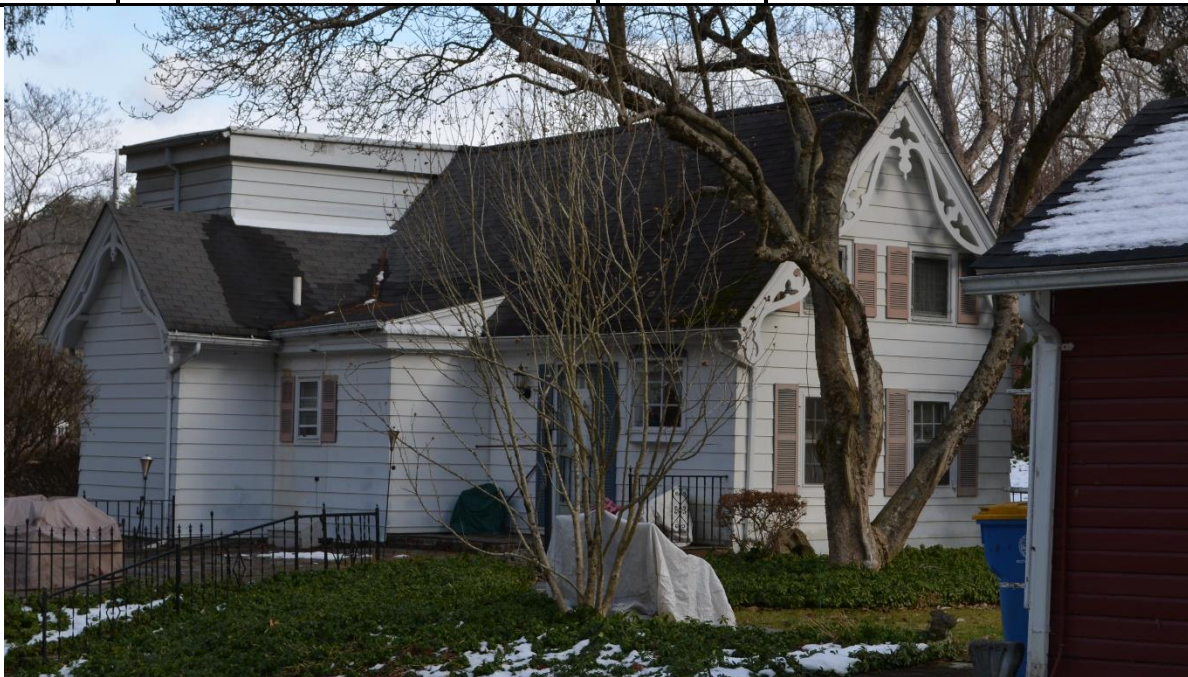
Description: A Gothic Revival cottage, with metal siding and asphalt roof. Altered form and fenestration. Lacks integrity.

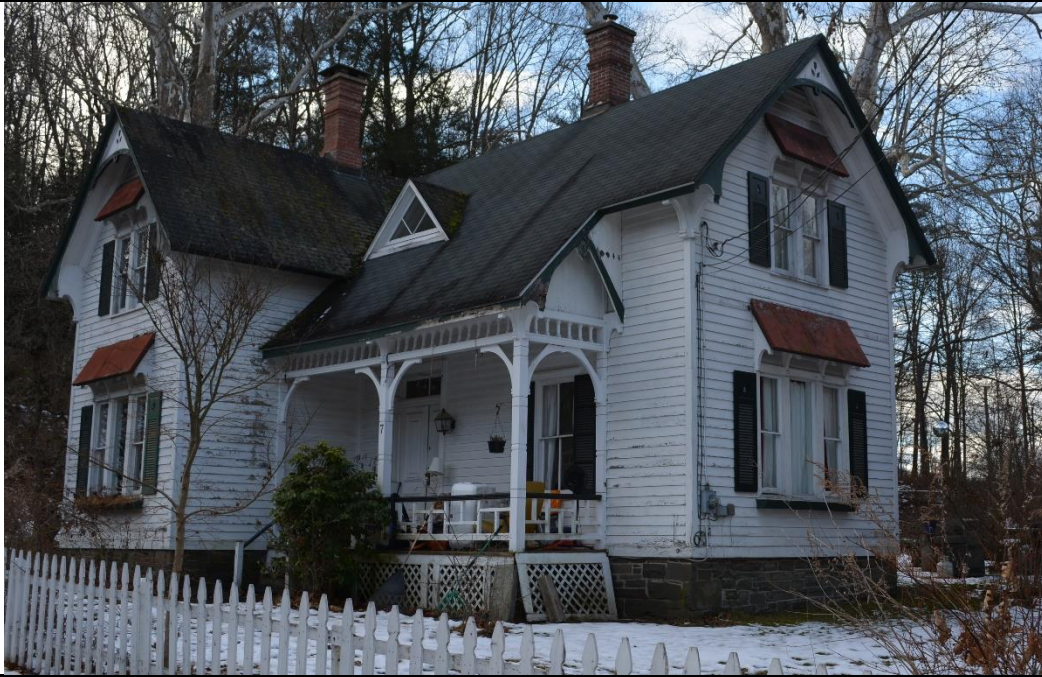
Description: A Queen Anne wood house with stone foundation, asphalt roof, and covered porch. High integrity. Likely a Palliser & Palliser pattern book house.

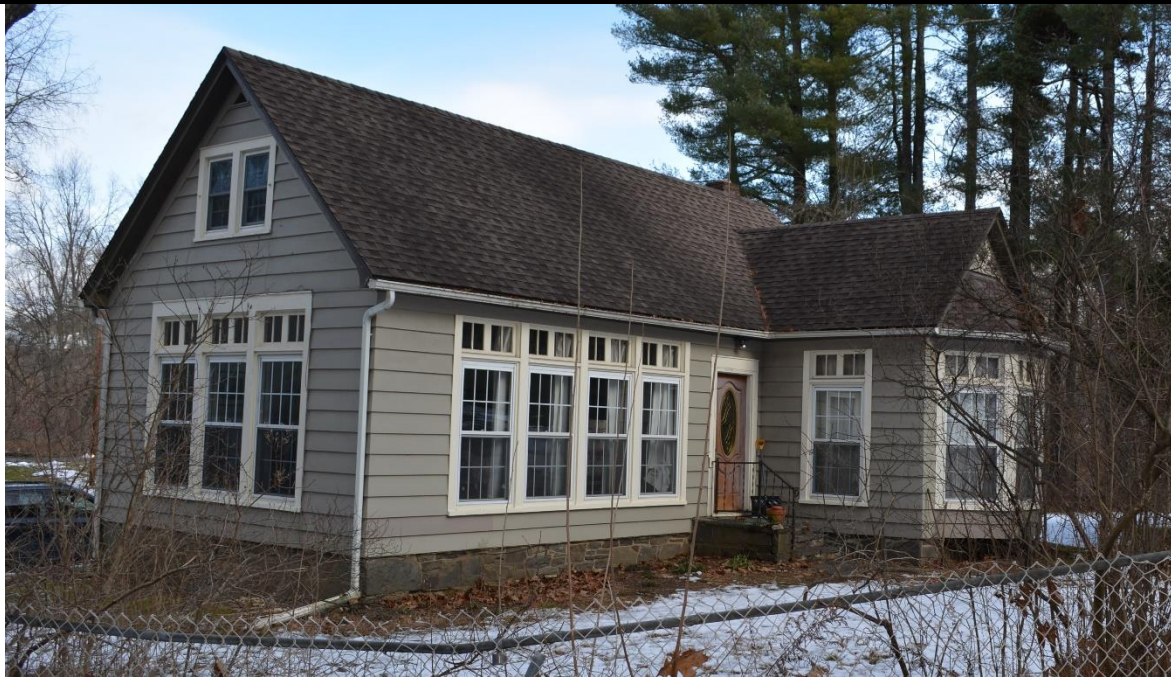
Description: A Folk Victorian style building with stone foundation and clapboard siding. Replacement windows and doors. Lacks integrity.

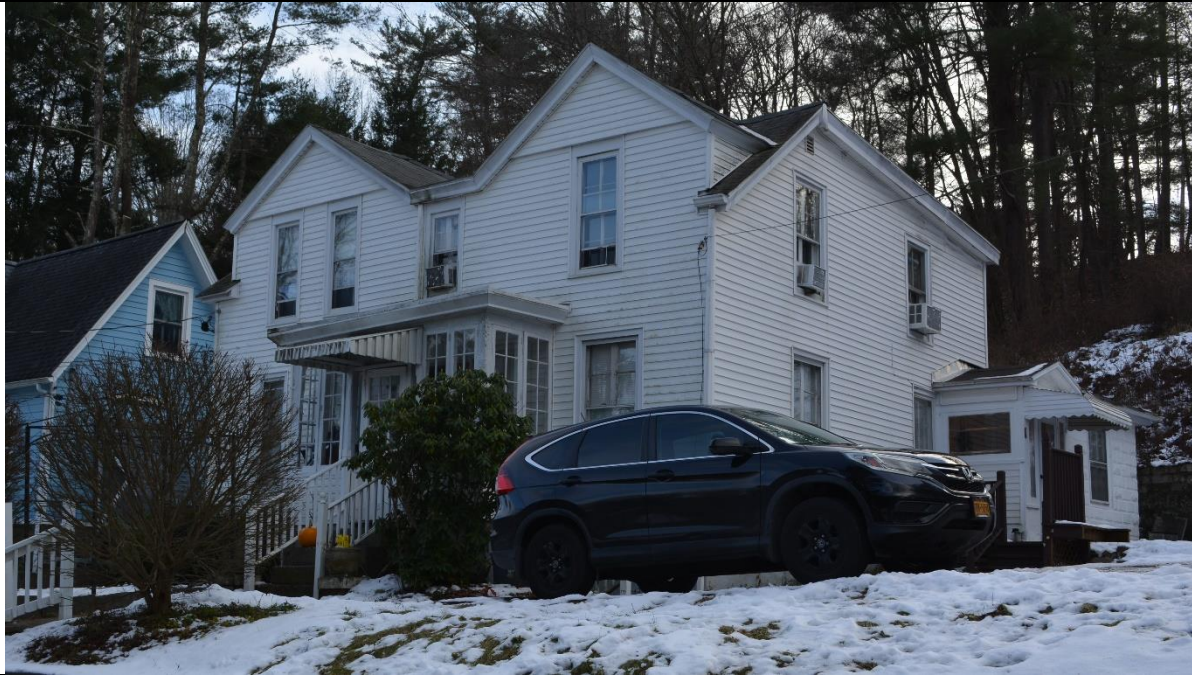
Description: a two-story, Vernacular style house with cement foundation. Two prominent front gables. Enclosed porch. Altered form and replacement siding. Lacks integrity.

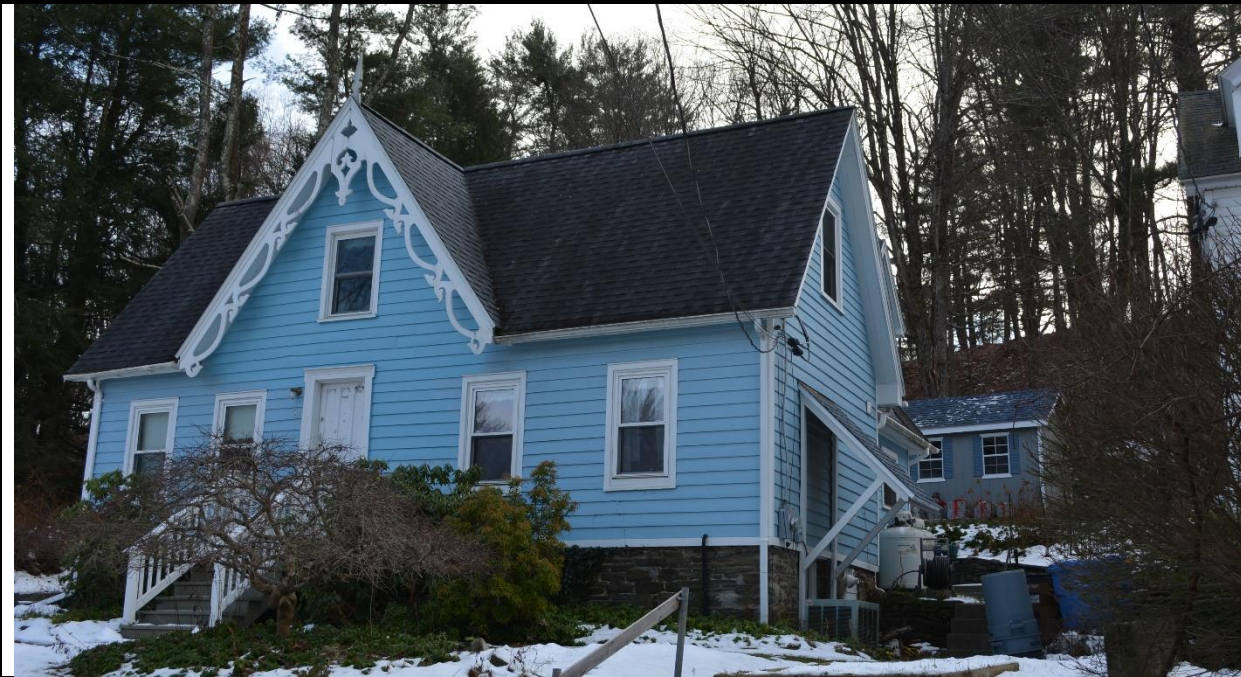
Description: A Gothic Revival style house with stone foundation, five bays wide. Decorative vergeboards. Replacement windows & siding. Large rear addition. Lacks integrity.

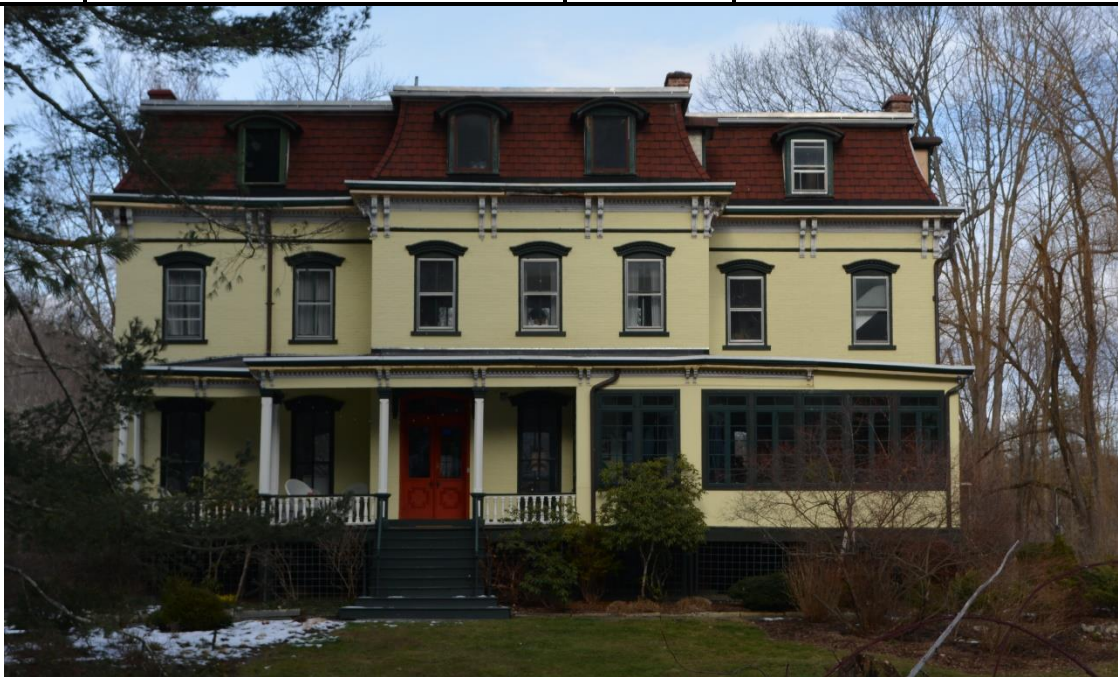
Description: Three-story, Second Empire, brick house with a brick foundation, asphalt roof, seven bays wide. Full-width front porch, partially enclosed (historic). Historic windows and doors. High integrity.

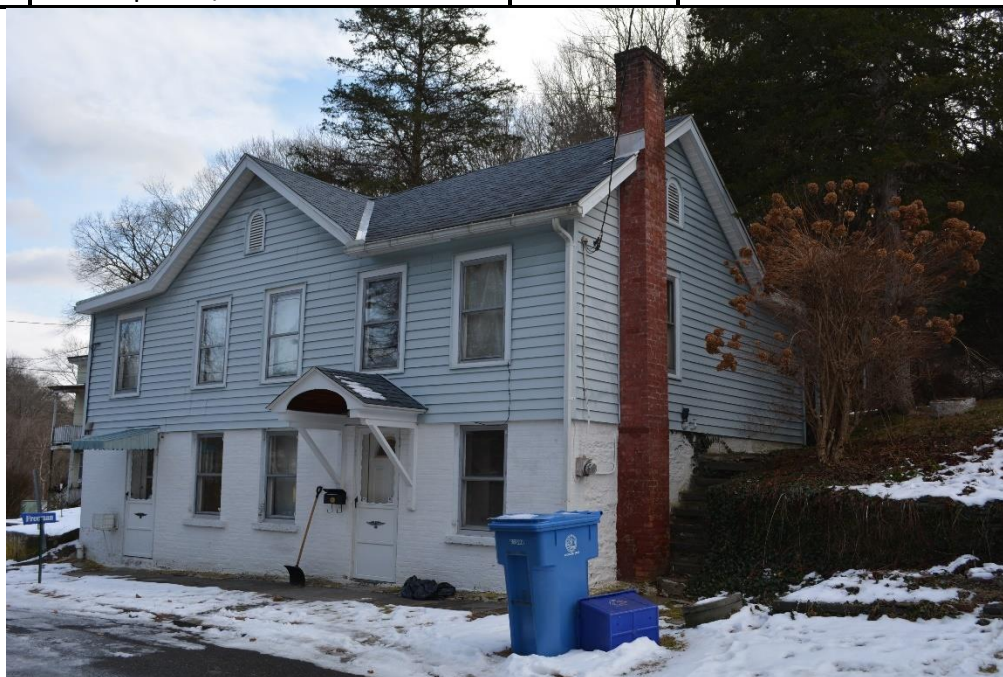
Description: A two-story, Gothic Revival house with brick and stone foundation and vinyl siding, four bays wide. Replacement siding, doors, and soffits (and maybe windows). Lacks integrity.

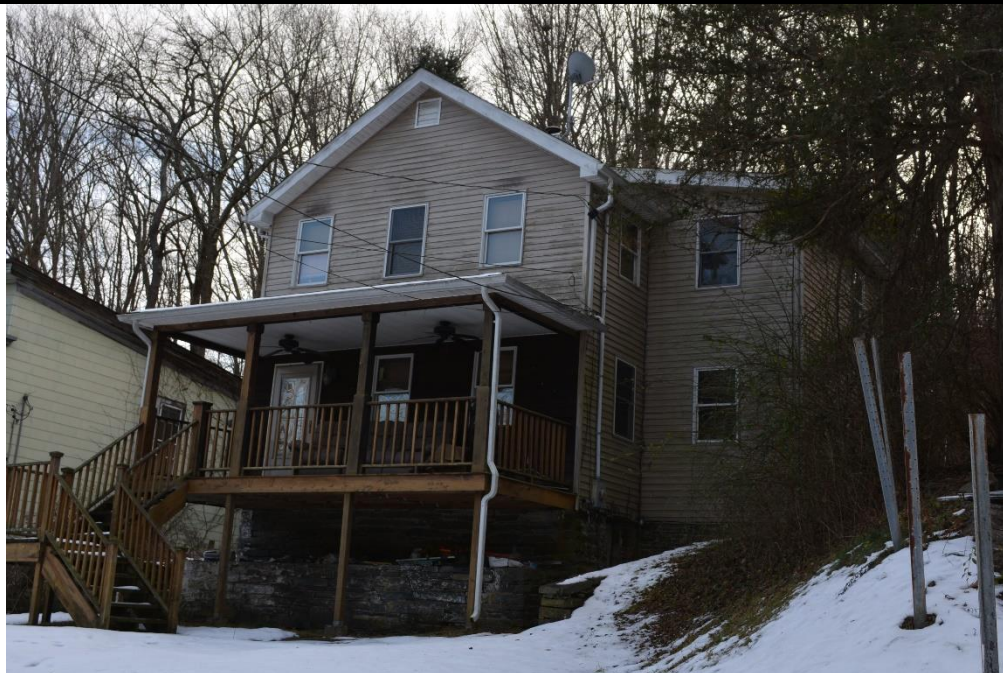
Photo #:	Address / Block & Lot:	Year Built:	Eligibility Recommendation:
56	38 Chapel St / 56.49-4-5	1900	NOT ELIGIBLE:

Description: A two-story vernacular/National style house with stone foundation and asphalt roof. Altered form with replacement siding, windows, and doors. Lacks integrity.

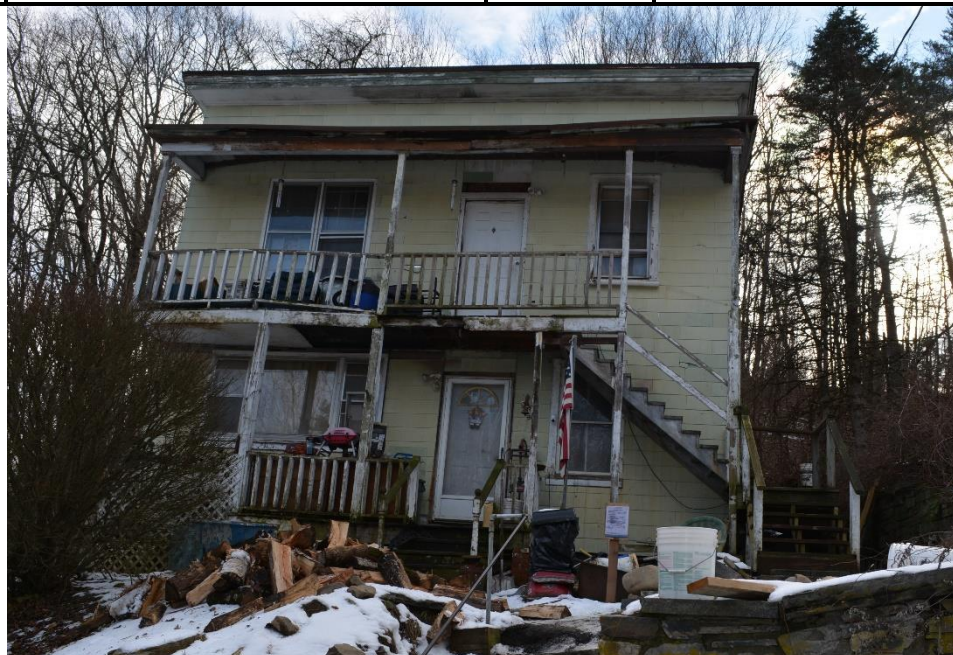
Photo #:	Address / Block & Lot:	Year Built:	Eligibility Recommendation:
57	34 Chapel St / 56.49-4-6	1878	NOT ELIGIBLE:

Description: A two-story, Italianate style house with stone foundation and asphalt roof, three bays wide. Two-story front porch. Replacement siding, porch elements, and doors. Altered fenestration. Lacks integrity.

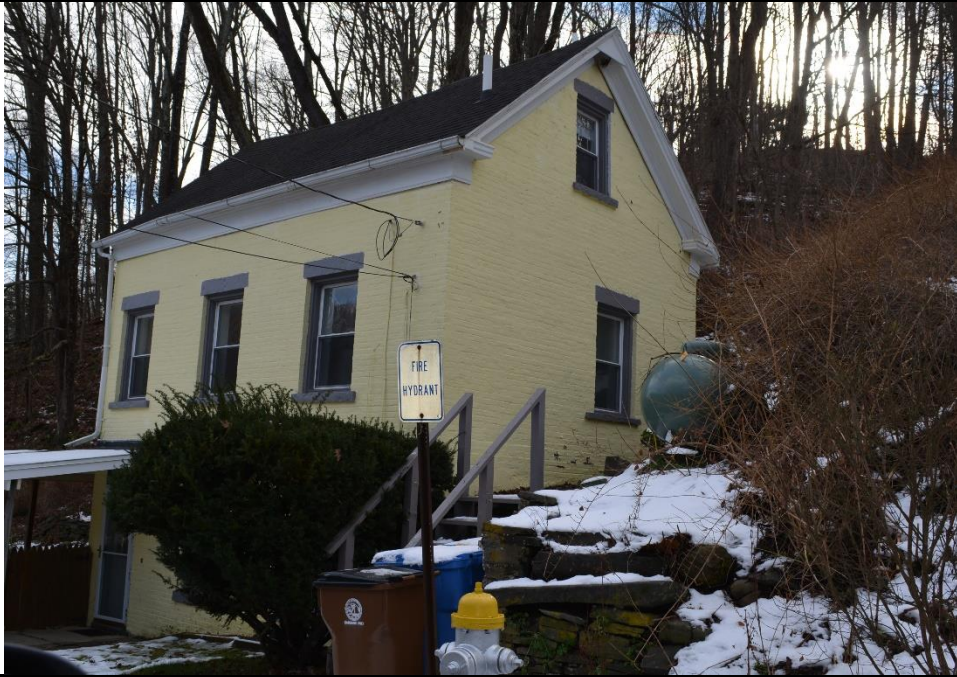
Photo #:	Address / Block & Lot:	Year Built:	Eligibility Recommendation:
58	28 Chapel St / 56.49-4-7	1900	NOT ELIGIBLE:

Description: A two-story, side-gabled, vernacular/National style brick house with brick foundation, three bays wide. Stone sills and lintels. Replacement windows and doors. Modern porch roof addition on front.

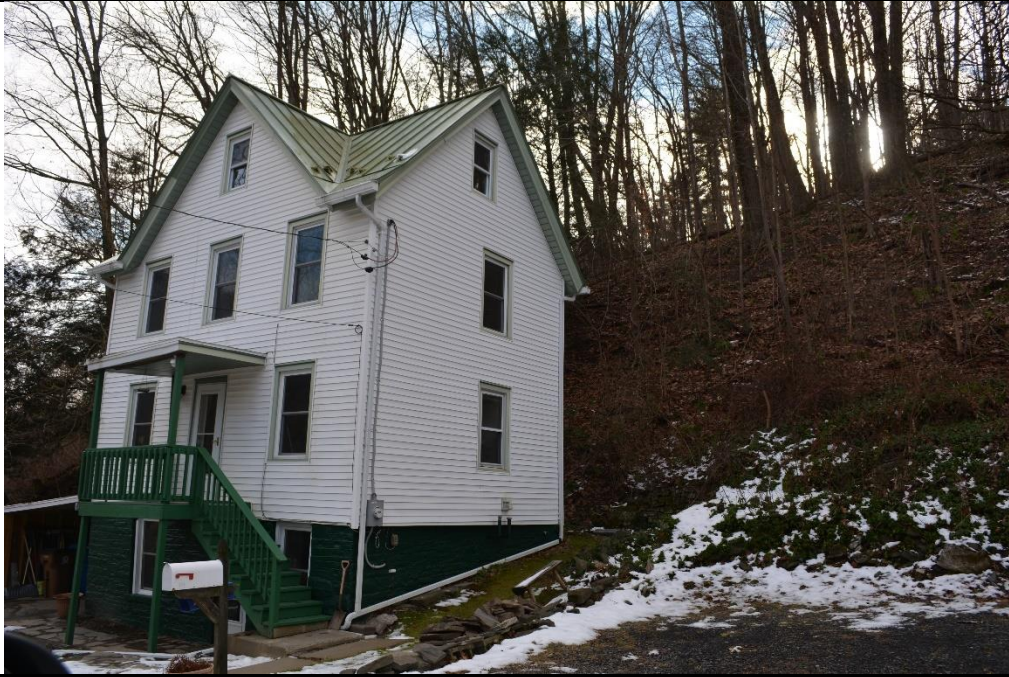
Description: A three-story, Gothic Revival, cross gabled form with metal roof, vinyl siding, stone foundation, three bays wide. Replacement windows, doors, and siding. Entry porch all replaced. Lacks integrity.

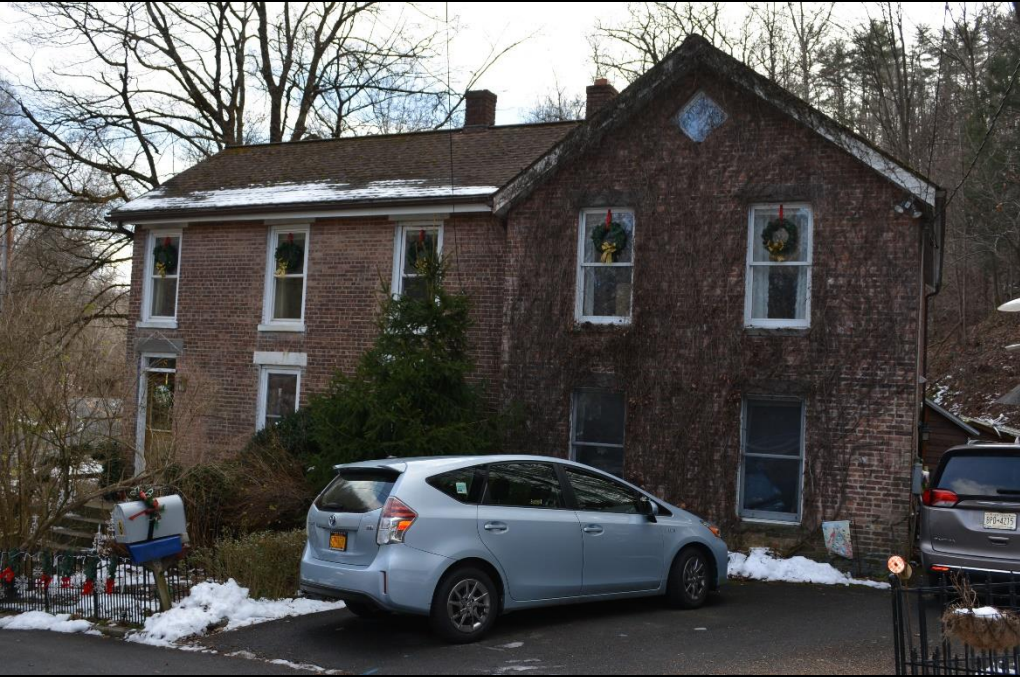
Description: A vernacular/National style brick house with cross gabled asphalt roof, brick foundation, five bays wide. Diamond window in attic gable. Stone sills and lintels. Entry porch removed. Soffits replaced. Possibly some altered fenestration. Difficult to assess.

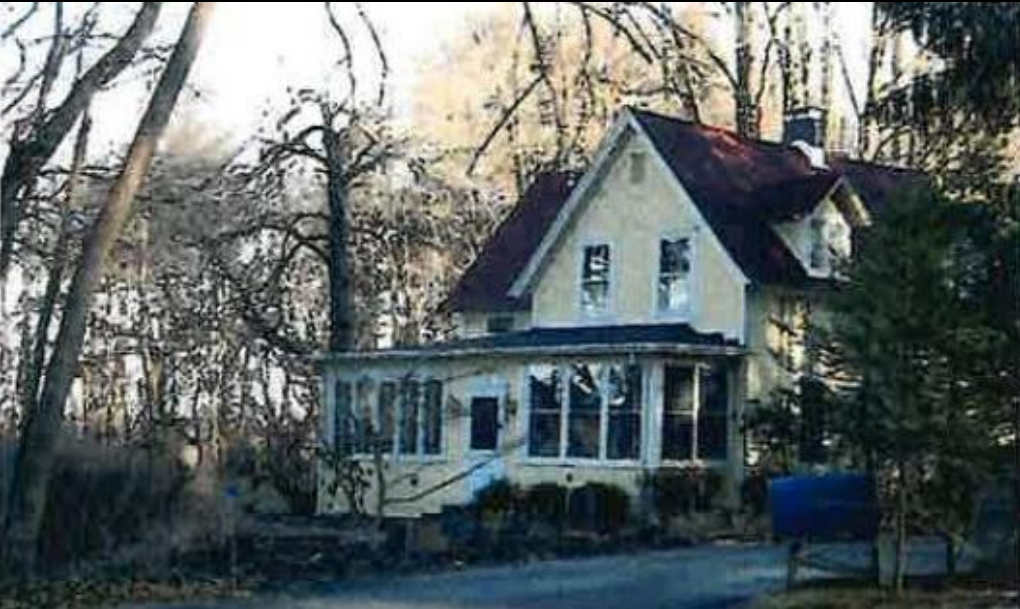
Photo #:	Address / Block & Lot:	Year Built:	Eligibility Recommendation:
61	76 Chapel St / 56.49-4-1	1880	NOT ELIGIBLE:

Description: A two-story, cross gabled house, like of vernacular/National style. Enclosed full-width front porch. Not visible from public right-of-way. Appears to lack integrity.

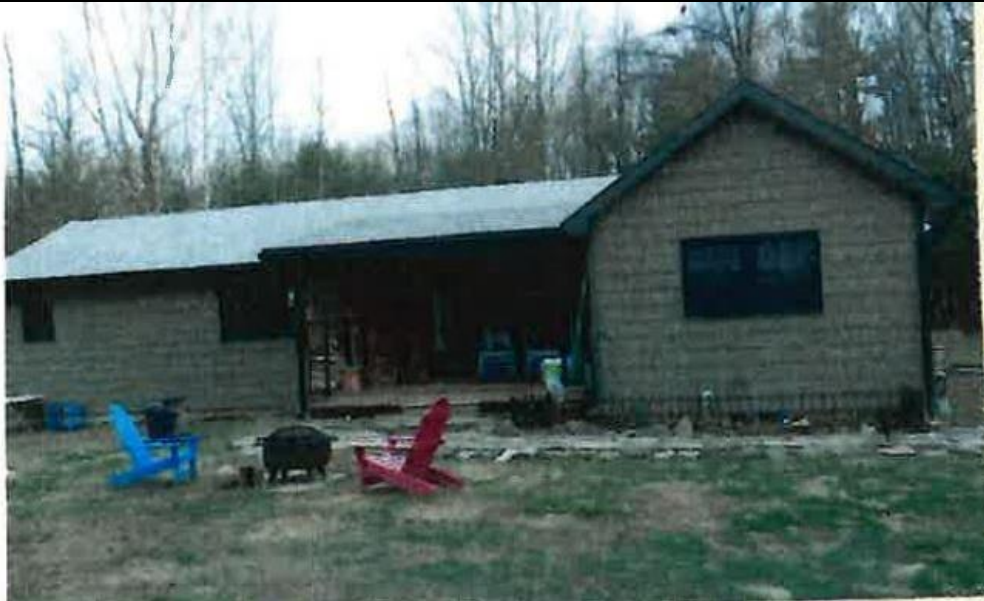
Photo #:	Address / Block & Lot:	Year Built:	Eligibility Recommendation:
62	78 Chapel St / 56.56-1-2	2014	NOT ELIGIBLE:

Description: A ranch style home with shingle siding. Less than 50 years old.

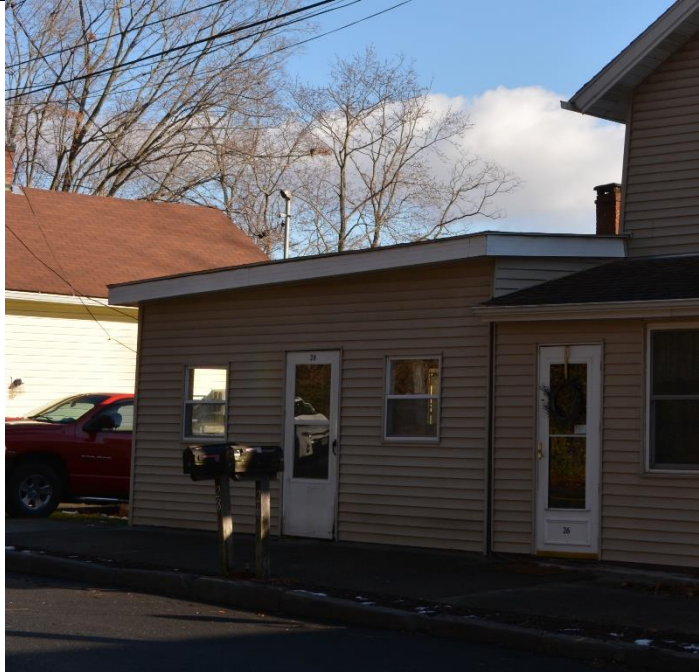
Photo #:	Address / Block & Lot:	Year Built:	Eligibility Recommendation:
5	28 North St / 56.36-1-28	c. 1875	NOT ELIGIBLE

Description: A one-story vernacular/National shed style roof, brick foundation, vinyl siding, and asphalt roof shingles. The first floor is divided into three bays. This building is attached to the building in photo 5. Appears to be an old addition with replacement windows, doors, siding, altered fenestration.

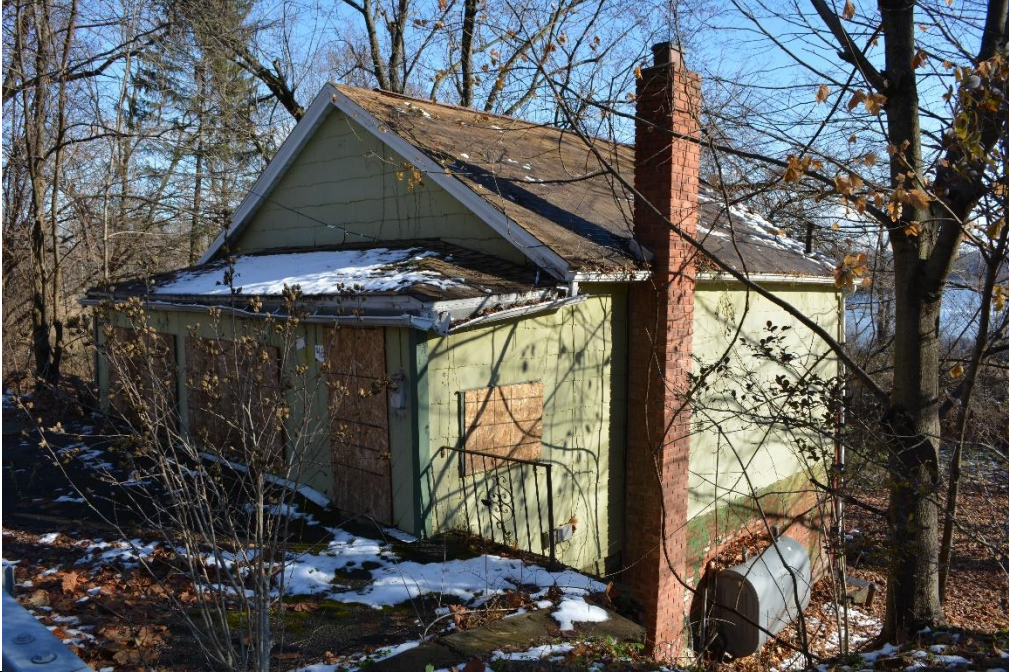
Description: A one-story vernacular/National front-gabled roof, brick foundation, fibrous siding, asphalt roof shingles. The first floor is divided into five bays. Enclosed front porch.

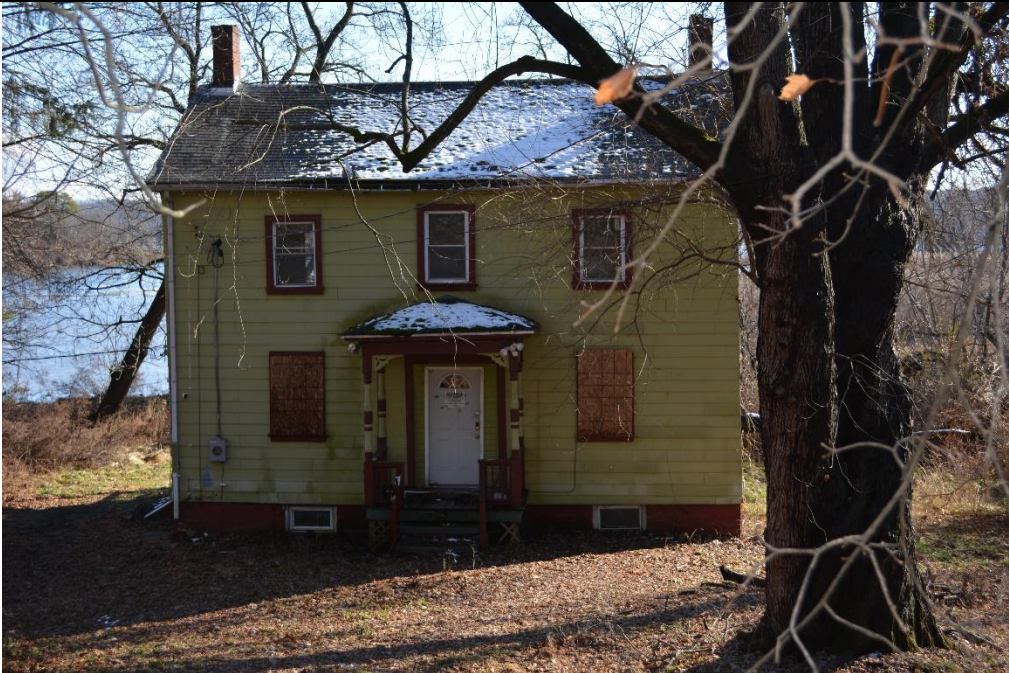
Description: A two-story vernacular/National side-gabled roof, brick foundation, metal siding, asphalt roof shingles. The first floor is divided into three bays. Replacement windows and door.
