**INTENSIVE-LEVEL HISTORIC RESOURCES
& BUILDING SURVEY
WILBUR & PONCKHOCKIE NEIGHBORHOODS
CITY OF KINGSTON, ULSTER COUNTY, NEW YORK
RFPK #22-11**

EXECUTIVE SUMMARY

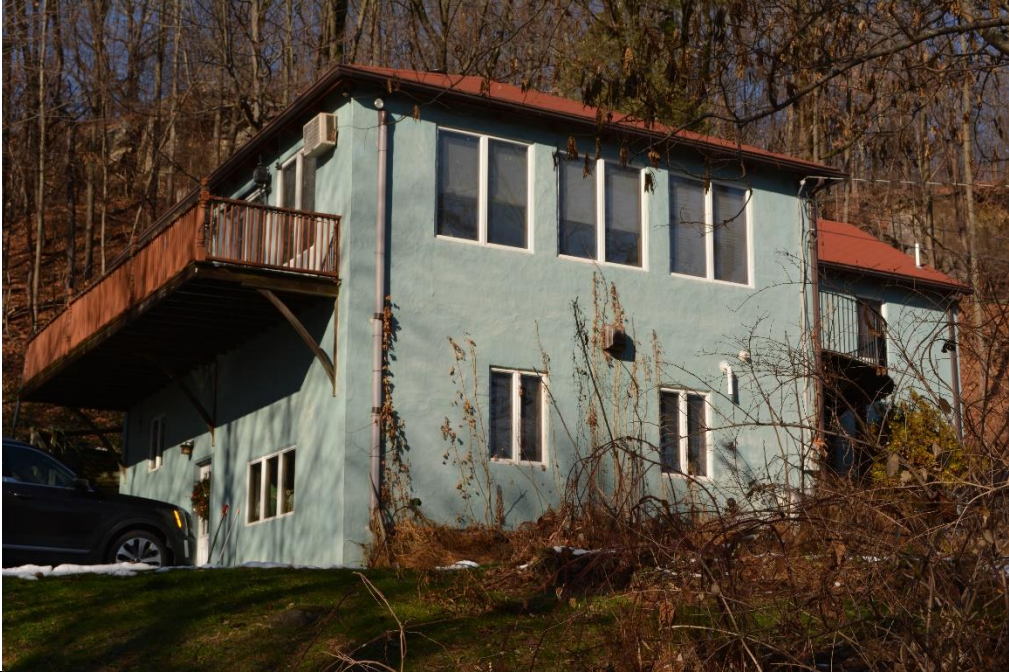
Photo #:	Address / Block & Lot:	Year Built:	Eligibility Recommendation:
11	151 E Union St / 56.35-9-17	c. 1988	NOT ELIGIBLE

Description: A two-story Contemporary house with hipped roof, cement foundation, stucco siding, asphalt roof shingles. The first floor is divided into three bays.

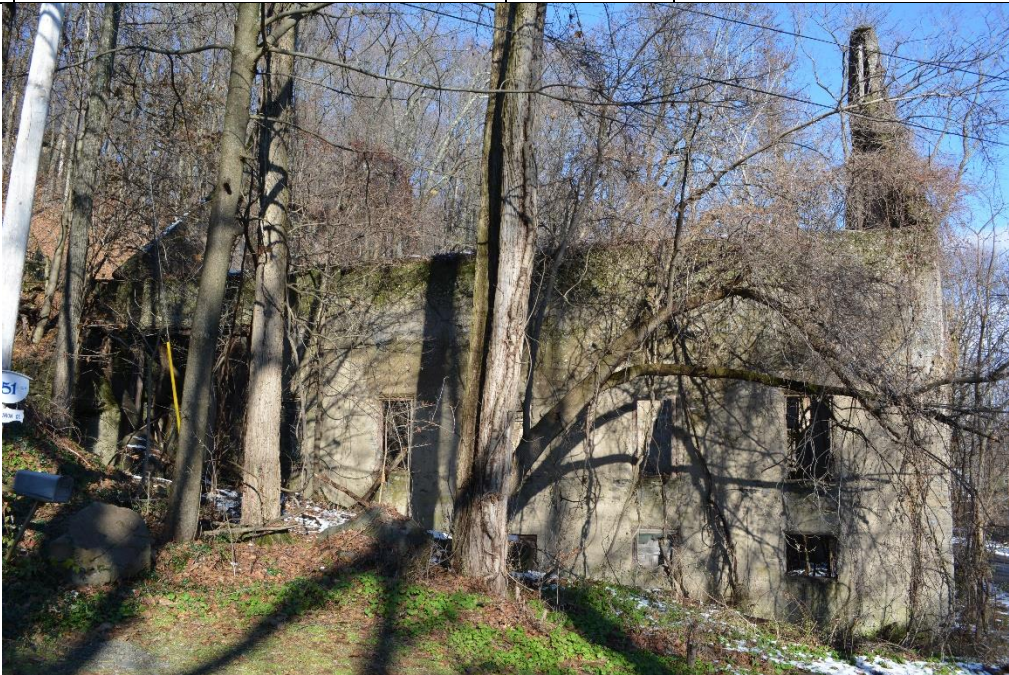
Description: Ruin of Mule Barn. Made of poured concrete. See report for details.

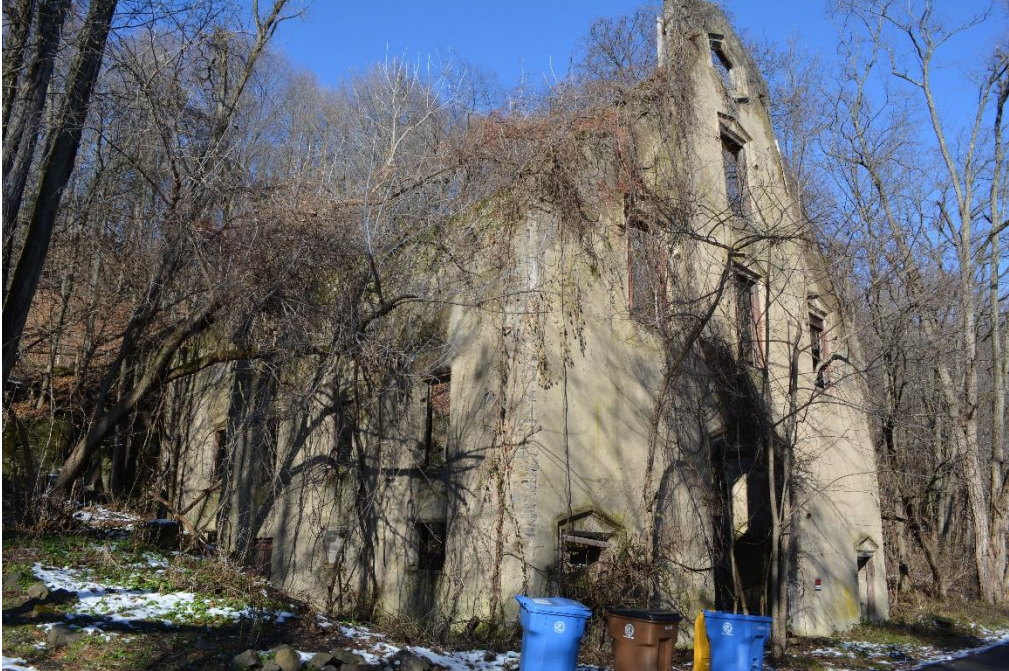
Photo #:	Address / Block & Lot:	Year Built:	Eligibility Recommendation:
13	151 E Union St / 56.35-9-17	c. 1870	ELIGIBLE

Description: Ruin of Mule Barn. See report for details.

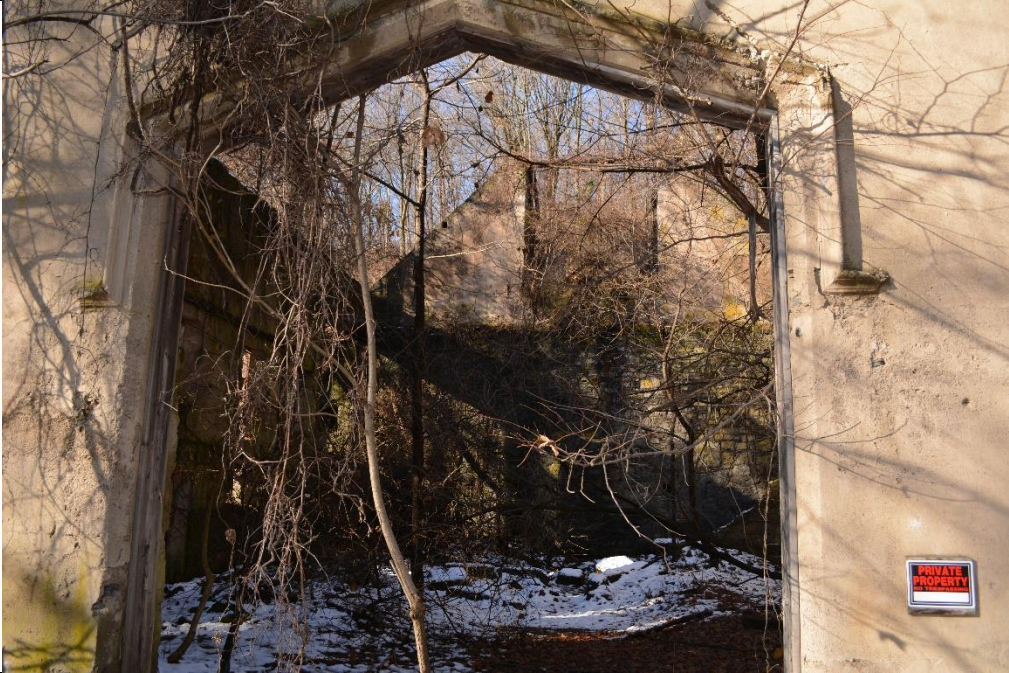
Description: Closeup of Mule Barn. See report for details.

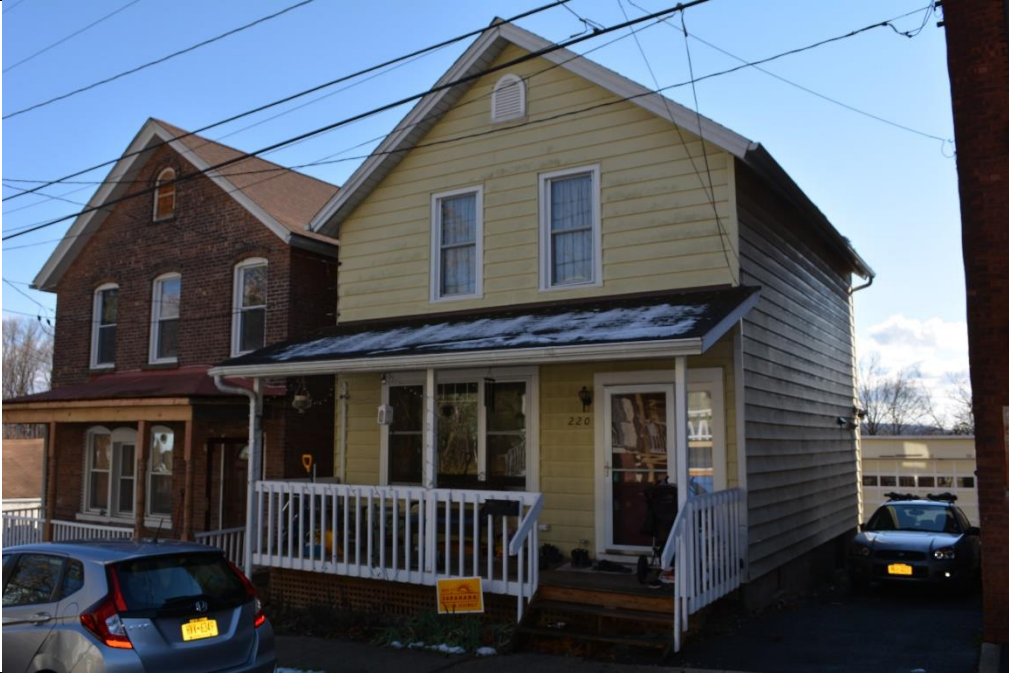
<p>Description: A two-story Italianate front-gabled roof, brick foundation, vinyl or metal siding, asphalt roof shingles. The first floor is divided into two bays. Replacement windows, doors, and porch elements.</p>

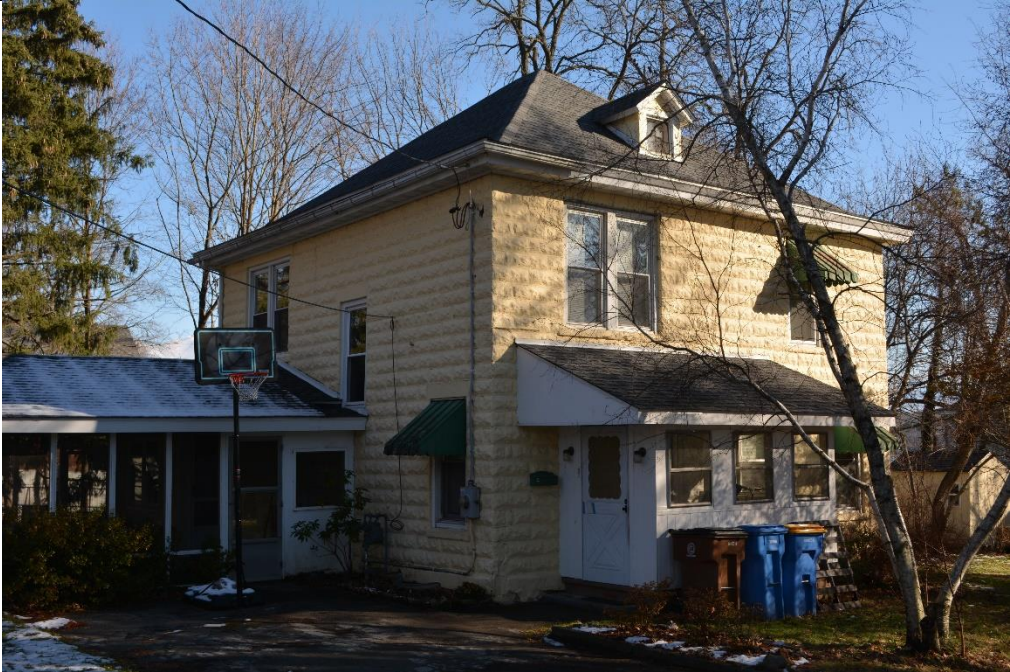
Description: A two-story Foursquare pyramidal roof with flared eaves and small dormer on front, concrete block foundation and siding, asphalt roof shingles. The first floor is divided into three bays. There are two enclosed porches. Remarkably similar to 285 E Strand (same house plan?).

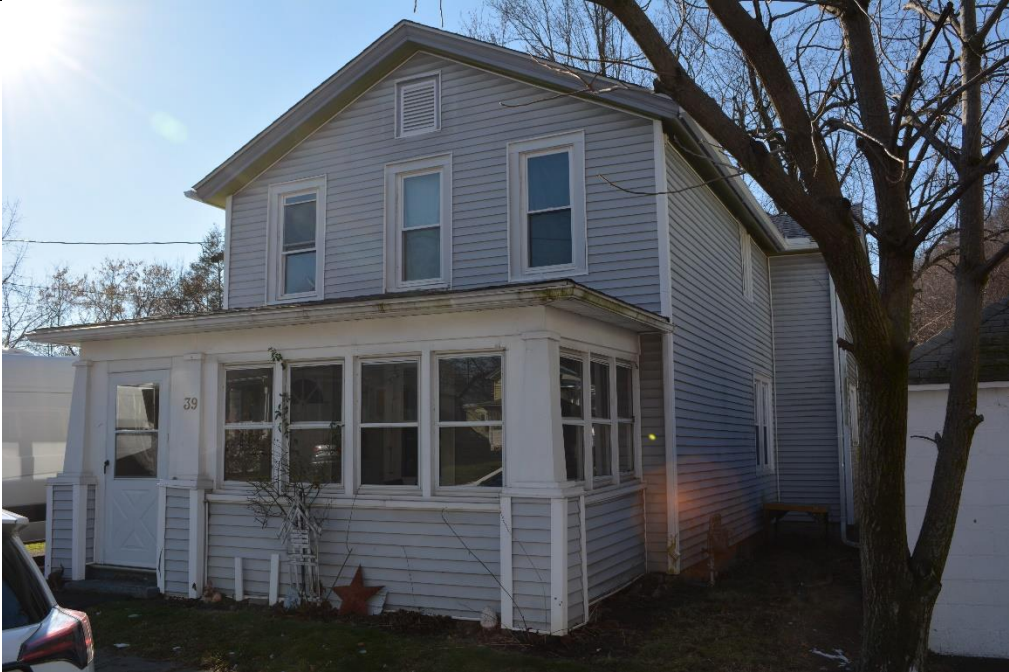
Description: A two-story vernacular/National front-gabled roof, brick foundation, vinyl siding, and asphalt roof shingles. Three bays wide, enclosed porch with battered columns. Replacement windows.			
Photo #: 55	Address / Block & Lot: 43 Ponckhockie St / 56.36-4-11	Year Built: c. 1875	Eligibility Recommendation: HD, CONTR

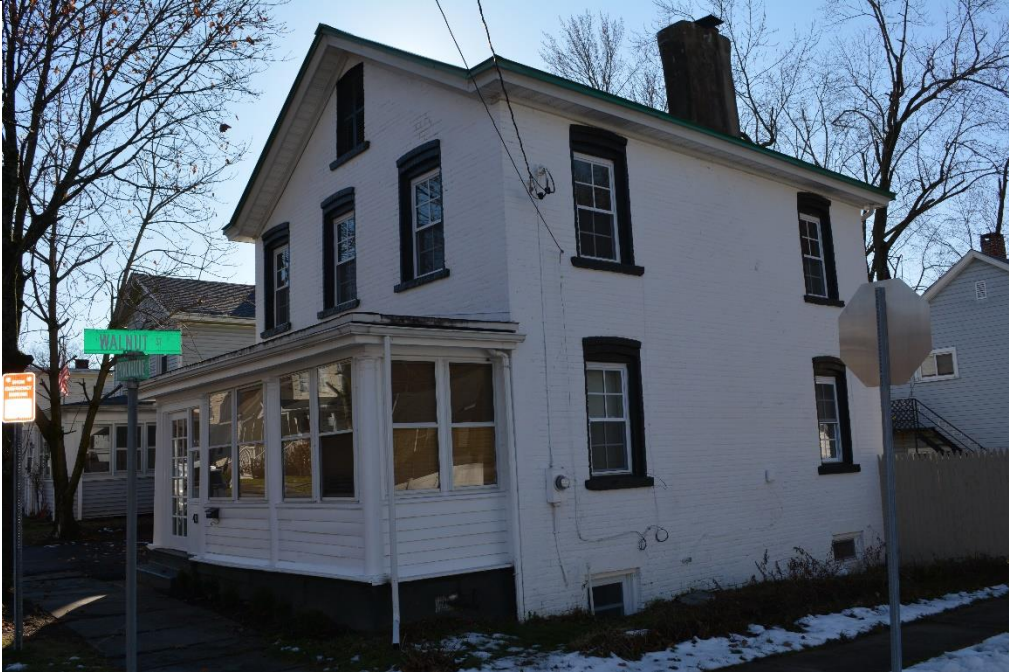
Description: A two-story Italianate front-gabled roof, brick foundation and brick siding, and asphalt roof shingles. Three bays wide, enclosed porch with Tuscan columns. Replacement windows and soffits.

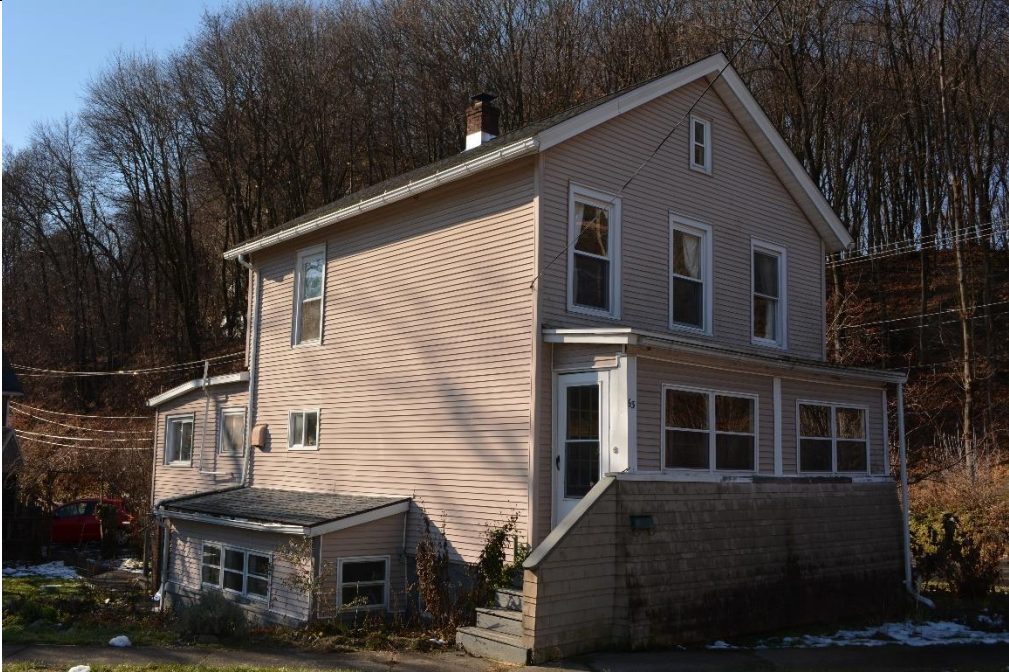
Description: A two-story vernacular/National front-gabled roof, brick foundation, vinyl siding, and asphalt roof shingles. The first floor is divided into three bays. Full-width front porch is enclosed. Rear addition plus basement side addition. Replacement windows, doors, soffits.

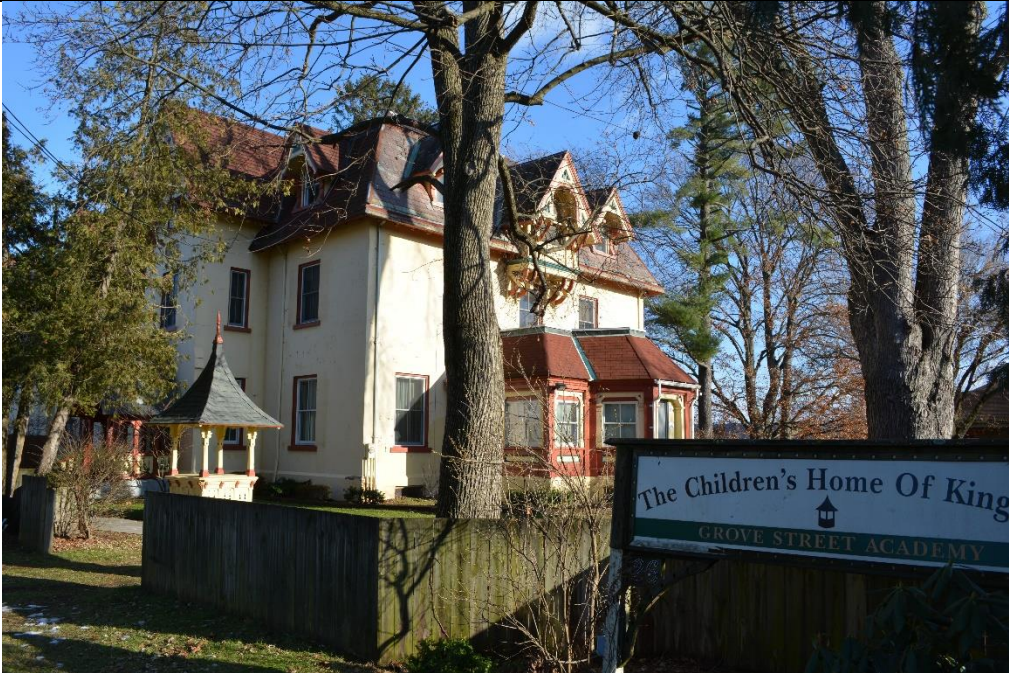
Photo #:	Address / Block & Lot:	Year Built:	Eligibility Recommendation:
64b	2-12 Abruyn St / 56.36-10-7.200	c.1870	IND

Description: Another view of the building. See report for details. Note historic wood elements.

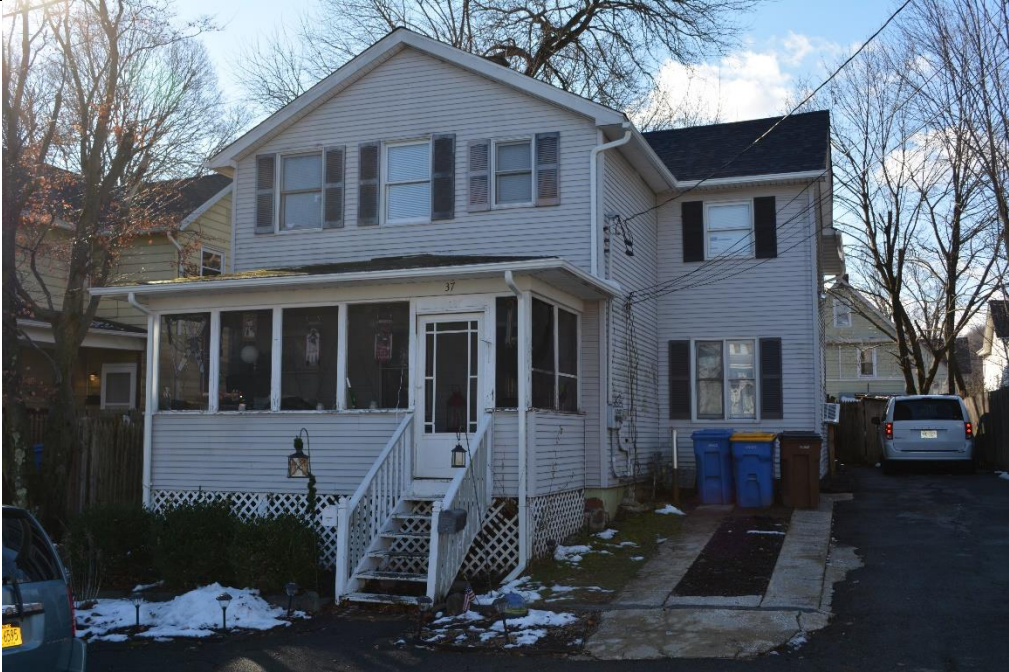
Photo #:	Address / Block & Lot:	Year Built:	Eligibility Recommendation:
72	37 Abruyn St / 56.36-11-26	c.1870	NOT ELIGIBLE

<p>Description: A two-story vernacular/National with cross-gabled roof, cement block foundation, vinyl siding, and asphalt roof shingles. Front wing is three bays wide with full-width front porch (enclosed). Replacement windows, soffits, and front stair elements. Altered fenestration. Rear wing likely an addition.</p>

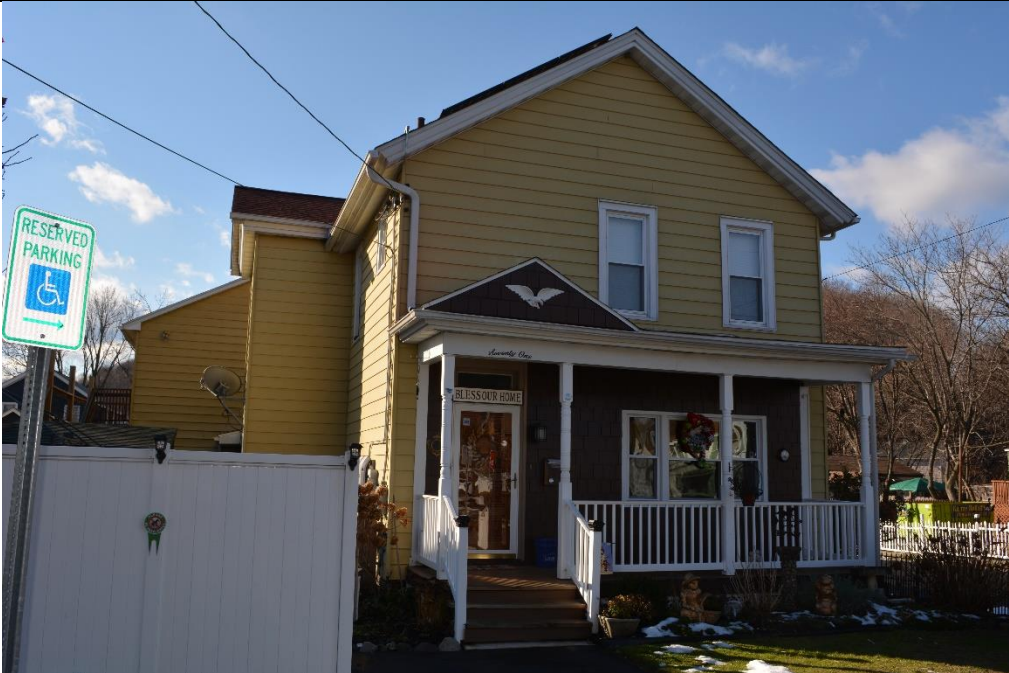
<p>Description: A two-story national/Vernacular style house with cross-gabled roof, brick foundation, metal siding, and asphalt roof shingles. The first floor is divided into two bays and a covered porch with pediment gable over entry. Replacement windows, doors, porch elements. Altered fenestration. Large rear addition or converted 2-story carriage house on rear, fronting Walnut Street.</p>

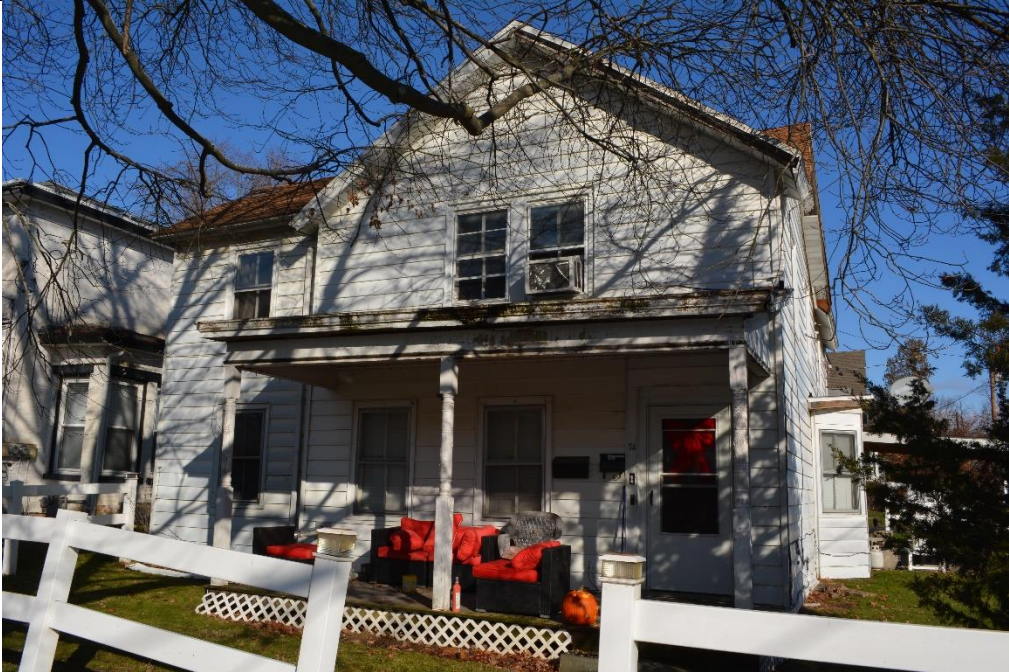
Photo #:	Address / Block & Lot:	Year Built:	Eligibility Recommendation:
85	74 Abruyn St / 56.36-6-13	c. 1900	HD, CONTR

Description: A two-story vernacular/National style house with cross-gabled roof, cement foundation, metal siding and asphalt roof material. The first floor is divided into four bays (three in front gable wing). There is a covered porch on the first floor. Historic windows.

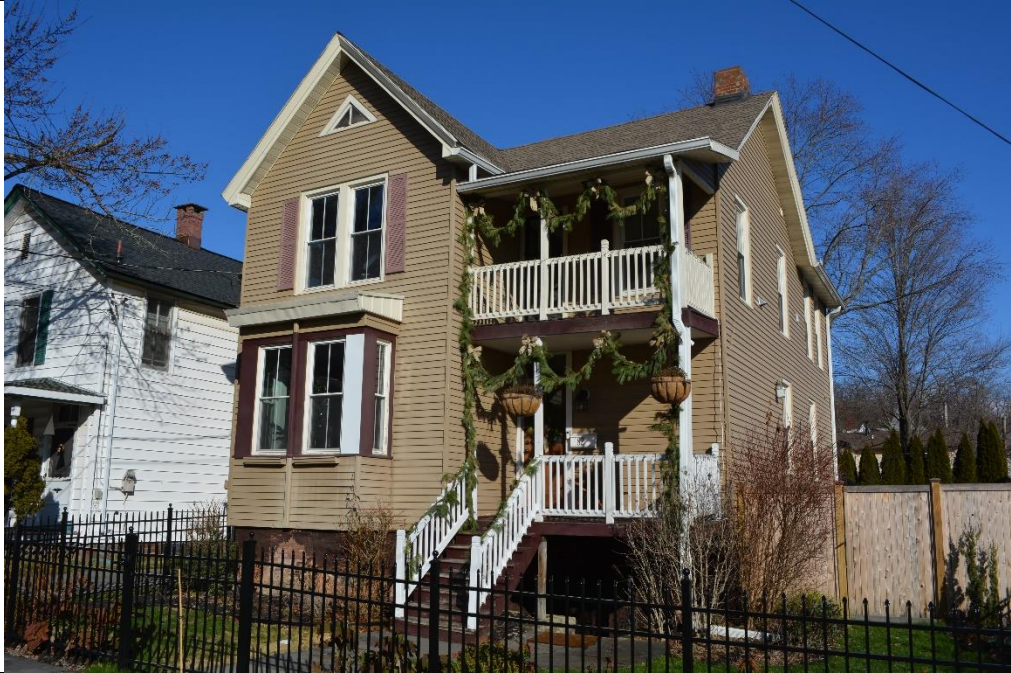
Description: A two-story Stick Stick or Queen Anne Style cross-gabled roof, brick foundation, vinyl siding and asphalt roof shingles. Two-story front porch. Replacement windows, soffits, and all porch elements.

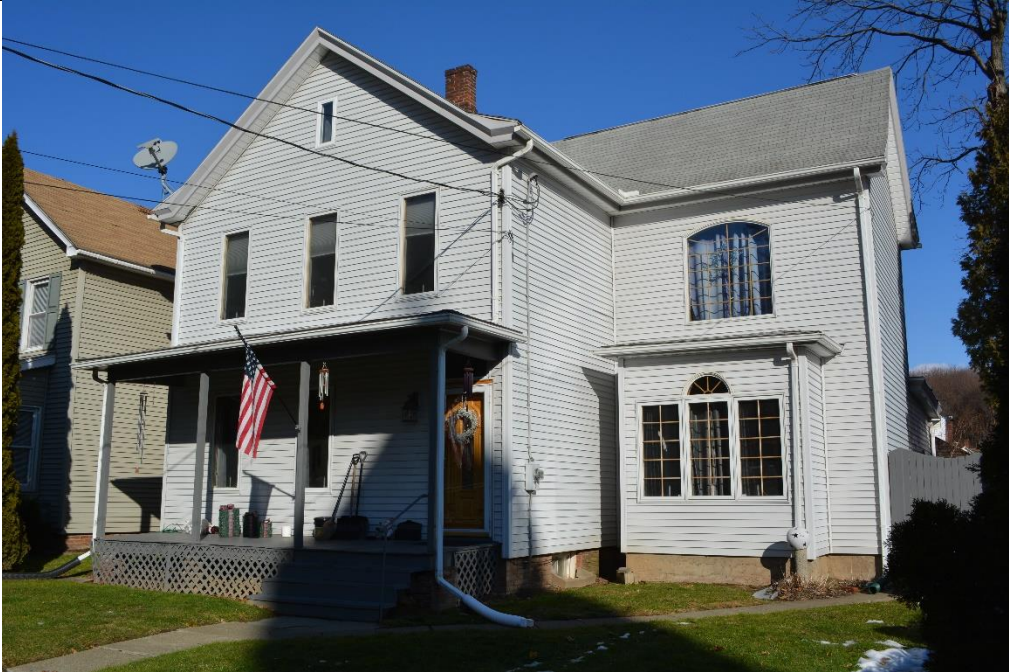
Description: A two-story Italianate cross-gabled roof with flared eaves, stone foundation, vinyl siding, and asphalt roof shingles. The first floor is divided into three bays (front gabled end) and a covered porch. Altered fenestration. Replacement windows, door, and porch columns.

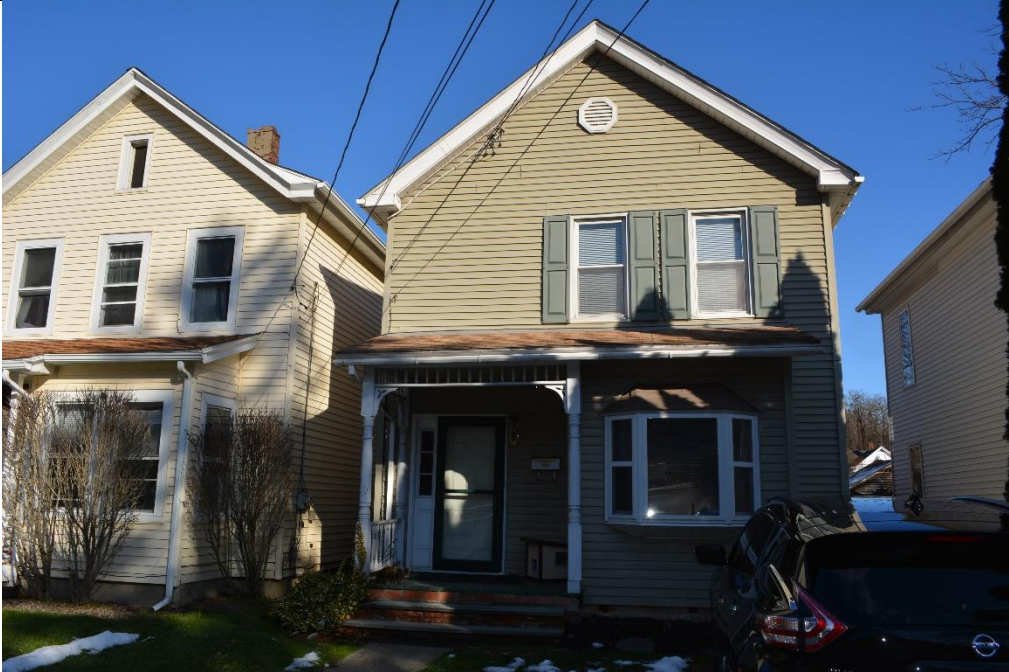
Photo #:	Address / Block & Lot:	Year Built:	Eligibility Recommendation:
98	104 Abruyn St / 56.36-6-20	c. 1890	NOT ELIGIBLE

<p>Description: A two-story vernacular/National front-gabled roof, brick foundation, vinyl siding, and asphalt roof shingles. Covered porch over entry with historic columns, brackets, and possibly railings. Portion of porch enclosed, perhaps historic (see neighboring house at 106 Abruyn), with later polygonal oriel. Replacement windows, doors, & soffits. Possible altered fenestration.</p>

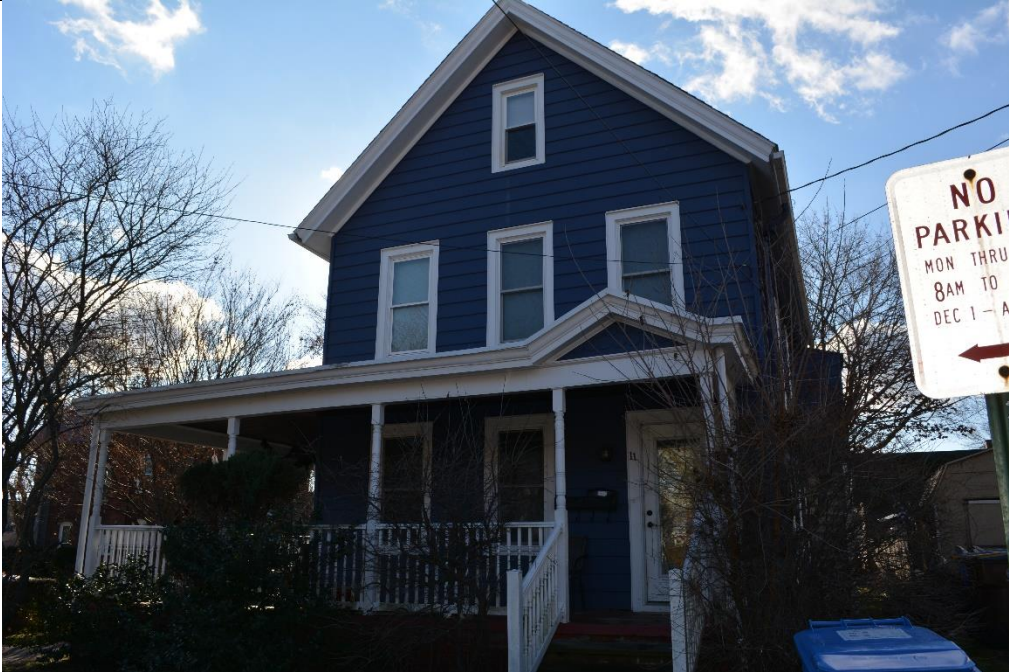
Description: A two-story vernacular/National cross-gabled roof, brick foundation, vinyl siding, and asphalt roof shingles. The first floor is divided into three bays with a wrap-around covered porch with pediment over entry. Replacement windows, doors, and all porch elements.

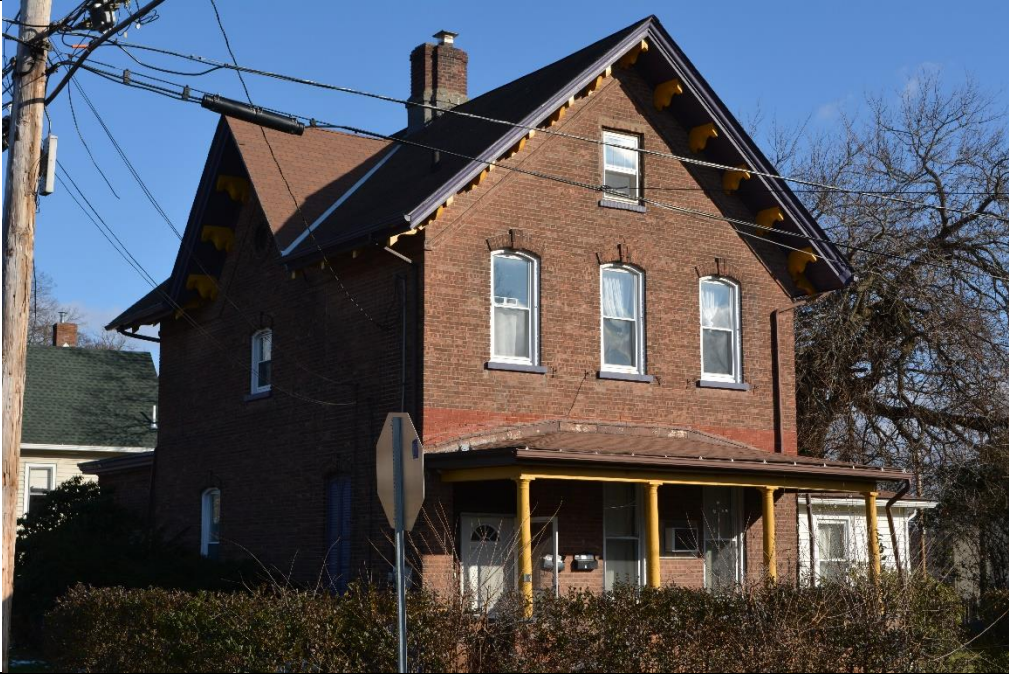
<p>Description: A two-story Italianate with cross-gabled roof, brick foundation and brick siding, and asphalt roof shingles. Three bays wide with full-width front porch. Large corbels under overhanging roof eaves. Front attic window opening altered. Replacement windows & doors. Thru-wall A/C unit. One-story vinyl addition on south façade and separate one at rear. One-story brick wing on rear with altered fenestration.</p>

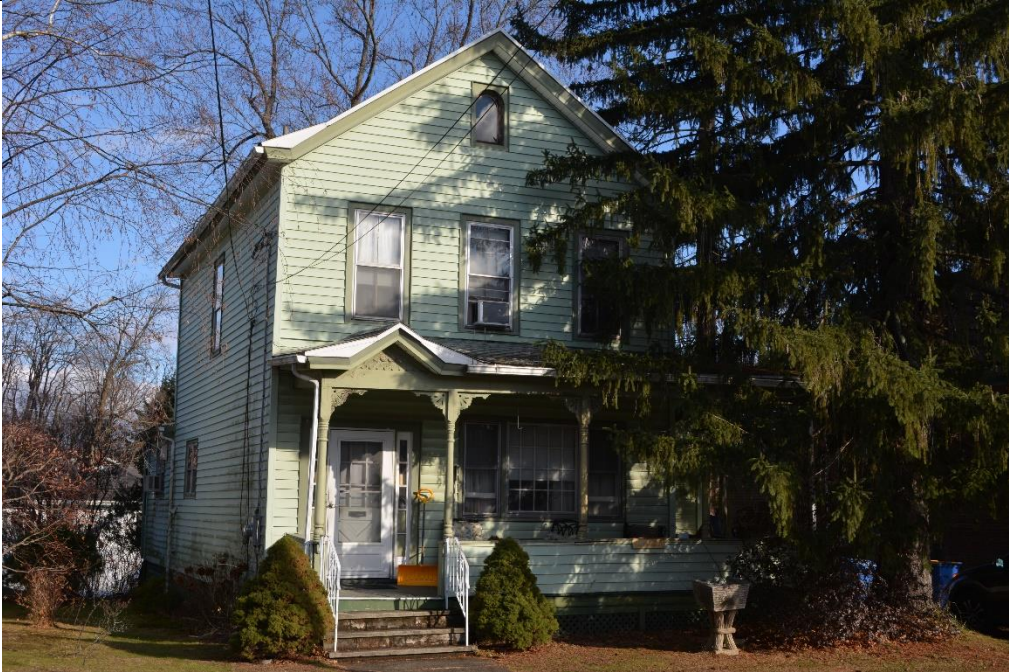
Photo #:	Address / Block & Lot:	Year Built:	Eligibility Recommendation:
108	26 Crane St / 56.36-9-12	c. 1877	HD, CONTR

<p>Description: A two-story Italianate front-gabled roof with flared eaves, cement block foundation, vinyl siding, and asphalt roof shingles. The first floor is divided into three bays and a covered porch with decorative pediment. Some historic windows, porch columns, and porch brackets. Replacement door, railings, soffits.</p>

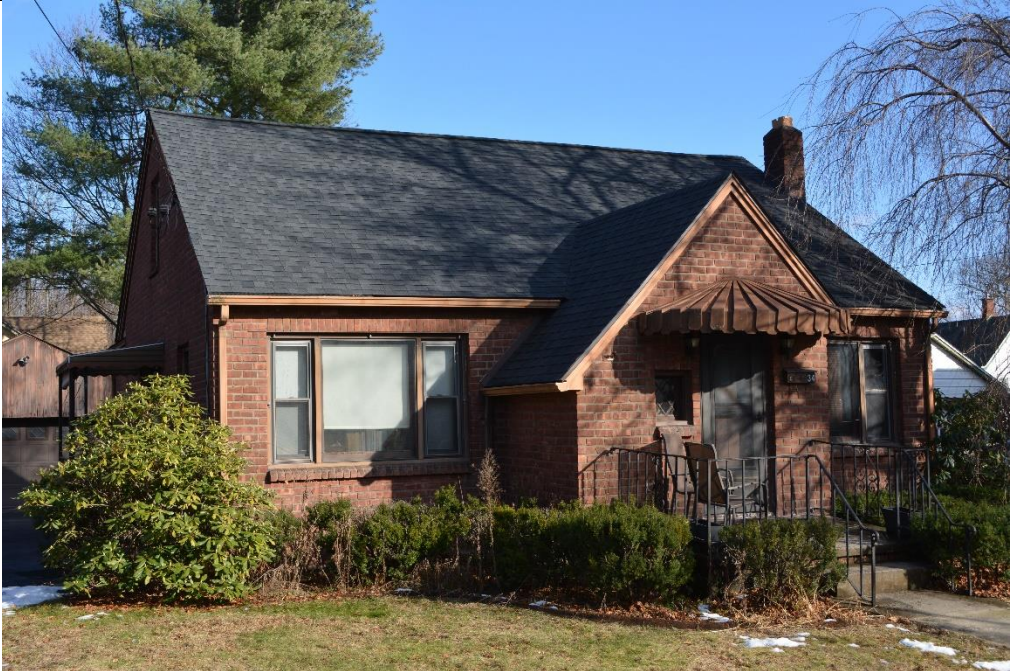
Description: A one-story, Minimal Traditional side gabled roof with front gabled entry, brick foundation and siding, and asphalt roof shingles. The first floor is divided into three bays.

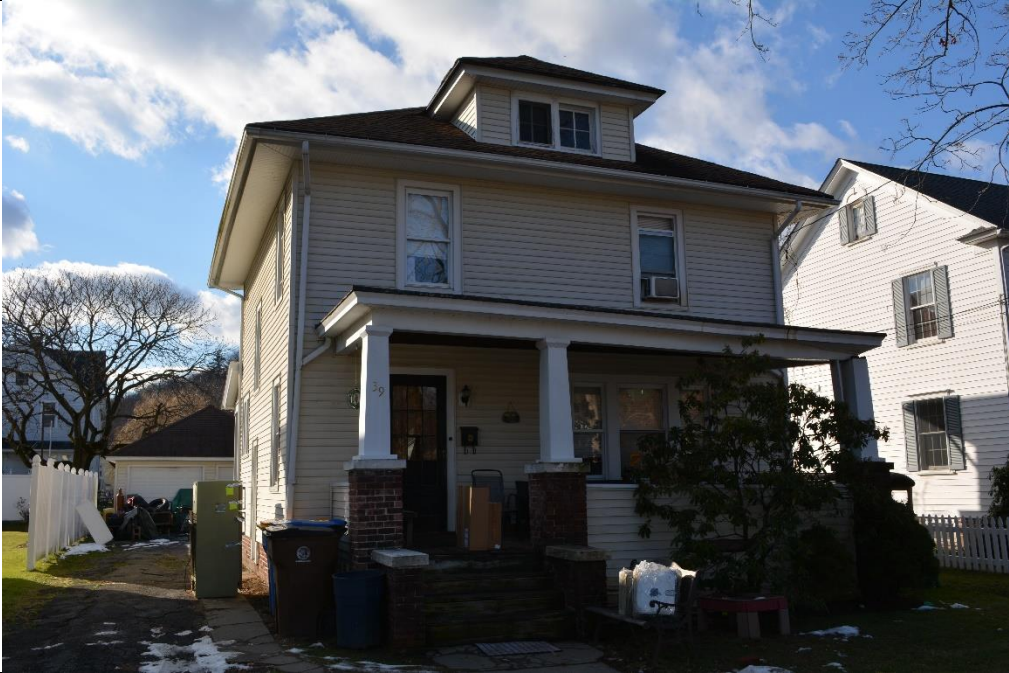
Description: A two-story Foursquare pyramidal hipped roof with hipped roof dormer, brick foundation, vinyl siding, and asphalt roof shingles. A full-width front porch is supported by three battered columns. Replacement windows and soffits.

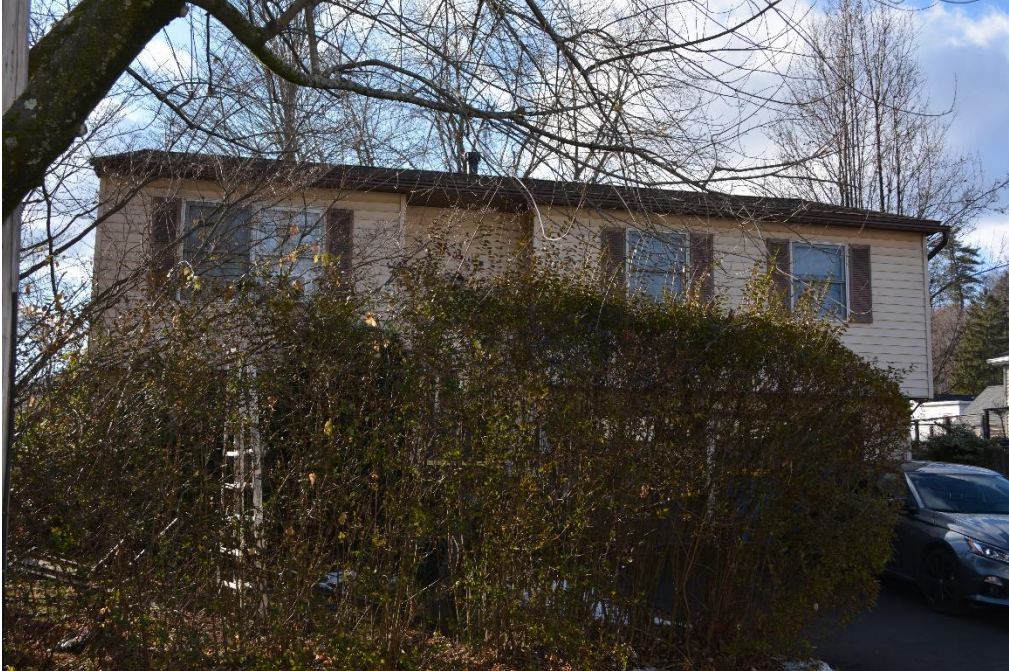
Photo #:	Address / Block & Lot:	Year Built:	Eligibility Recommendation:
118	53 Crane St / 56.36-6-11.100	c. 1987	NOT ELIGIBLE:

Description: A two-story Contemporary raised ranch side-gabled roof, cement block foundation, vinyl siding, and asphalt roof shingles. The first floor is divided into four bays.

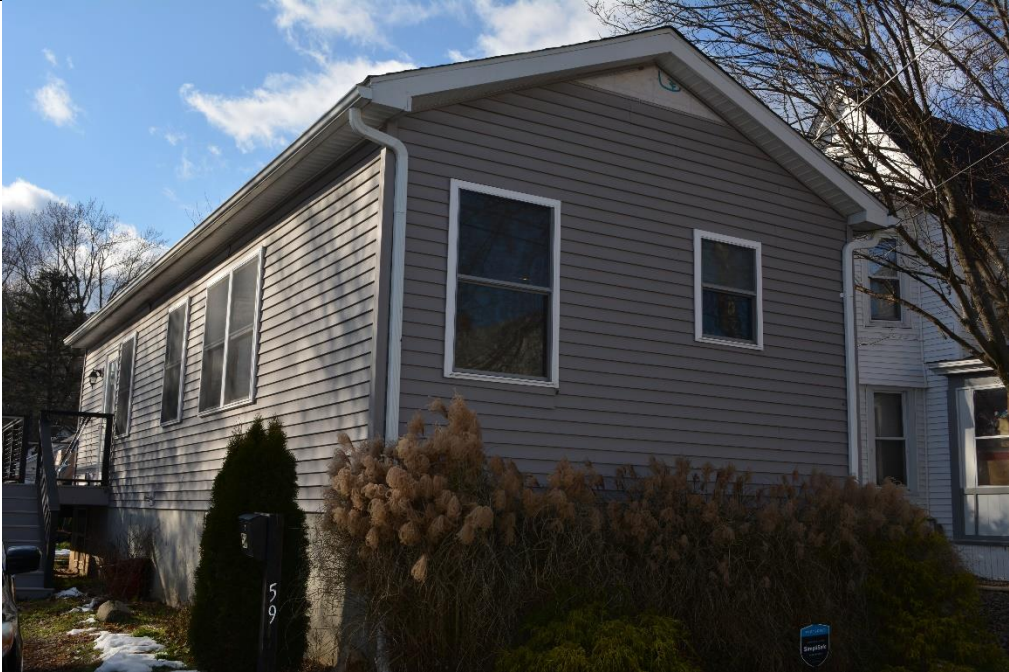
Photo #:	Address / Block & Lot:	Year Built:	Eligibility Recommendation:
120	59 Crane St / 56.36-6-10	c. 2019	NOT ELIGIBLE:

Description: A one-story Contemporary side-gabled roof with flared eaves, cement foundation, vinyl siding, and asphalt roof shingles. The first floor is divided into roughly four bays.

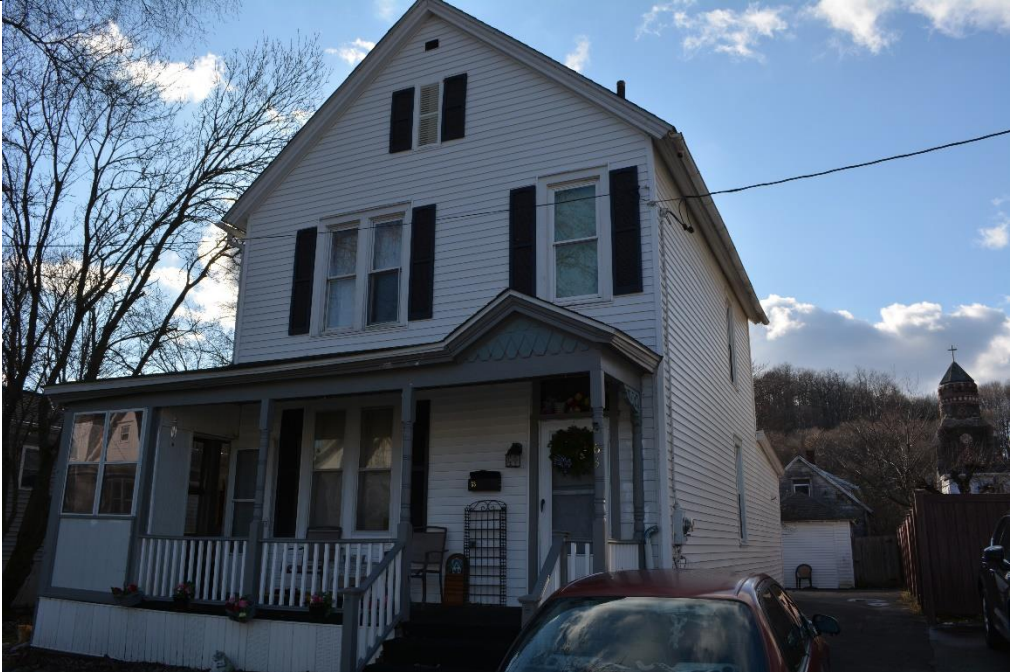
Description: A two-story Queen Anne front-gabled roof., brick foundation, vinyl siding, and asphalt roof shingles. The first floor has a full-width, wrap-around front porch (partially enclosed). Queen Anne details mostly removed & unclear if historic. Replacement windows and porch elements.

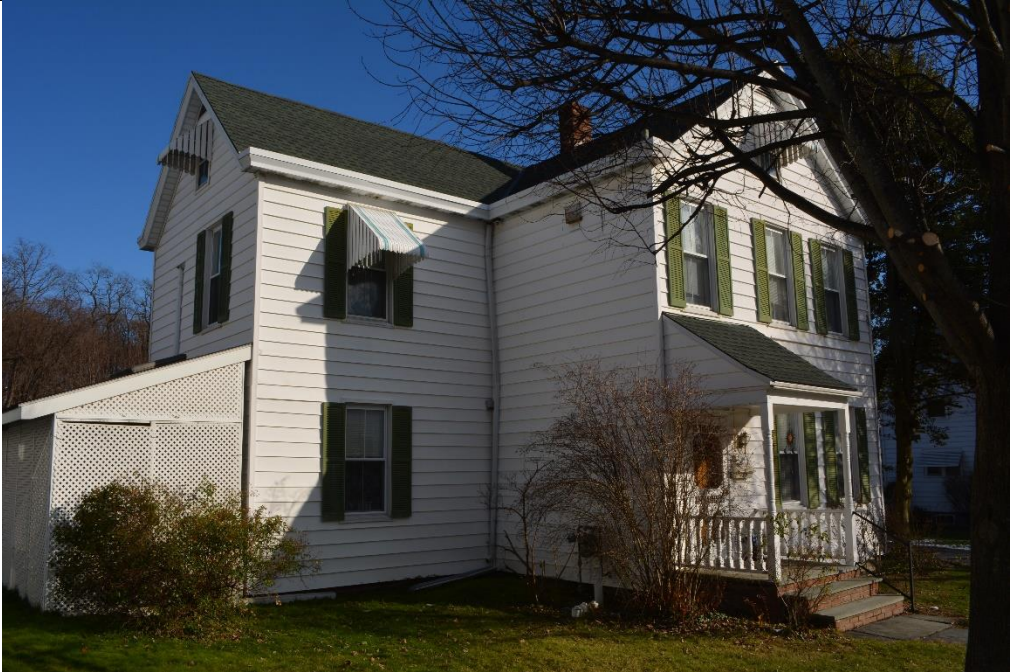
Description: A two-story Italianate, cross-gabled roof with flared eaves, brick foundation, metal or vinyl siding, and asphalt roof shingles. The first floor is divided into three bays (front gabled wing) and a has a shed-roof covered entry. Replacement windows and porch elements. Lean-to addition at side.			
Photo #:	Address / Block & Lot:	Year Built:	Eligibility Recommendation:
127	73 Crane St / 56.36-6-6	c. 1950	NOT ELIGIBLE:

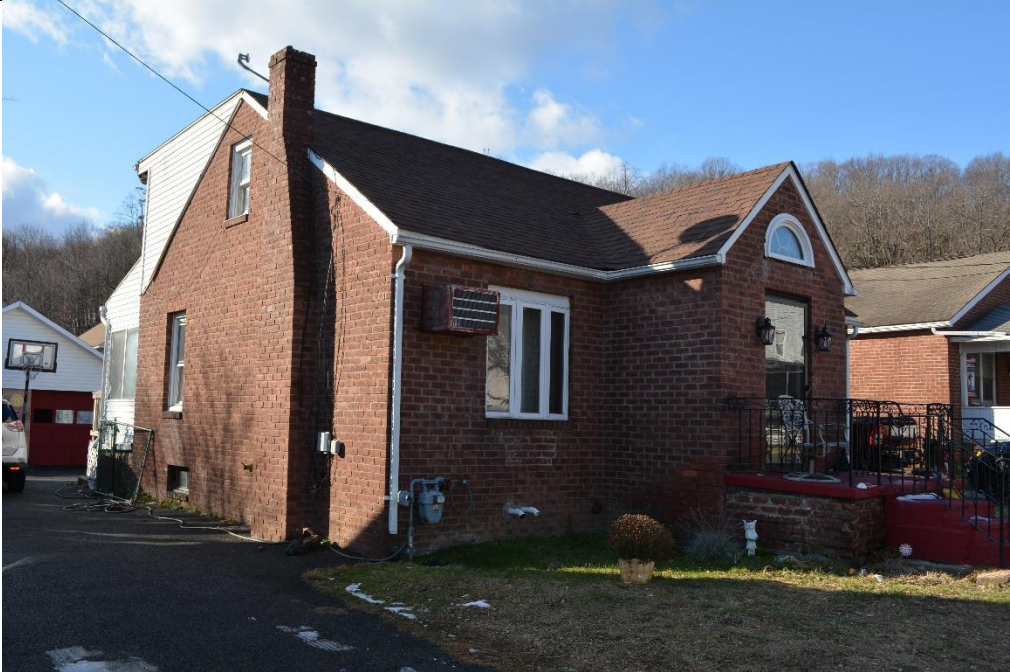
Description: A two-story Minimal Traditional cross-gabled roof brick foundation and siding, and asphalt roof shingles. The first floor is divided into three bays. Replacement windows. Large vinyl-clad additions at rear.

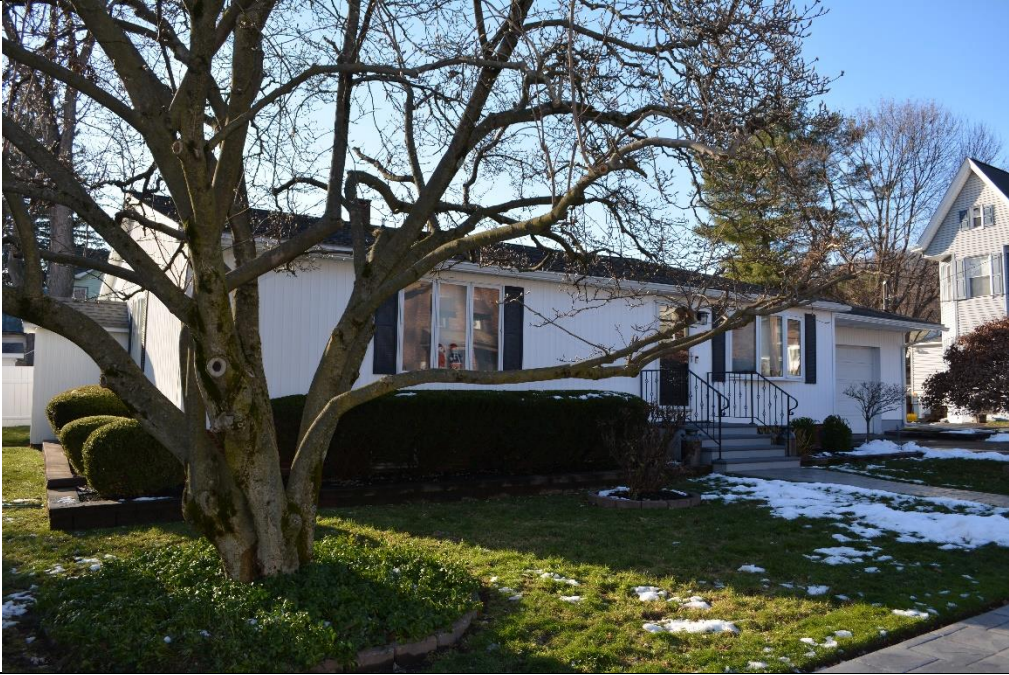
Photo #:	Address / Block & Lot:	Year Built:	Eligibility Recommendation:
144	9 Lindsley Ave / 56.36-9-7	c. 1976	NOT ELIGIBLE:

Description: A one-story Contemporary side-gabled roof, brick foundation, vinyl siding, and asphalt roof shingles. The first floor is divided into four bays. Replacement windows. Less than 50 years old.

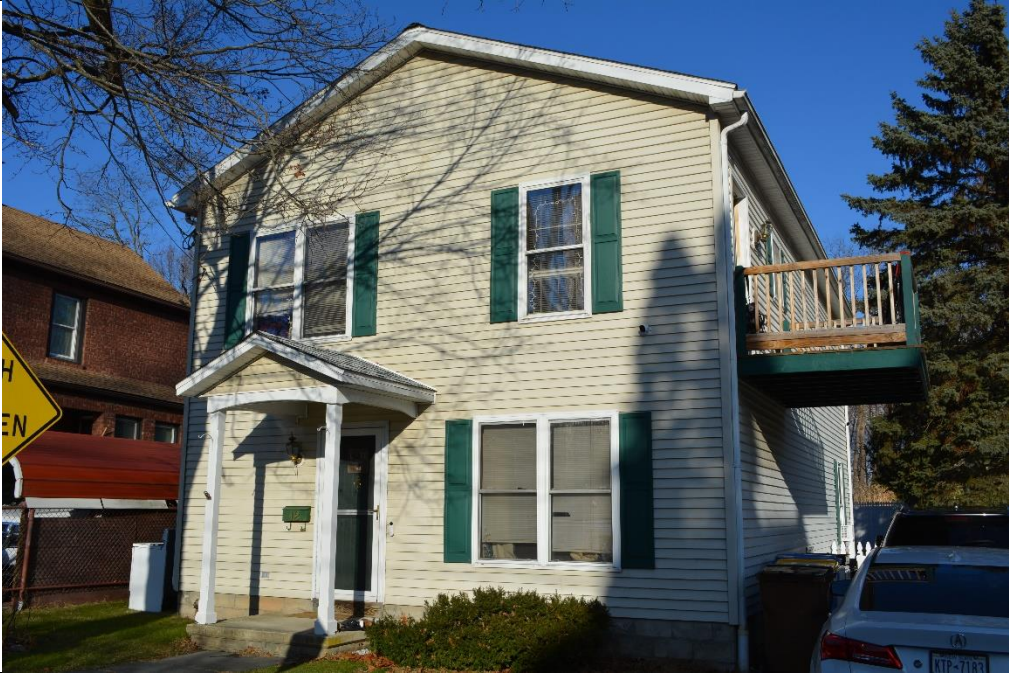
Photo #:	Address / Block & Lot:	Year Built:	Eligibility Recommendation:
145	12 Lindsley Ave 56.36-8-11.200-1	c. 1991	NOT ELIGIBLE:

Description: A two-story Contemporary front-gabled roof, brick foundation, vinyl siding, and asphalt roof shingles. The first floor is divided into three bays and pediment over the front door. Less than 50 years old.

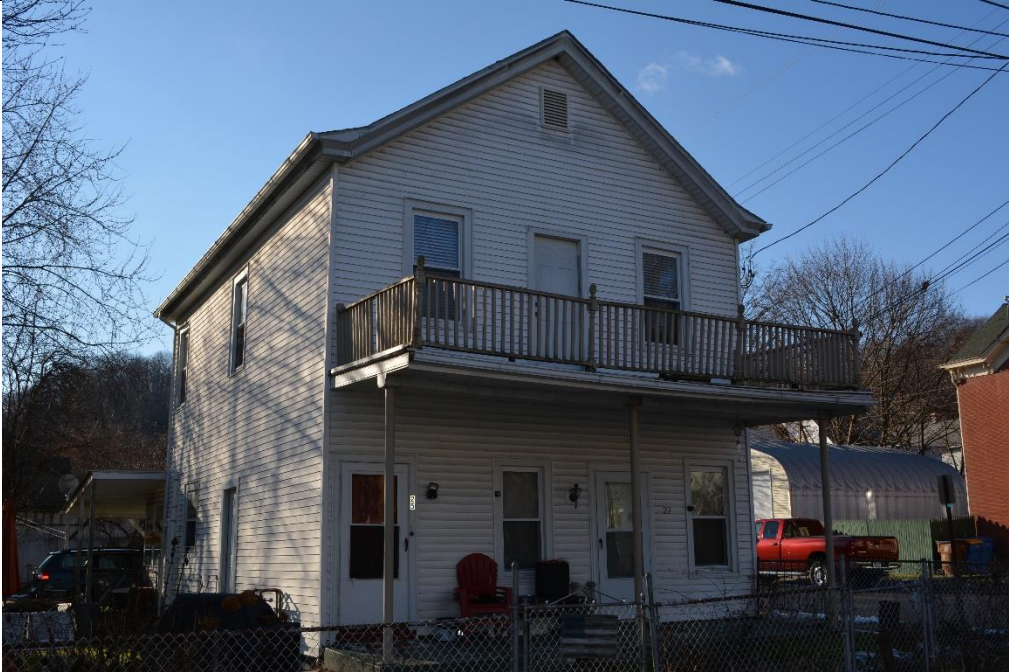
Description: A two-story vernacular/National front-gabled roof with flared eaves, brick foundation, vinyl siding, and asphalt roof shingles. The first floor is divided into four bays and a porch located on the second floor. Replacement windows & doors. Altered fenestration. Loss of first story porch.

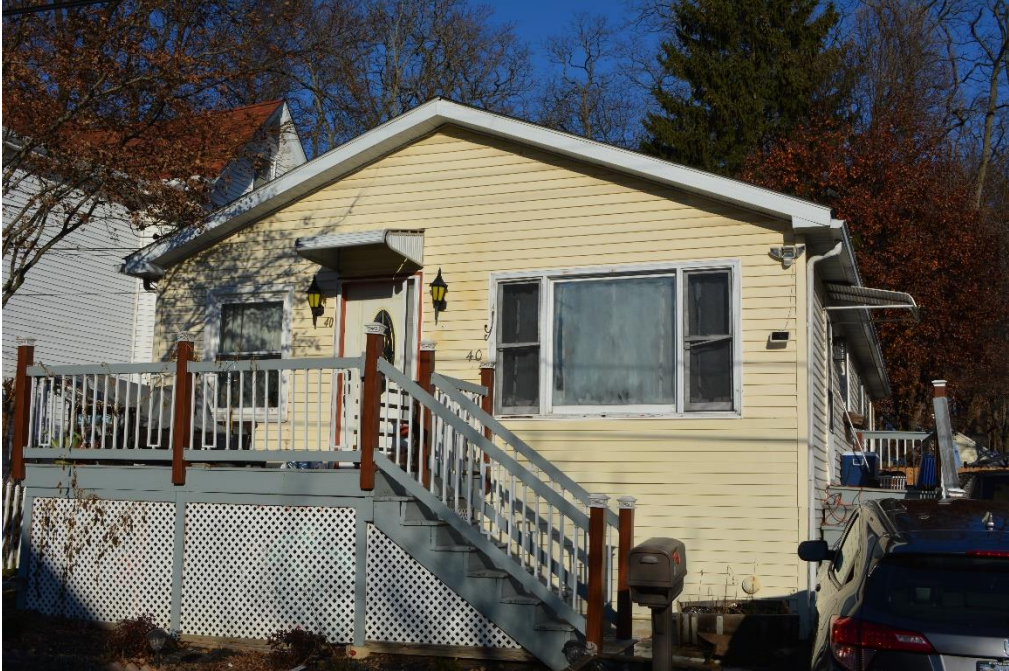
Photo #:	Address / Block & Lot:	Year Built:	Eligibility Recommendation:
158	40 Lindsley Ave / 56.36-8-5.200	c. 1987	NOT ELIGIBLE:

Description: A one-story Contemporary front-gabled roof with brick foundation, vinyl siding, and asphalt roof shingles. The first floor is divided into three bays. Less than 50 years old.
