**INTENSIVE-LEVEL HISTORIC RESOURCES
& BUILDING SURVEY
WILBUR & PONCKHOCKIE NEIGHBORHOODS
CITY OF KINGSTON, ULSTER COUNTY, NEW YORK
RFPK #22-11**

EXECUTIVE SUMMARY

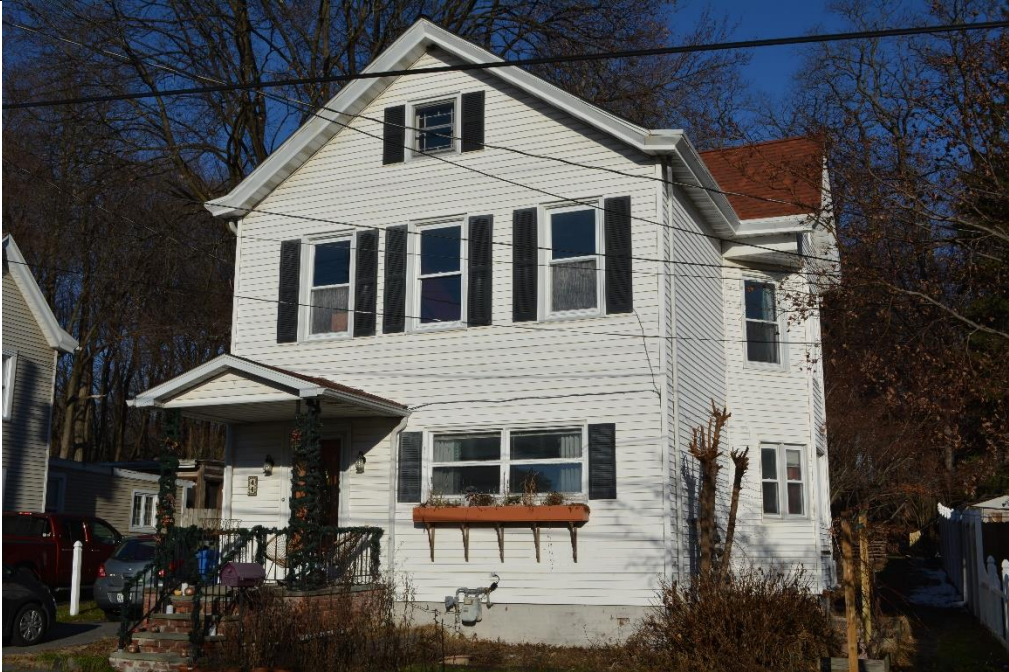
Photo #:	Address / Block & Lot:	Year Built:	Eligibility Recommendation:
160	44 Lindsley Ave / 56.36-8-5.100	c. 1896	HD, CONTR

<p>Description: A two-story Queen Anne cross-gabled roof with flared eaves, brick foundation, vinyl siding, and asphalt roof shingles. Front is three bays wide. Replacement windows, doors, and soffits. Altered fenestration.</p>

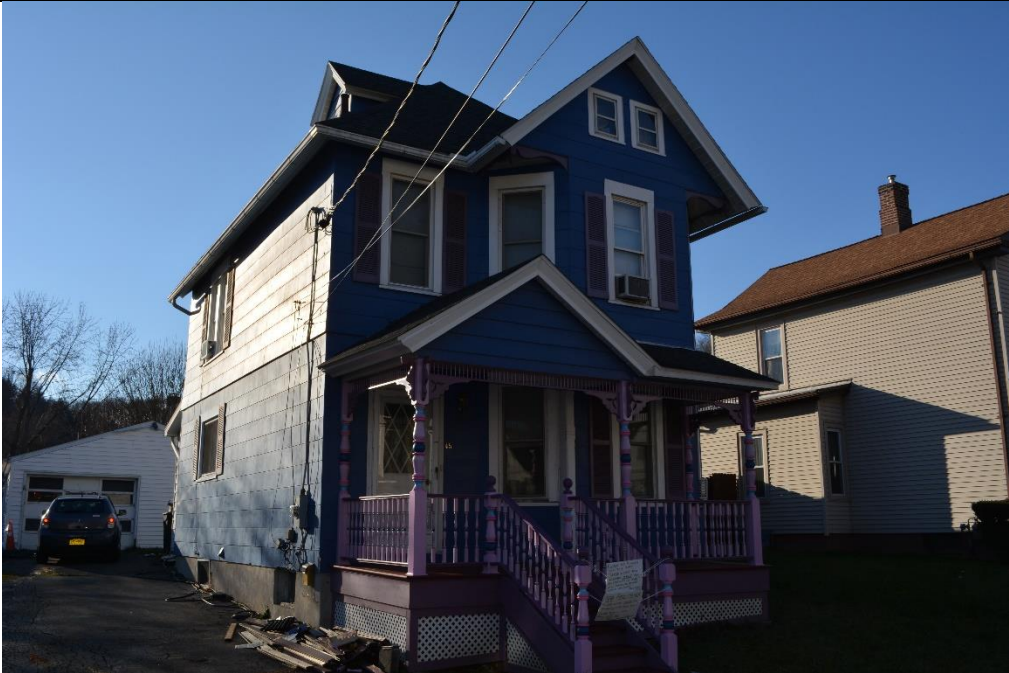
<p>Description: A two-story Queen Anne crossed-gabled roof, cement block foundation, vinyl siding, and asphalt roof shingles. Nearly full-width covered porch. All porch elements are well-executed modern replacements. Replacement windows, doors, and soffits.</p>

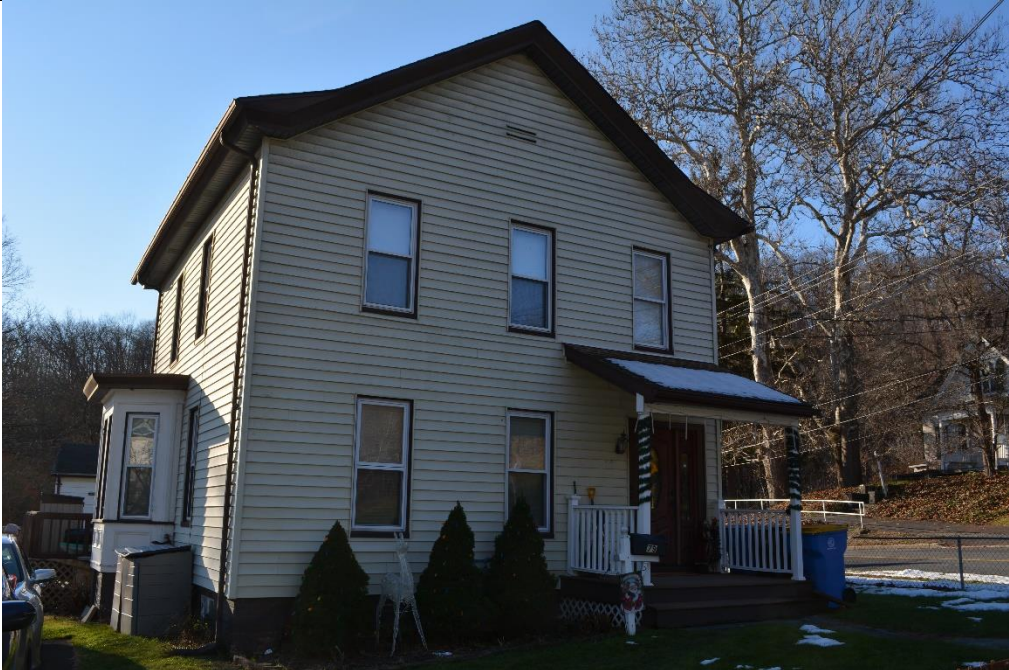
Photo #:	Address / Block & Lot:	Year Built:	Eligibility Recommendation:
171	79 Lindsley Ave / 56.28-2-3	c. 1890	HD, CONTR

<p>Description: A two-story Italianate front-gabled roof with flared eaves, brick foundation, vinyl siding, and asphalt roof shingles. The first floor is divided into three bays. Replacement windows, doors, and soffits.</p>

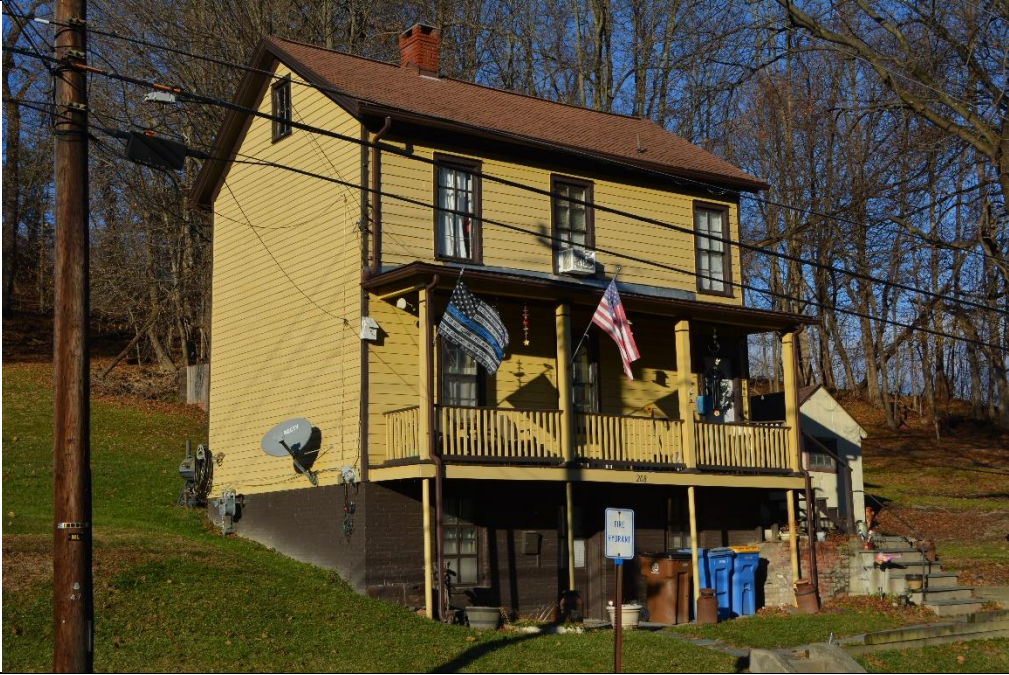
Description: A two-story Colonial Revival side-gabled roof. brick foundation, wood siding, and asphalt roof shingles. The first floor is divided into three bays and a covered porch. Historic windows. Porch elements replaced. Porch door replaced.

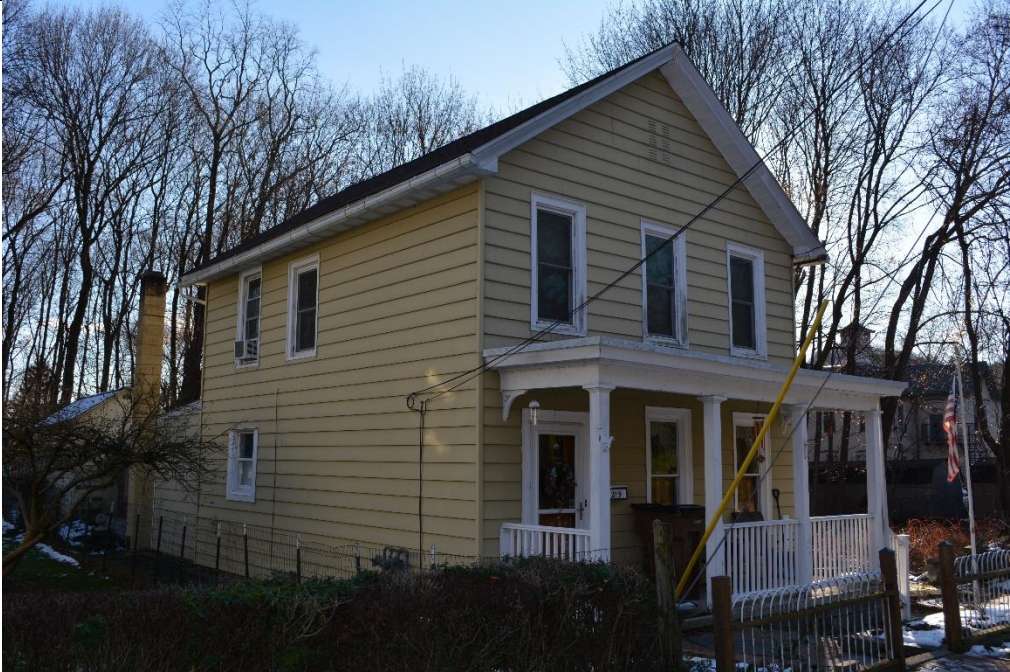
Description: A two-story vernacular/National front-gabled roof, cement block foundation, metal siding, and asphalt roof shingles. The first floor is divided into three bays. There is a covered porch. Replacement windows, doors, and soffits. Replacement porch railings and balusters.

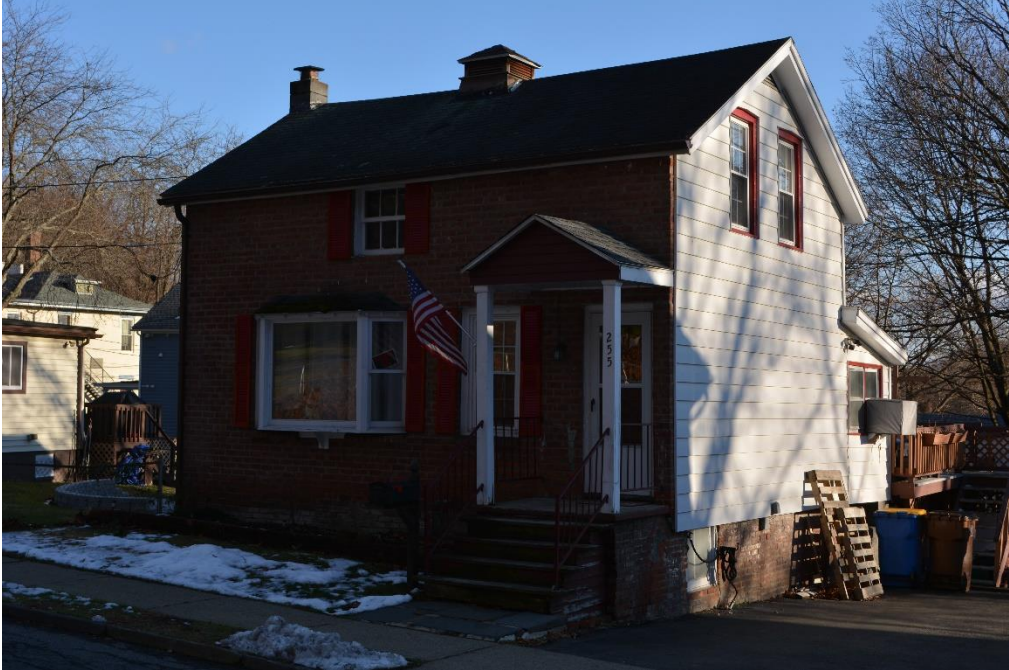
Photo #:	Address / Block & Lot:	Year Built:	Eligibility Recommendation:
179	255 Delaware Ave / 56.28-2-2	c. 1890	NOT ELIGIBLE

<p>Description: A one-story vernacular/National side-gabled roof, brick foundation, brick and metal siding, and asphalt roof shingles. The first floor is divided into three bays. Replacement windows (majority), doors, and soffits. Oriel an alteration.</p>

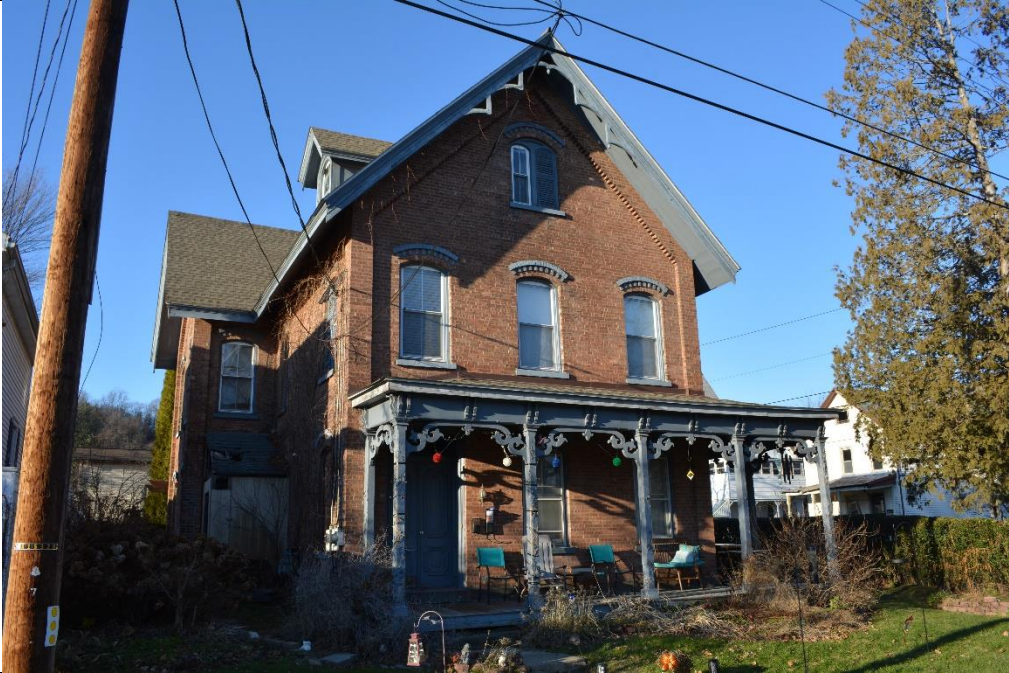
Description: A two-story Italianate with cross-gabled roof and flared eaves, brick foundation, and asphalt roof shingles. The first floor is divided into three bays. See report for details.

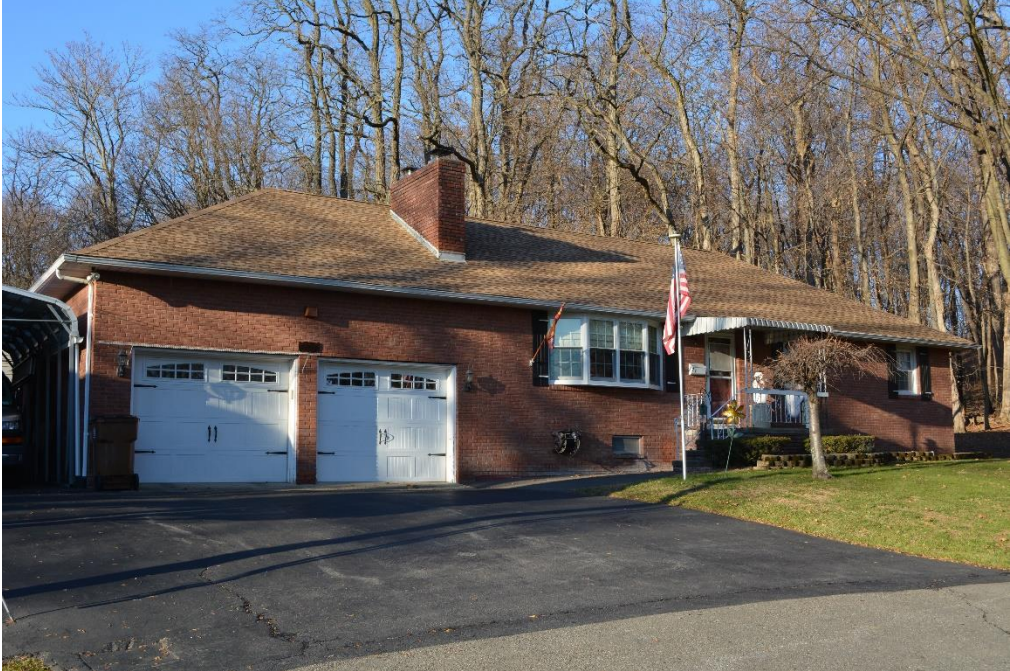
Photo #:	Address / Block & Lot:	Year Built:	Eligibility Recommendation:
188	77 Walnut St / 56.36-8-16	c. 1966	NOT ELIGIBLE:

Description: A one-story Contemporary hipped roof, brick foundation, brick siding, and asphalt roof shingles. Replacement windows and garage doors.

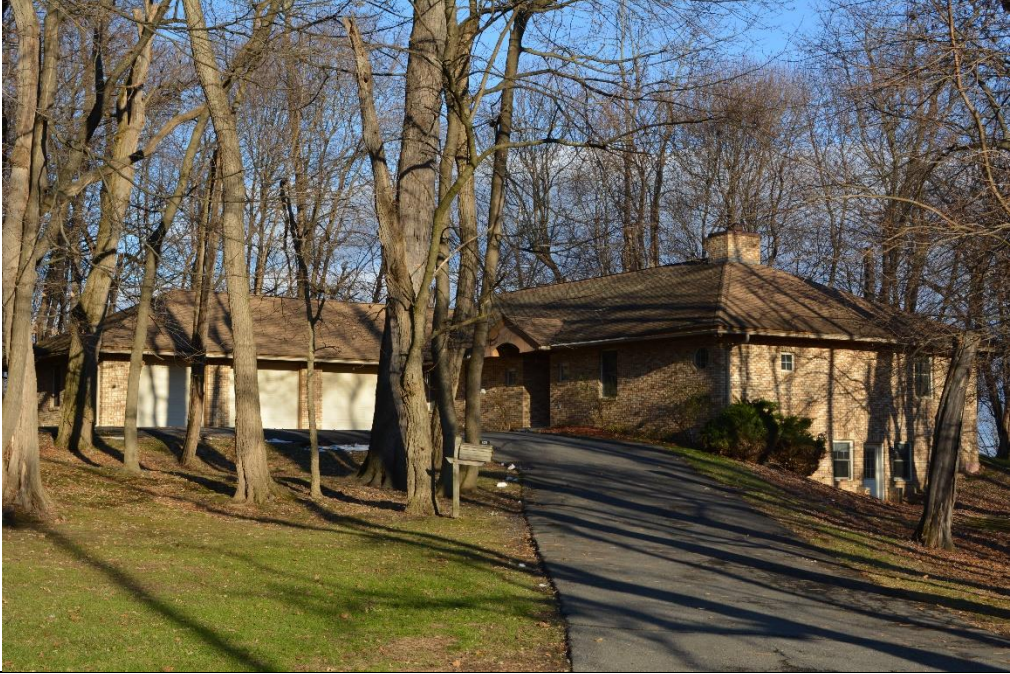
Photo #:	Address / Block & Lot:	Year Built:	Eligibility Recommendation:
190	100 Walnut St / 56.28-2-17.100	c. 1997	NOT ELIGIBLE:

Description: A two-story Contemporary cross-gabled roof, brick foundation, brick siding, and asphalt roof shingles. The first floor is divided into four bays. Less than 50 years old.

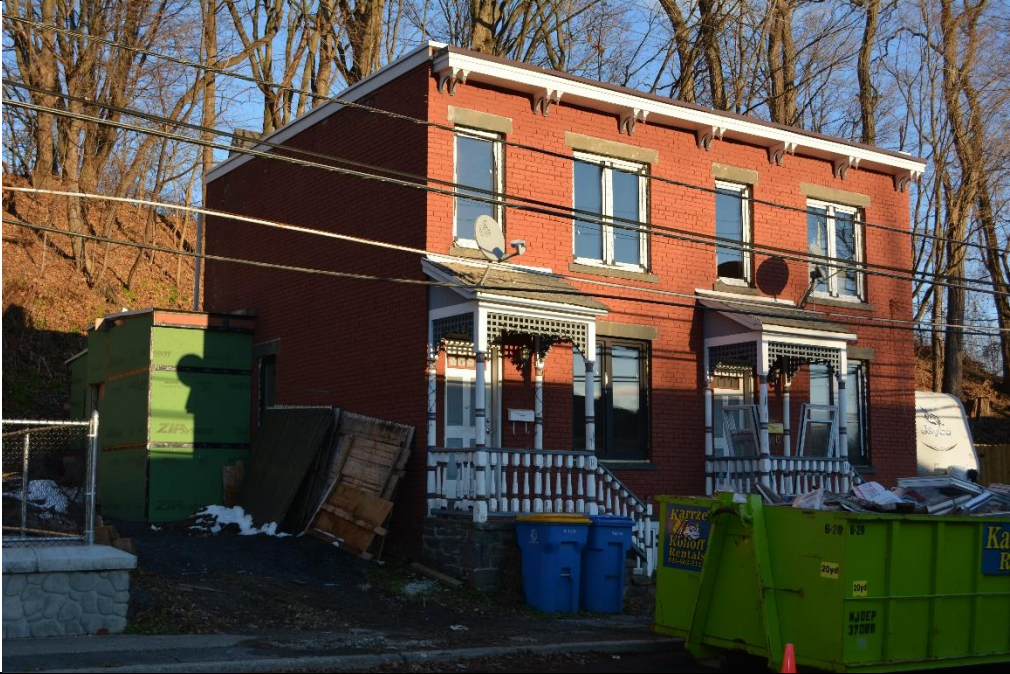
Photo #:	Address / Block & Lot:	Year Built:	Eligibility Recommendation:
191	16-18 Gill St / 56.36-11-7	c. 1885	HD, CONTR

Description: A two-story Italianate flat roof, brick foundation, brick siding, decorative cornices on the eaves and pediments over two entrance doors. Stone sills and lintels. The first floor is divided into four bays. Replacement windows. Porch elements likely modern replacements.

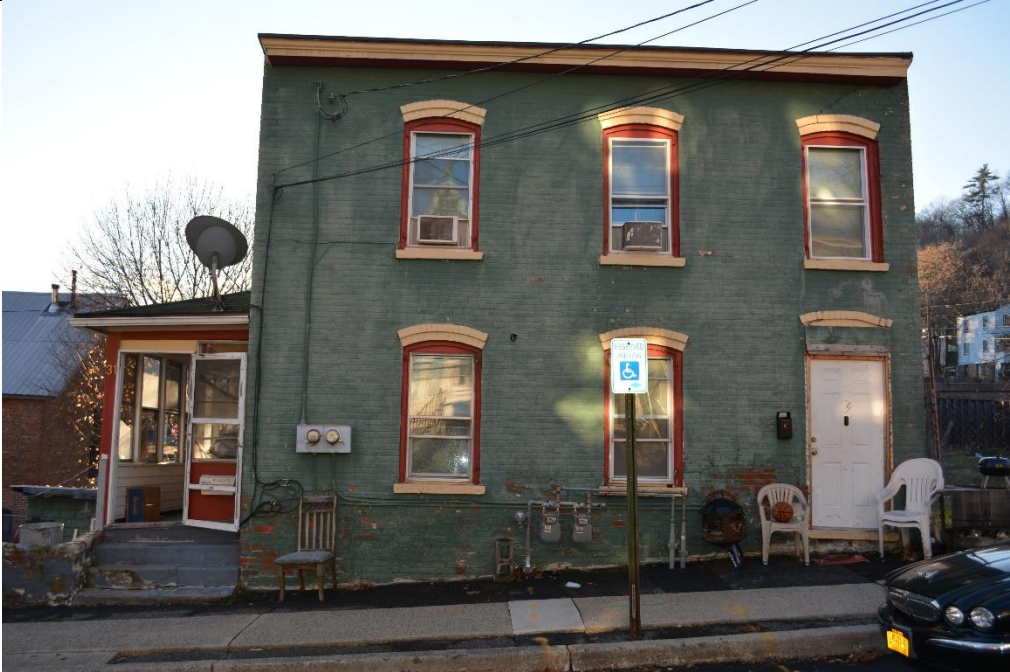
Photo #:	Address / Block & Lot:	Year Built:	Eligibility Recommendation:
193	31 Gill St / 56.36-3-23	c. 1875	HD, CONTR

Description: A two-story Italianate flat roof, brick foundation, and brick siding. The first floor is divided into three bays plus a side addition. Replacement windows and doors.

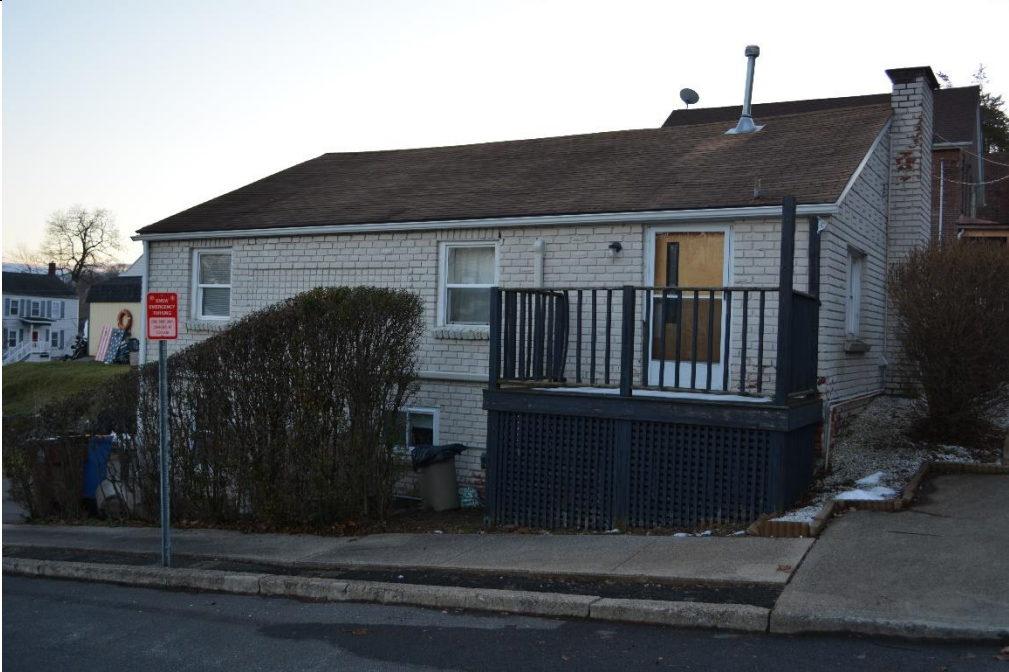
Photo #:	Address / Block & Lot:	Year Built:	Eligibility Recommendation:
218	35 Sycamore St / 56.36-2-21.100	c. 1930	NOT ELIGIBLE

Description: A two-story Minimal Traditional side gabled roof, stone foundation, brick siding (mostly running bond, with interesting panel on front and fancy pattern in gables), and asphalt roof shingles. The entrance/second floor is divided into three bays. Replacement windows and door.

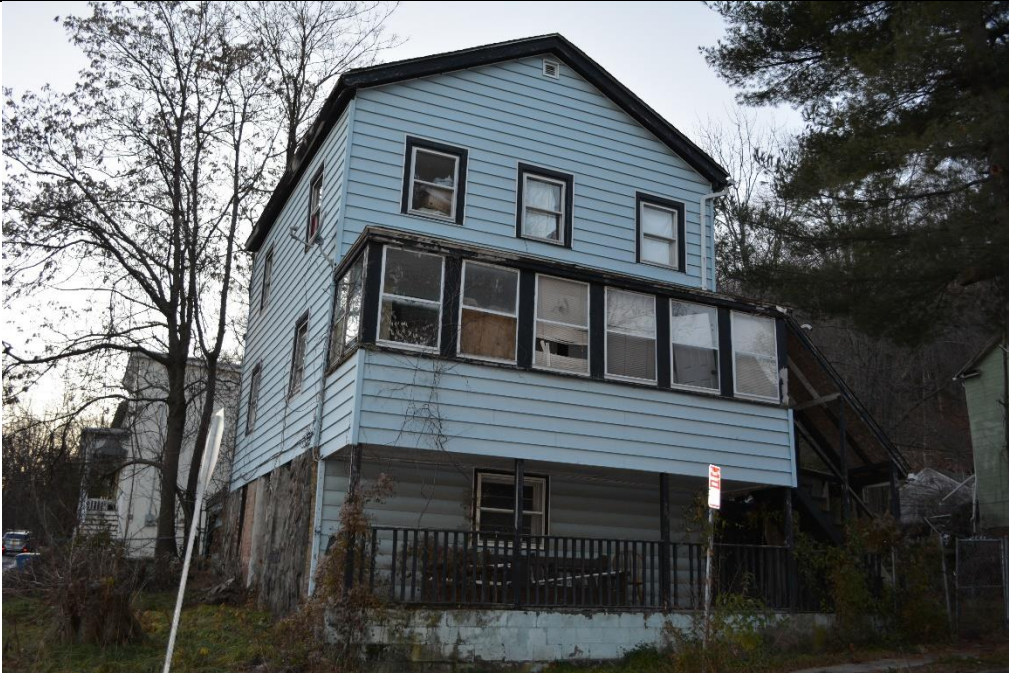
Photo #:	Address / Block & Lot:	Year Built:	Eligibility Recommendation:
219	39 Sycamore St / 56.36-2-9	c. 1876	NOT ELIGIBLE

Description: A three-story vernacular/National style front-gabled roof, cement block foundation, vinyl siding, and asphalt roof shingles. There is an enclosed porch on the second floor. Replacement windows and doors.

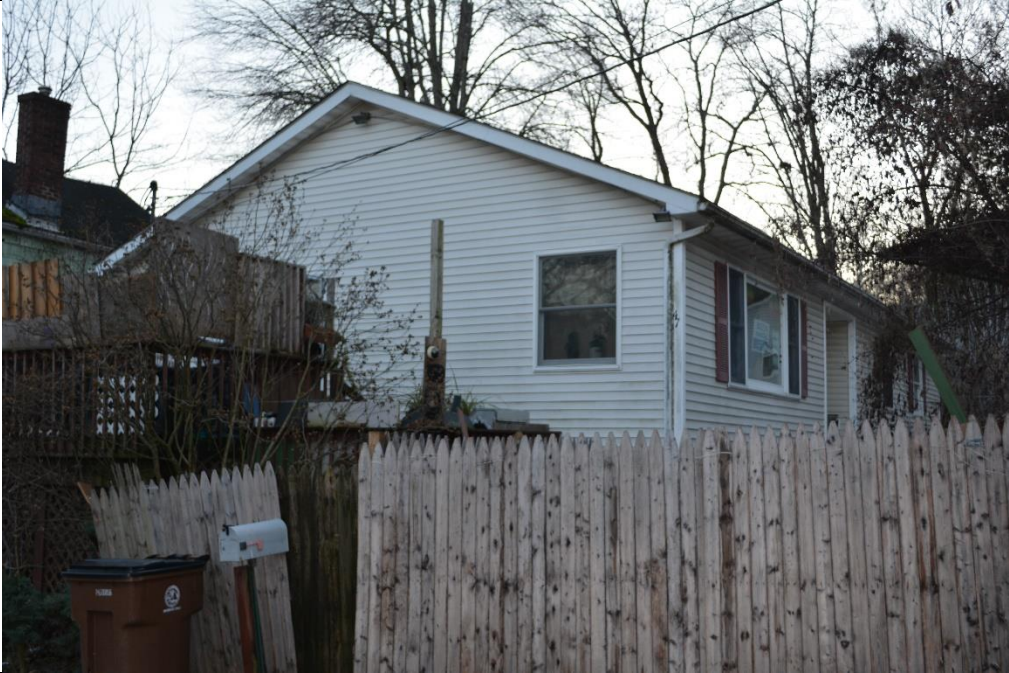
Photo #:	Address / Block & Lot:	Year Built:	Eligibility Recommendation:
223	47 Sycamore St / 56.36-2-7	c. 1992	NOT ELIGIBLE:

Description: A one-story Contemporary side-gabled roof, cement foundation, vinyl siding, and asphalt roof shingles. The first floor is divided into two bays. Less than 50 years old.

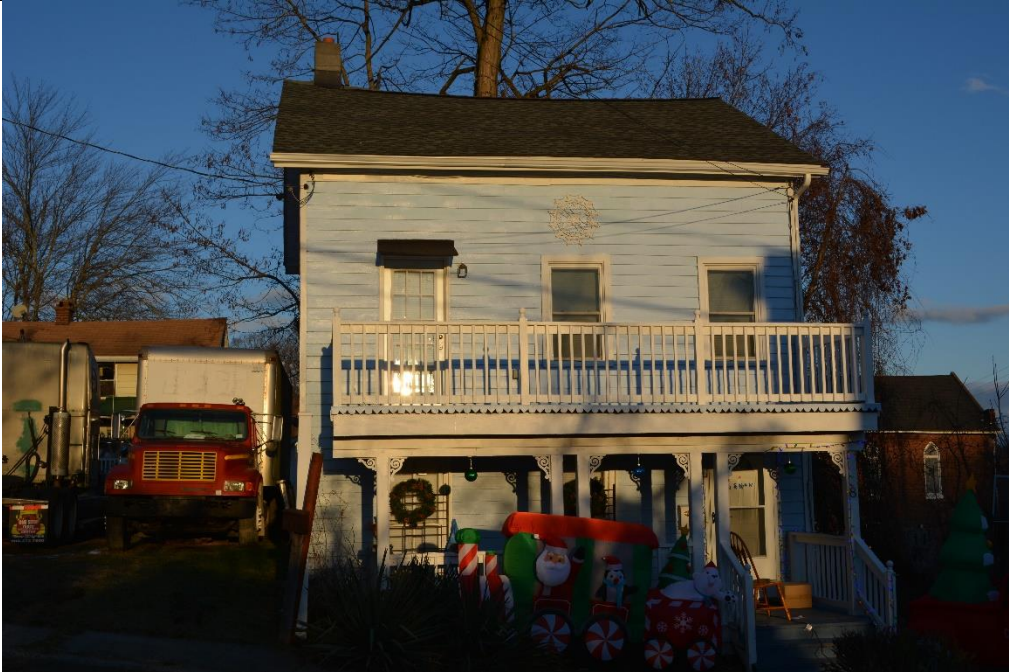
Photo #:	Address / Block & Lot:	Year Built:	Eligibility Recommendation:
228	8 Tompkins St / 56.36-12-5	c. 1860	NOT ELIGIBLE

Description: A two-story vernacular/National style house with side-gabled roof, cement foundation, wood siding, and asphalt roof shingles. The first floor is divided into three bays. Has a covered porch on the first floor and open deck on the second floor, all elements replaced. Replacement doors, most windows (historic one or more at first story). Likely altered fenestration (for upper story walk-out).

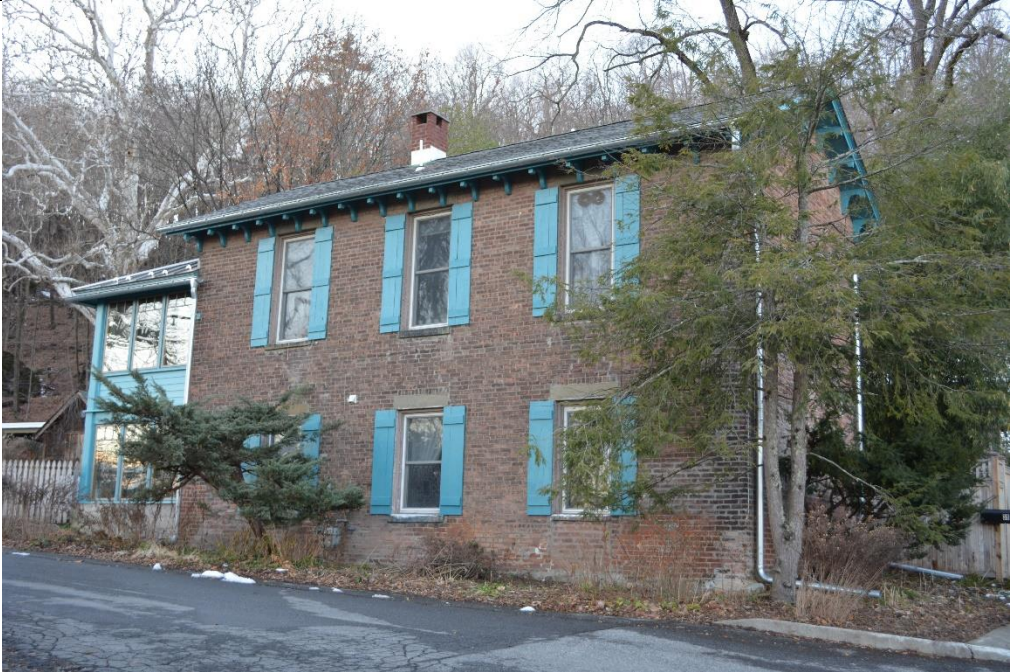
Photo #:	Address / Block & Lot:	Year Built:	Eligibility Recommendation:
231	39 Tompkins St / 56.36-1-5	c. 1855	IND, HD

<p>Description: A two-story Federal style side-gabled roof, brick foundation, brick siding, and asphalt roof shingles. The first floor is divided into three bays. Addition at side. See report for details.</p>

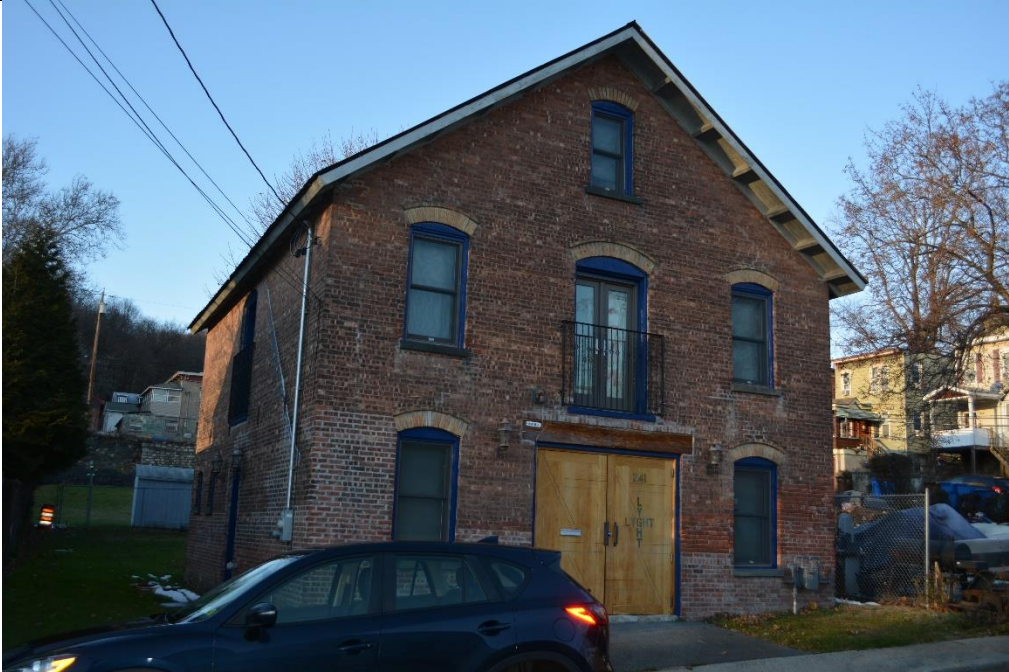
Photo #:	Address / Block & Lot:	Year Built:	Eligibility Recommendation:
245	241 Catherine St / 56.36-3-24	c. 1830	IND, HD

Description: A two-and-a-half-story Italianate, front-gabled, former barn/warehouse. Overhanging eaves not enclosed, brick foundation, brick walls, and asphalt roof shingles. The first floor is divided into three bays. Adapted for use as residence/studio. See details in report.

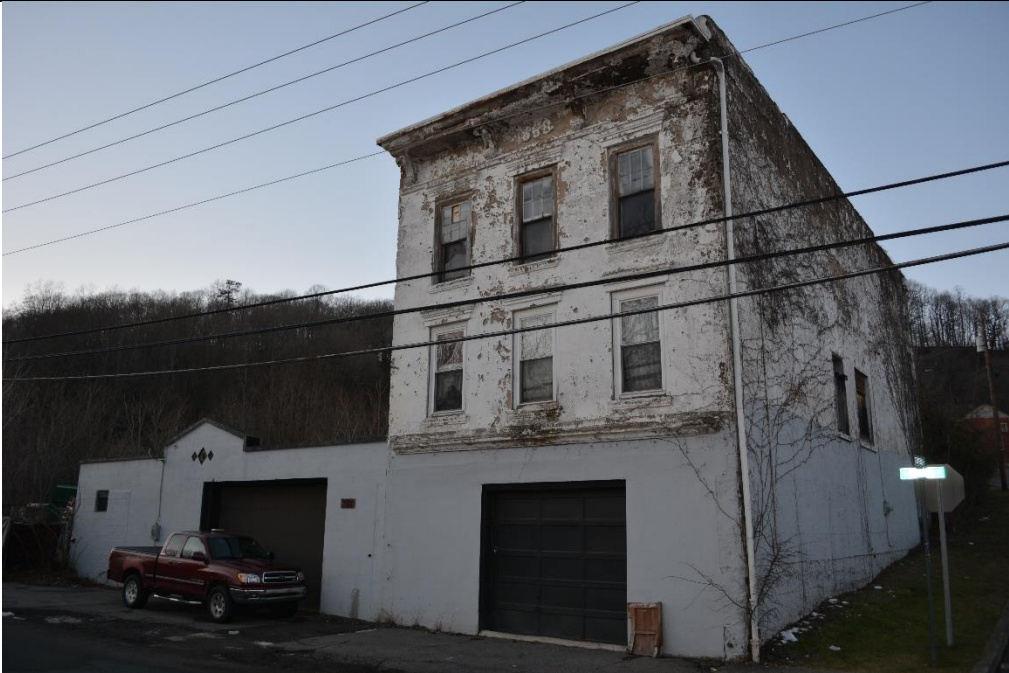
Photo #:	Address / Block & Lot:	Year Built:	Eligibility Recommendation:
246	181-207 E Strand St / 56.36-1-6	c. 1868	IND

Description: A three-story, Italianate style building with decorative cornice at roofline. The entire building is done in poured concrete which included the cornices. Altered first floor, plus 1-story addition. See Individual evaluation in the report.
