**REPORT:  
Pike Plan Canopy History, Integrity, & Eligibility  
(1976-2024)**

Prepared for the City of Kingston-NY: Planning Department

Prepared by Ethan Dickerman, HPA

27 September 2024

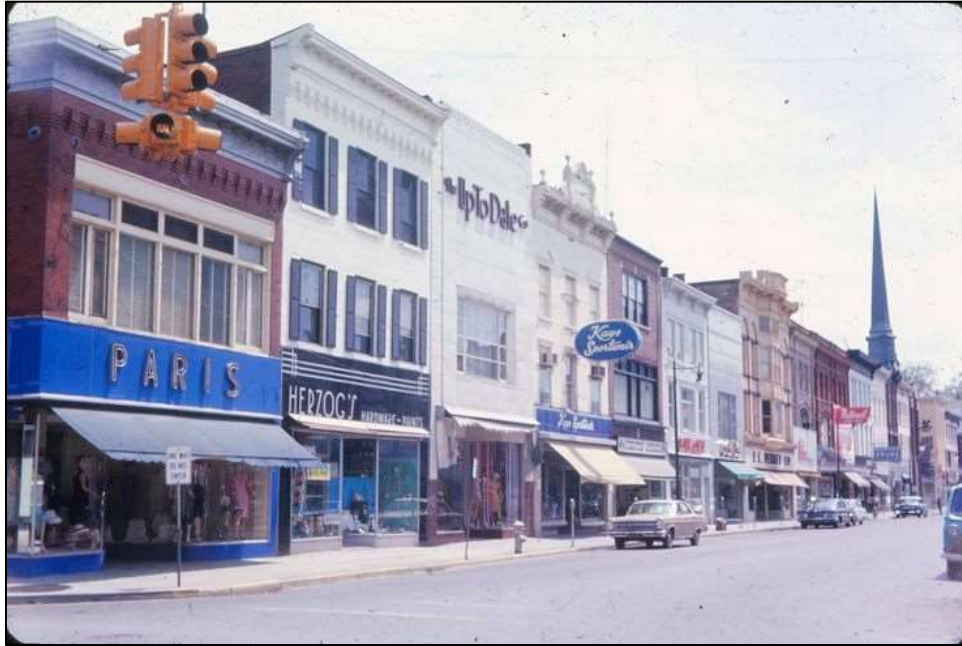
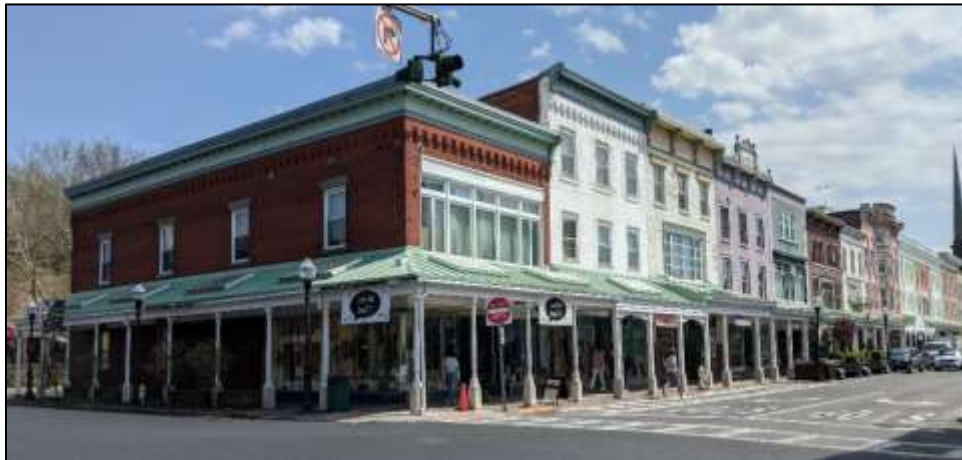
**Top:** View of the east side of Wall St. before Pike Plan, circa 1970. Sourced from the Charles Niles Collection <https://www.pinterest.com/pin/114349278016943578/>. **Bottom:** East side of Wall St. with the reconstructed Pike Plan Canopy in place in the spring of 2024. Photo by Ethan Dickerman, HPA.

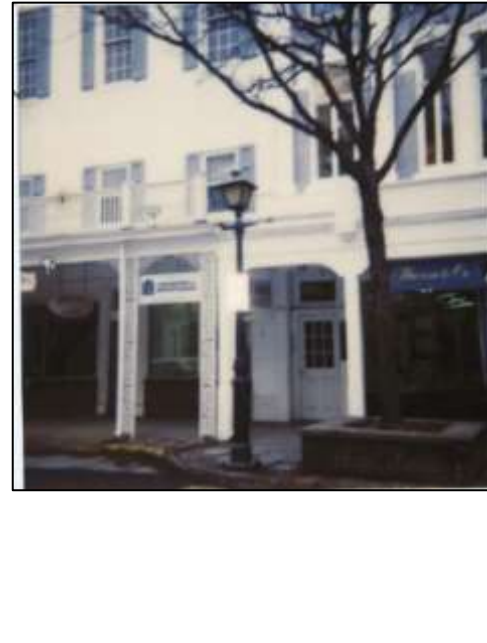
3	302 Wall St	48.331-2-15	 	 	 	<p>The original canopy obscured a key portion of 302 Wall Street's storefront façade regarding signage.</p> <p>The 2010s reconstruction of the canopy added modern readily visible from the public right of way at 302 Wall St.</p>
4	304 Wall St	48.331-2-14

<p>The original canopy obscured a key portion of 304 Wall Street's façade.</p> <p>The 2010s reconstruction removed the character defining balustrades at this location and added modern skylights readily visible from the public right of way at 304 Wall Street.</p>

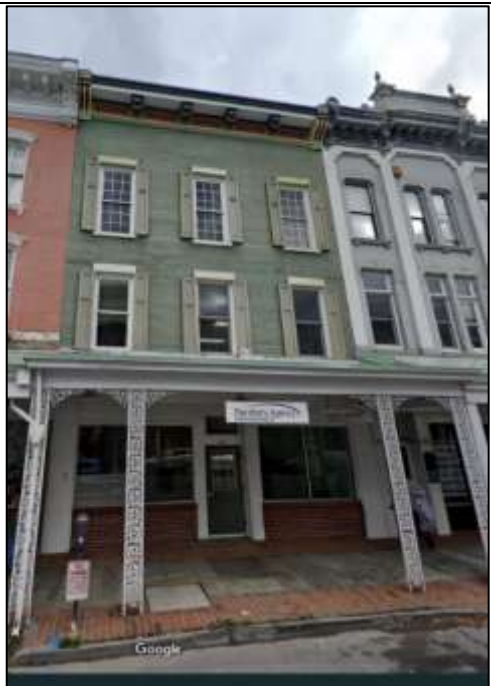
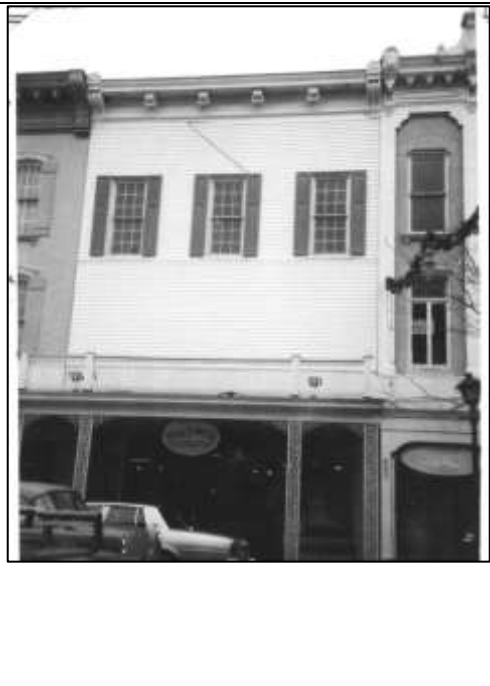
5	306 Wall St	48.331-2-13

<p>The 2010s reconstruction removed the canopy's character defining rooftop balustrades at this location and added modern skylights readily visible from the public right of way at 304 Wall Street.</p>
6	307 Wall St	48.331-1-18

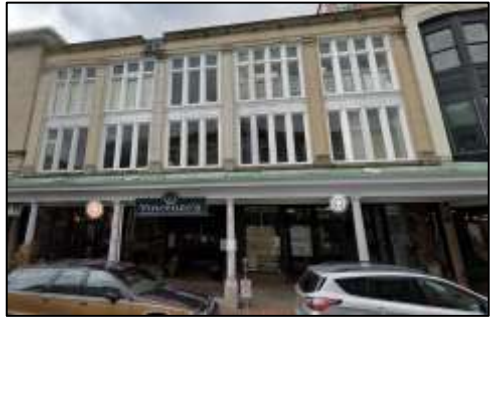
<p>The original canopy obscured a character defining feature of the façade at 307 Wall Street which was once the location of shopfront signage.</p> <p>The 2010s reconstruction removed the canopy's character defining balustrades and modern skylights were added.</p>

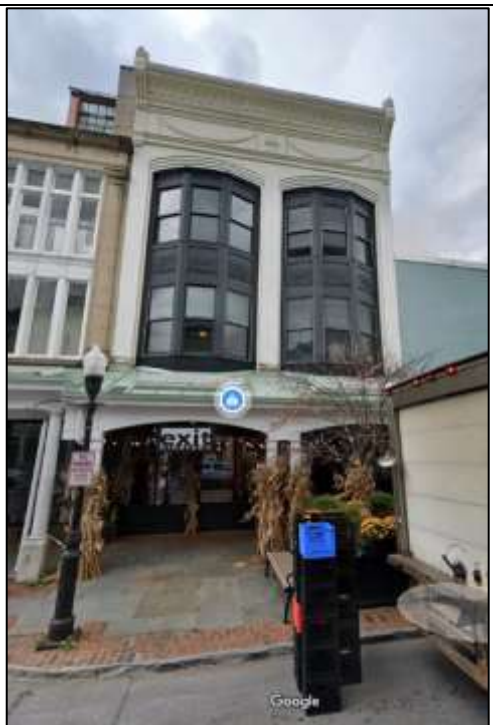
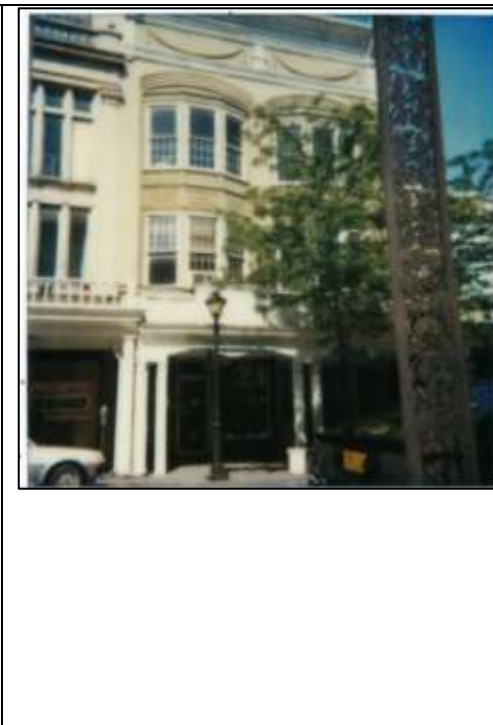
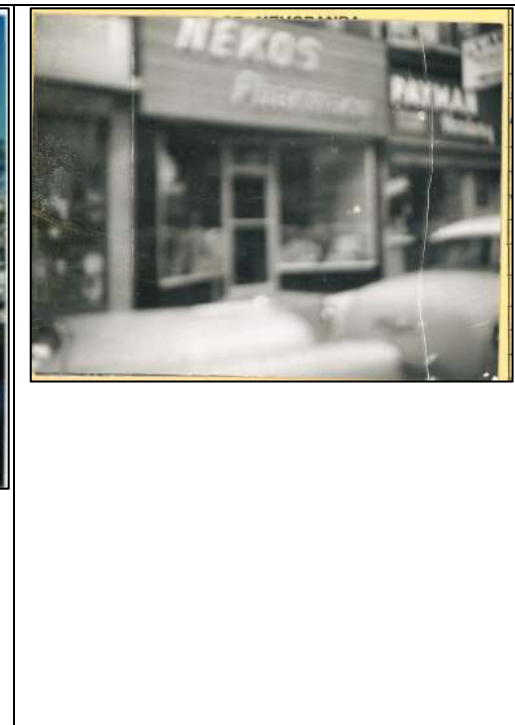
7	309 Wall St	48.331-1-17

<p>The original canopy substantially altered the façade at 308 Wall Street which was once the location of shopfront signage.</p> <p>The 2010s reconstruction removed the canopy's character defining balustrades and modern skylights were added</p>
8	310 Wall St	48.331-2-12

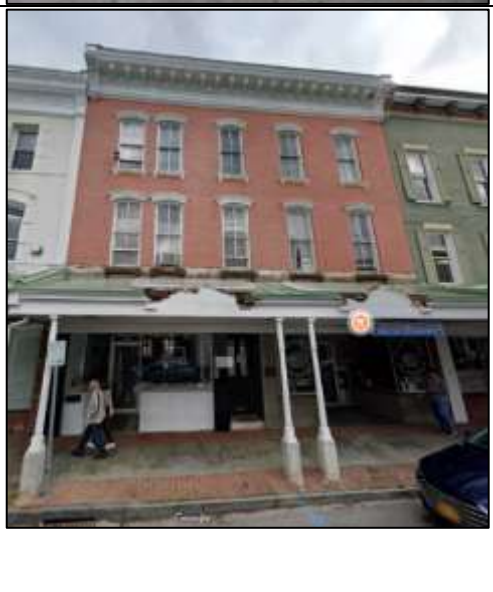
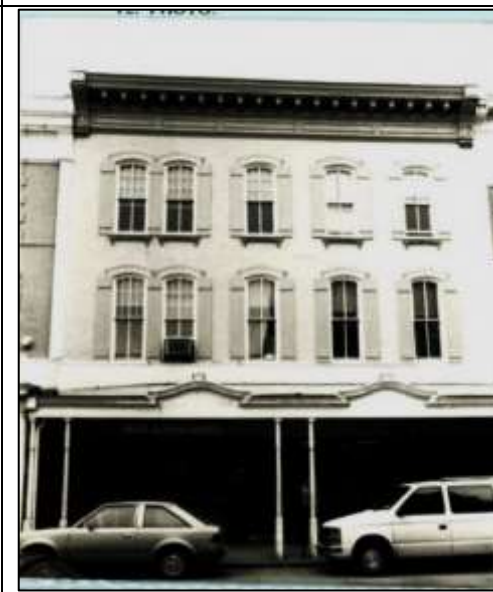
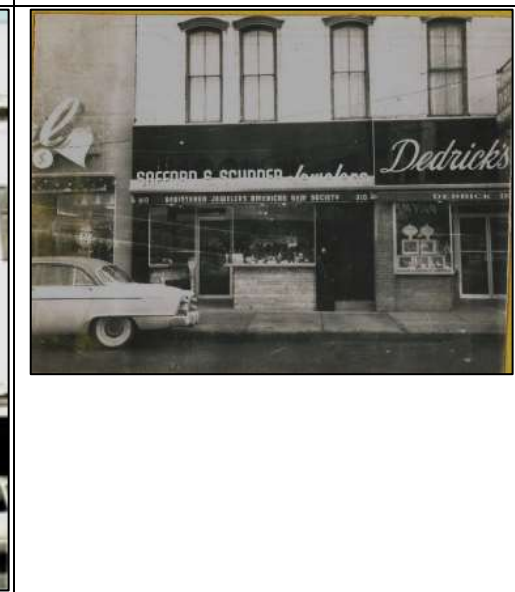
<p>The original canopy substantially obscured a character defining feature of the façade at 310 Wall Street which was once the location of shopfront signage.</p> <p>The 201s reconstruction of the canopy weakened the structure's integrity by shortening its columns and the addition of modern skylights.</p>

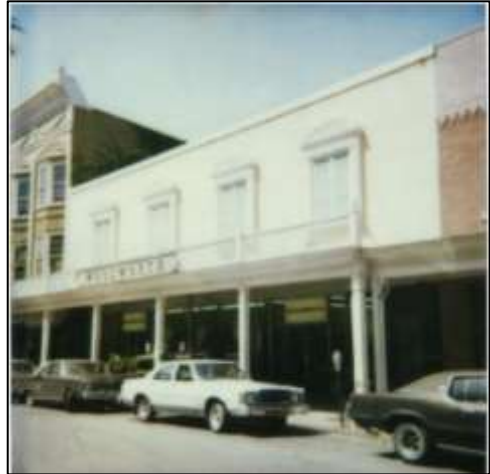
9	311 Wall St	48.331-1-16

<p>The original canopy obscured a character defining feature of the façade at 311 Wall Street which was once had an unobstructed view of the business's signage.</p> <p>The 2010s reconstruction removed the canopy's character defining balustrades and modern skylights were added.</p>
10	312 Wall St	48.331-2-11

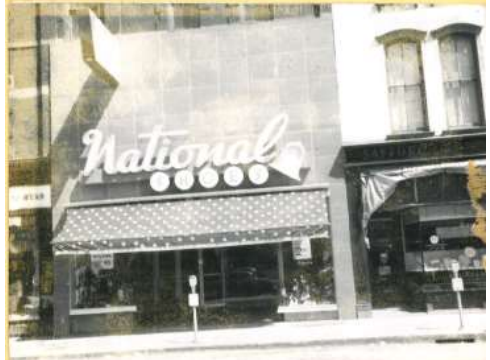
<p>The original canopy may have played a role in the substantial change's façade at 312 Wall Street which was once a paneled material servings as the primary location for signage. The more recent façade may be a more appropriate restoration to an earlier period.</p> <p>The 2010s reconstruction removed the canopy's character defining balustrades and modern skylights were added.</p>

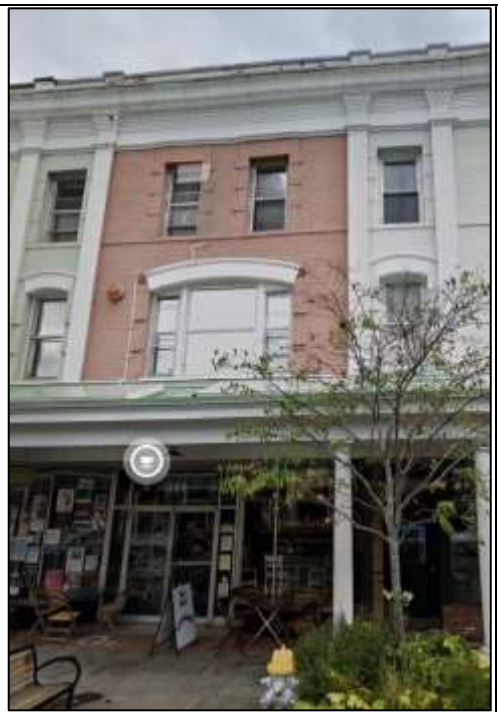
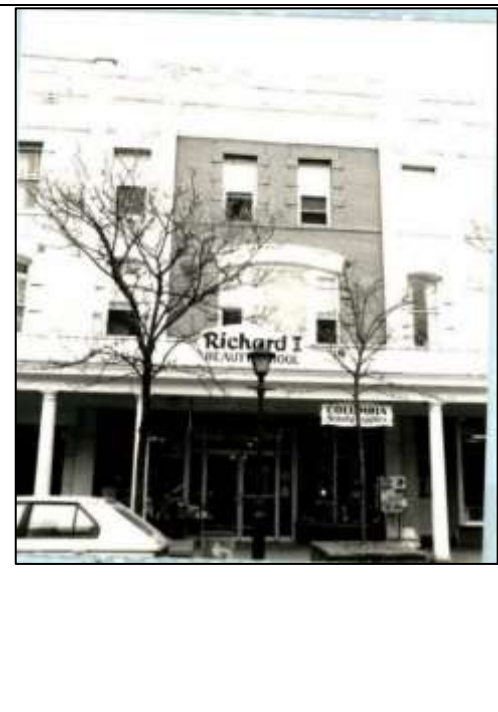
11	314 Wall St	48.331-2-10

*1956 property record card missing.	The 2010s reconstruction removed the canopy's character defining balustrades and modern skylights were added.
----	-------------	-------------	---	--	-------------------------------------	---

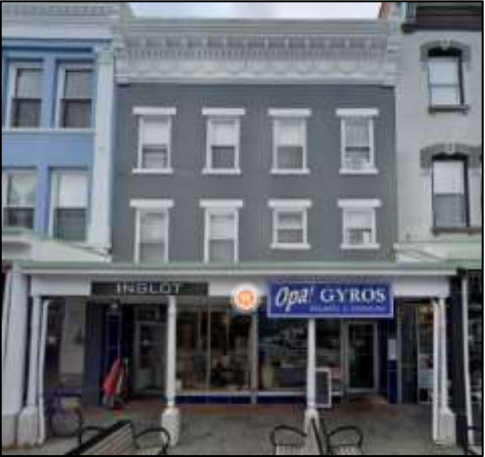
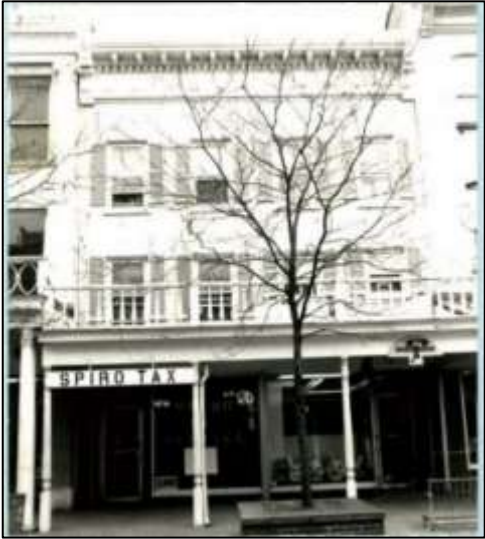
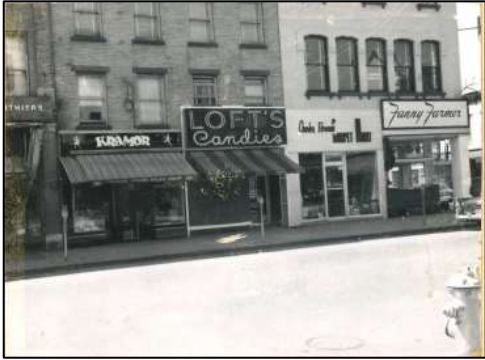
26	333 Wall St	48.331-1-9

<p>333 Wall Street displayed two storefronts with signage in 1956; the signage corresponds with the canopy's mounting location.</p> <p>The original canopy at 333 Wall Street had a flat roof with balustrades and full-length columns. After the 2010s reconstruction, the canopy lost its balustrades here and piers now support shortened columns.</p>
27	334 Wall St	48.331-2-1

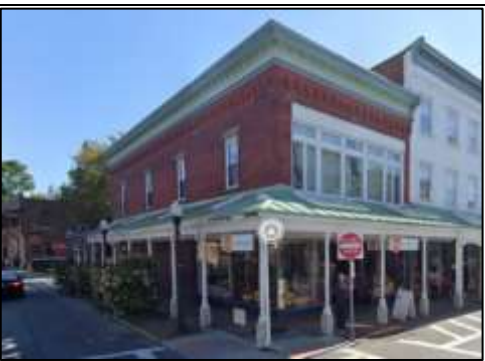
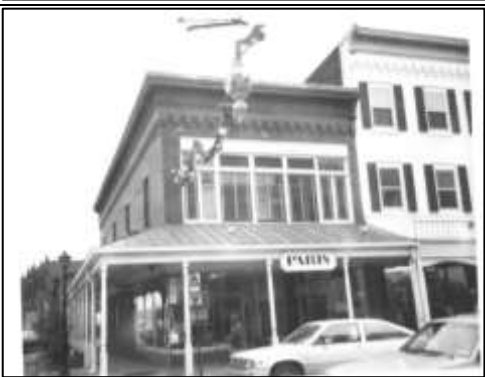
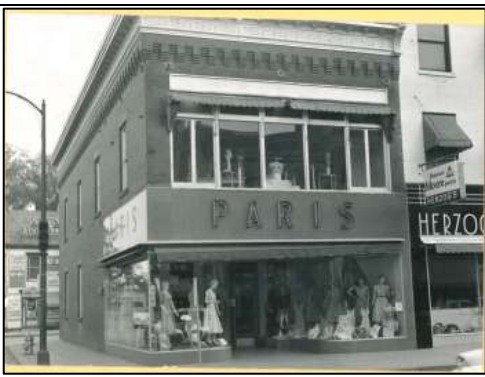
<p>334 Wall Street's façade displayed a wrap feature between the 1<sup>st</sup> &amp; 2<sup>nd</sup> floors that presented signage. The N. Front St façade was mostly plain brick.</p> <p>The original canopy obscured this feature and drastically altered the Front St façade. After the 2010s reconstruction, concrete piers supported shortened columns and roof received several skylights.</p>
28	335 Wall St	48.331-1-8

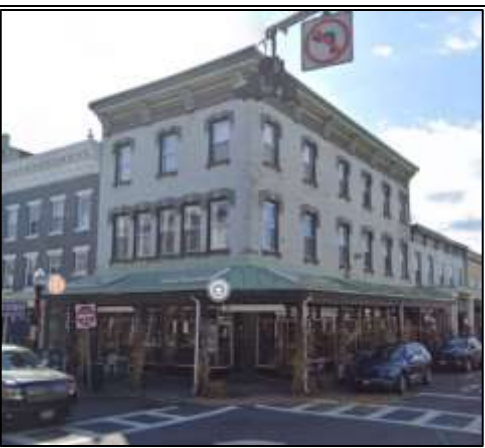
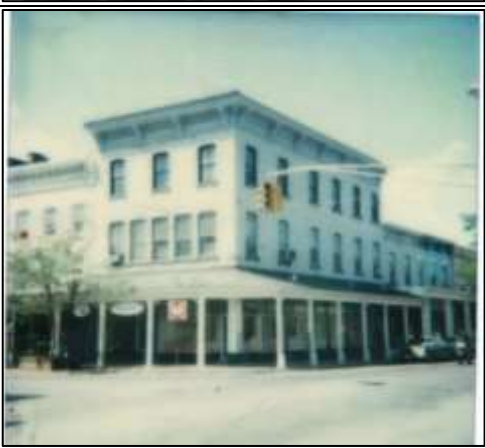
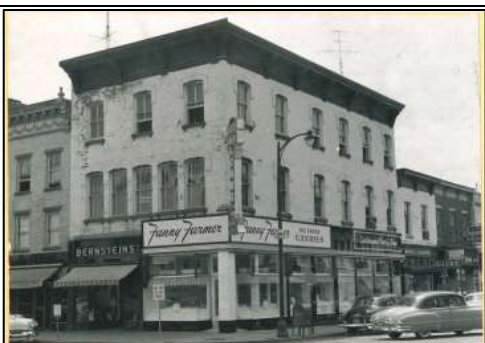
<p>335 Wall Street displayed three storefronts in 1956 with signage above between the 1<sup>st</sup> and 2<sup>nd</sup> floors.</p> <p>The original canopy was white with a mono pitches roof and wrapped around from wall to N. Front St. After the 2010s reconstruction, the structure was painted black with a green metal roof which received modern skylights.</p>

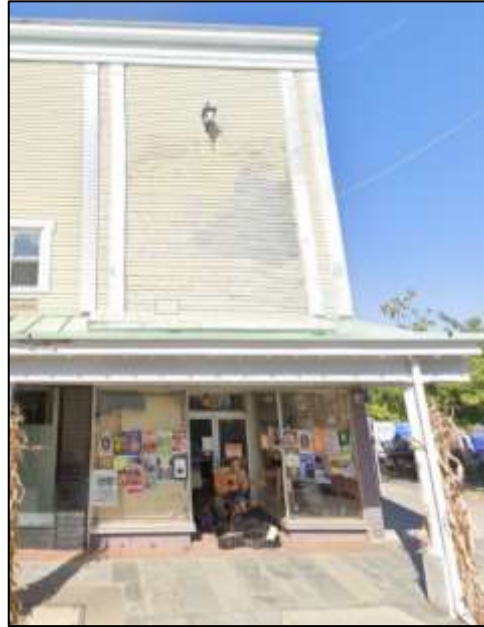
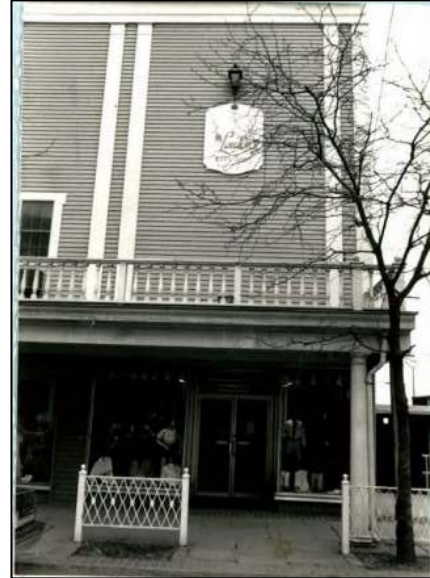
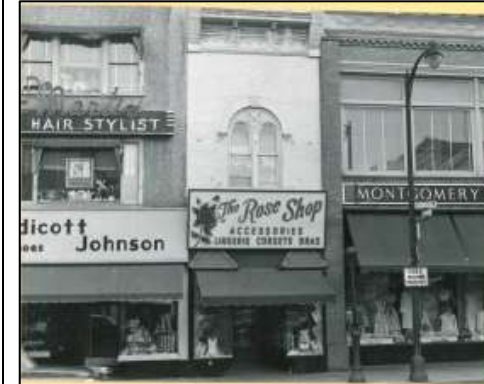
29 31 N. Front St

31 N. Front St displayed a radically different and more appropriate façade in 1956.

By the time the original canopy was built, the façade was altered/flattened beyond recognition. The original canopy displayed a flat roof, with balustrades, full-length columns, and iron fencing at the site.

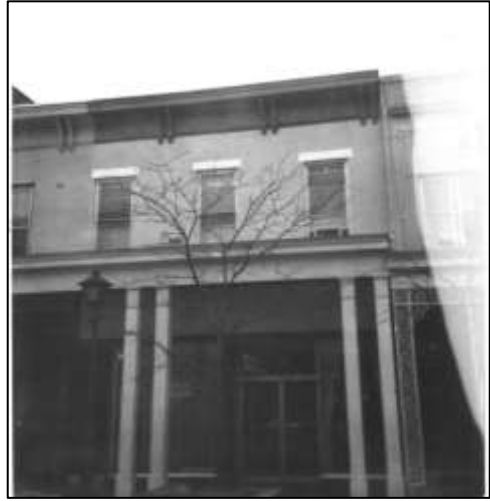
34	40 N. Front St	48.331-1-7

<p>40 N. Front Street displayed a simple early 20<sup>th</sup>-century storefront and row building façade.</p> <p>The original canopy obscured the traditional placement for signage at the site and hid the storefront from clear view.</p> <p>The 2010s reconstruction does not appear to have altered this section of the canopy much, with exception to new street lighting.</p>
35	41 N. Front St	48.314-2-8	 	 	 	<p>41 N. Front Street displayed a simple early 20<sup>th</sup>-century storefront façade (likely altered) and row building façade.</p> <p>The original canopy obscured the traditional placement for signage at the site and hid the storefront from clear view. New façade material like vitrolite appears to be in place by the 1970s.</p> <p>The 2010s reconstruction of the canopy removed the rooftop balustrades and saw the roof change from flat to a single-pitched roof with modern skylights.</p>

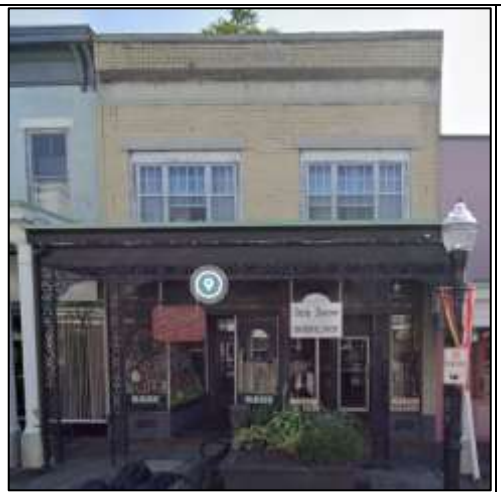
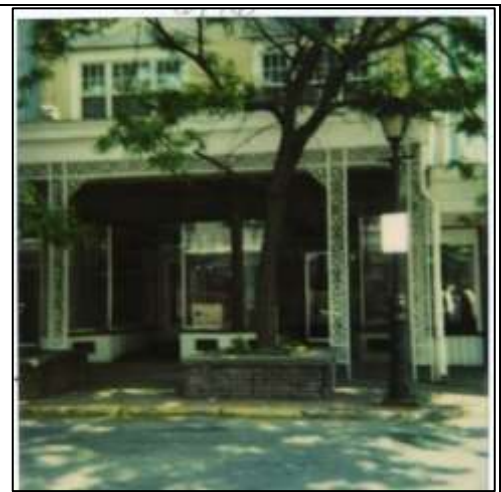
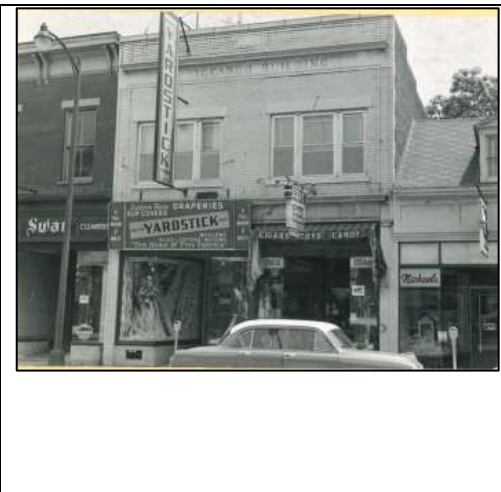
36	42 N. Front St	48.331-1-6

<p>42 N. Front Street displayed a simple early 20<sup>th</sup>-century storefront façade and row building façade. The original canopy obscured the traditional placement for signage at the site and hid the storefront from clear view. The 2010s reconstruction of the canopy may have raised the canopy at this location. It is unclear from photographs if this section contains skylights. Since 2010, this portion of the canopy was painted black.</p>
----	----------------	------------	---	--	--	---

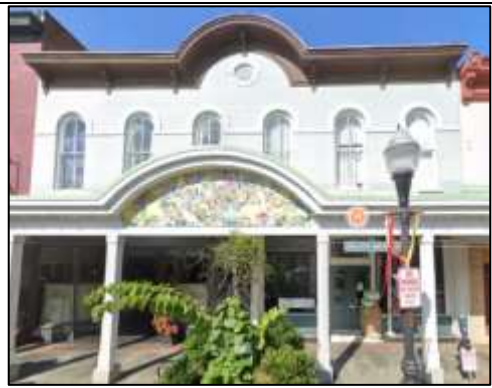
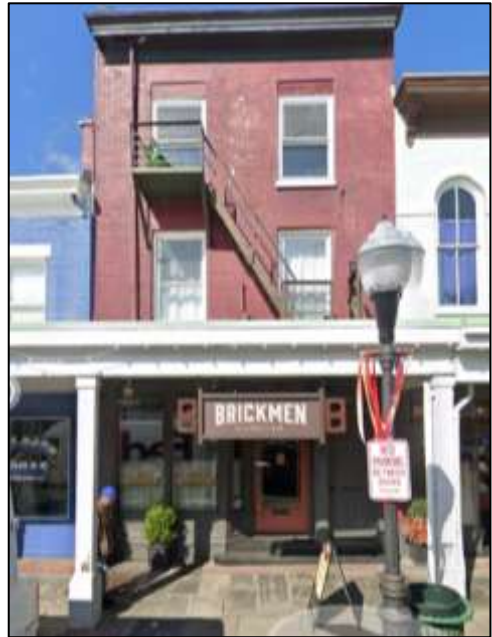
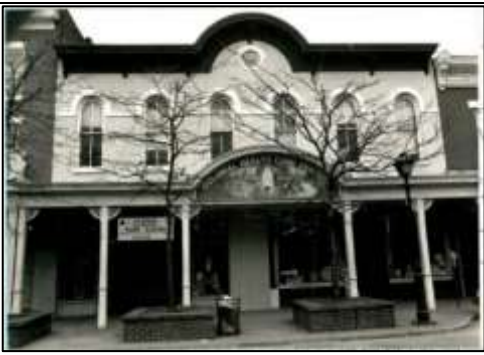
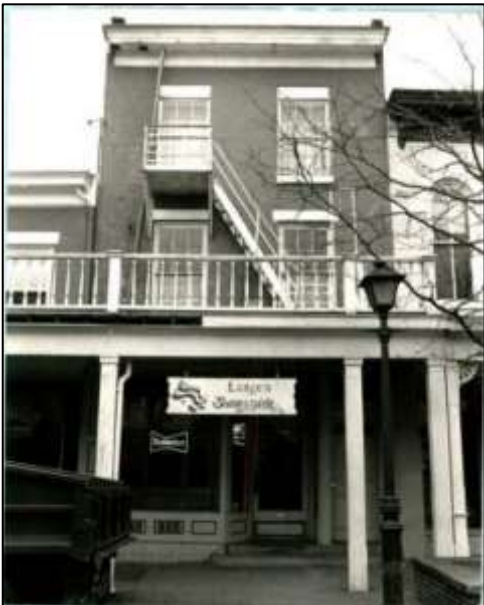
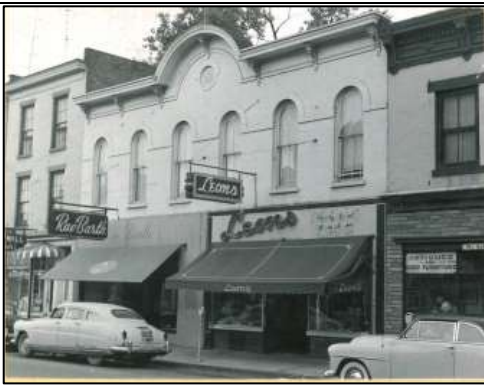
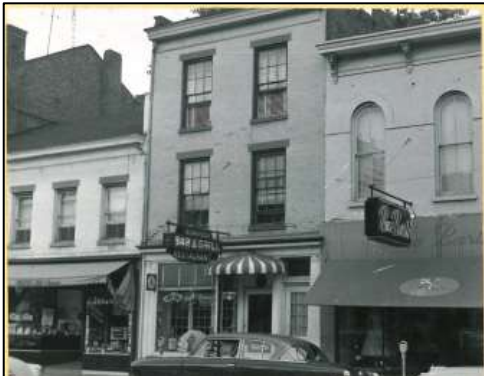
37 43-47 N. Front St

43-47 N. Front Street displayed a fine early late 19<sup>th</sup> or early 20<sup>th</sup>-century Italianate storefront façade (possibly altered) and row building façade.

The original canopy obscured the traditional placement for signage at the site, prevented the use of traditional awnings, and hid the storefronts from clear view.

The 2010s reconstruction of the canopy removed the rooftop balustrades at the western portion of the structure and the brackets supports beneath the canopy attached to the columns. The canopy's roof changed from flat to a single-pitched roof with modern skylights.

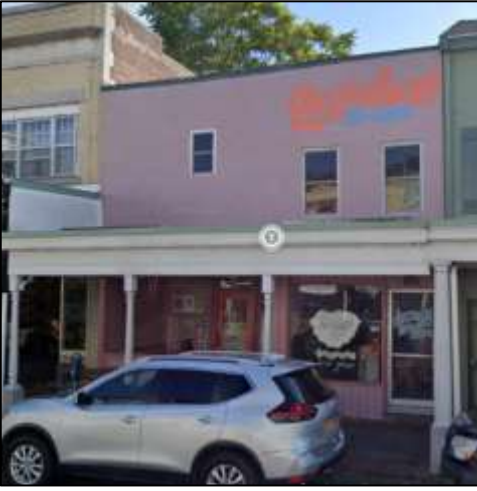
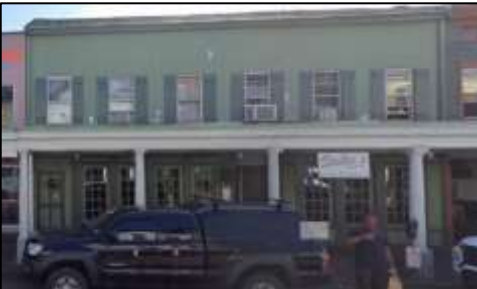
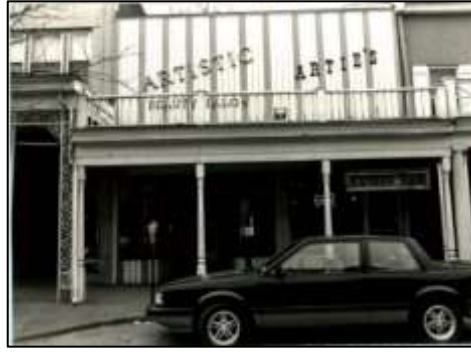
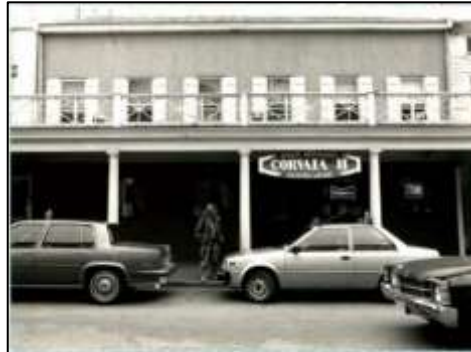
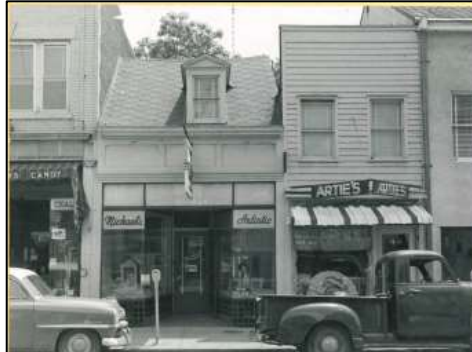
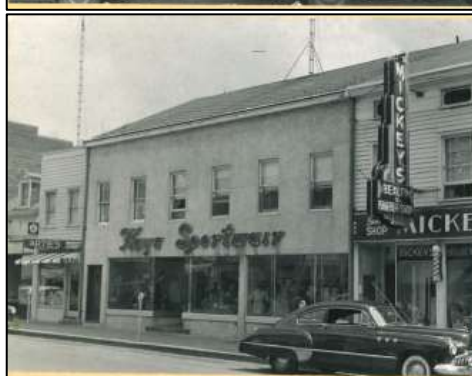
38	48 N. Front St	48.331-1-4.100

<p>48 N. Front Street displayed two different facades in 1956: one with a street-facing pitched roof with a single dormer, and the other with a more traditional clapboard façade with two 2<sup>nd</sup>-story windows.</p> <p>The original canopy obscured the traditional placement for signage at the site and may have influenced the substantial alterations that merged the two earlier structures into a single flat façade.</p> <p>The 2010s canopy reconstruction removed the rooftop balustrades and modern skylights were added.</p>
39	50 N. Front St	48.331-1-3

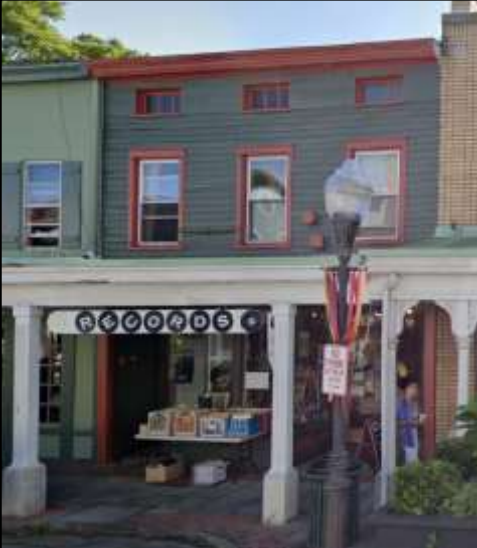
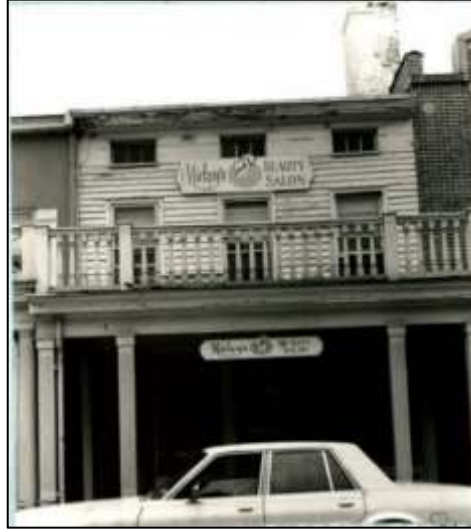
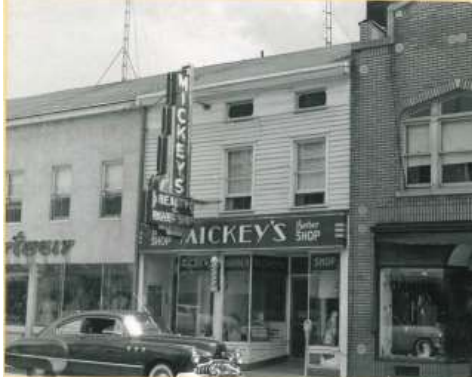
<p>50 N. Front displayed a single clapboard façade atop the shopfront in 1956. The original canopy obscured the traditional placement for signage at the site.</p> <p>The 2010s canopy reconstruction removed the rooftop balustrades and modern skylights were added. The canopy's columns were shortened and placed upon concrete piers, too.</p>

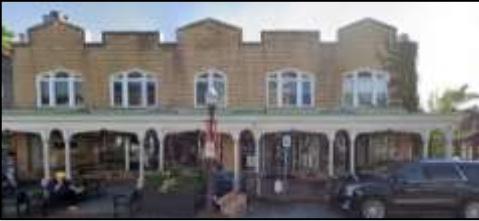
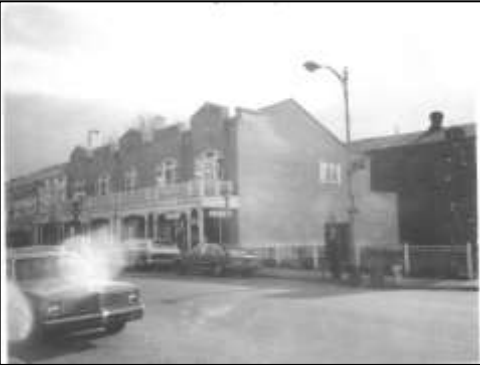
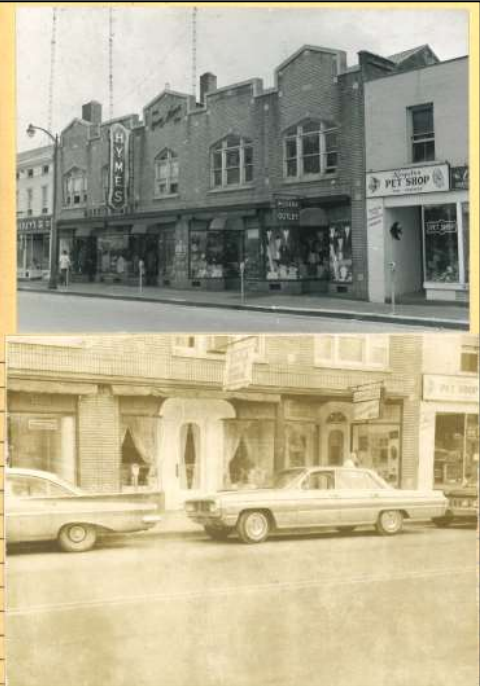
42	54 N. Front St	48.331-1-2

<p>54 N. Front displayed a simple brick façade atop the multiple and decorative shopfronts in 1956. The original canopy obscured the traditional placement for signage at the site and hindered the use of awnings.</p> <p>The 2010s canopy reconstruction removed the rooftop balustrades and modern skylights were added. The canopy's columns were shortened and placed upon concrete piers, too.</p>
43	57 N. Front St	48.314-2-13

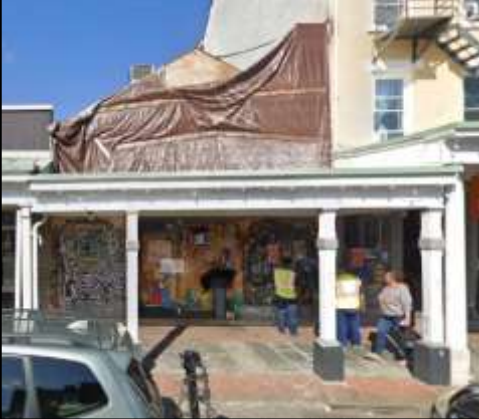
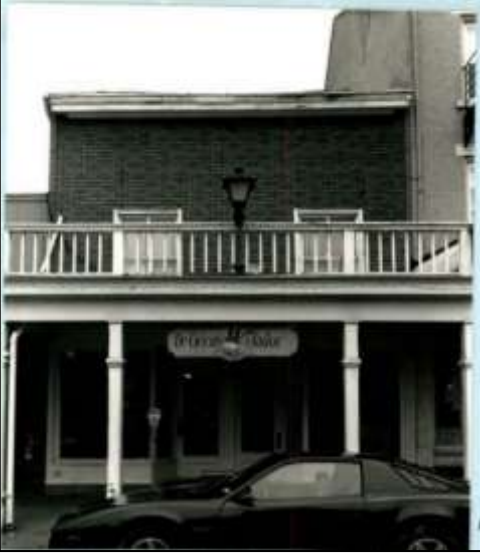
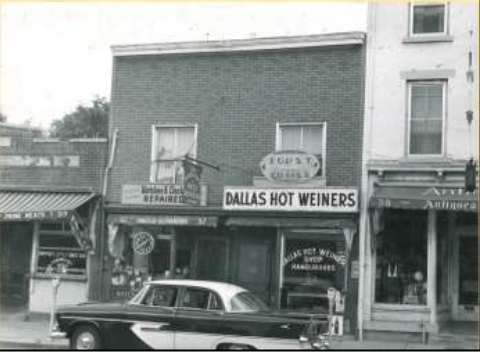
<p>57 N. Front displayed a simple brick façade atop the shopfronts in 1956. The original canopy obscured the traditional placement for signage at the site and hindered the use of awnings.</p> <p>The 2010s canopy reconstruction removed the rooftop balustrades and modern skylights were added. The canopy's columns were shortened and placed upon concrete piers, too.</p>
