# *EXISTING CONDITIONS REPORT*

## RONDOUT LIGHTHOUSE *Kingston, New York*

Re: **Conditions Report for Rondout Lighthouse  
Kingston, NY**

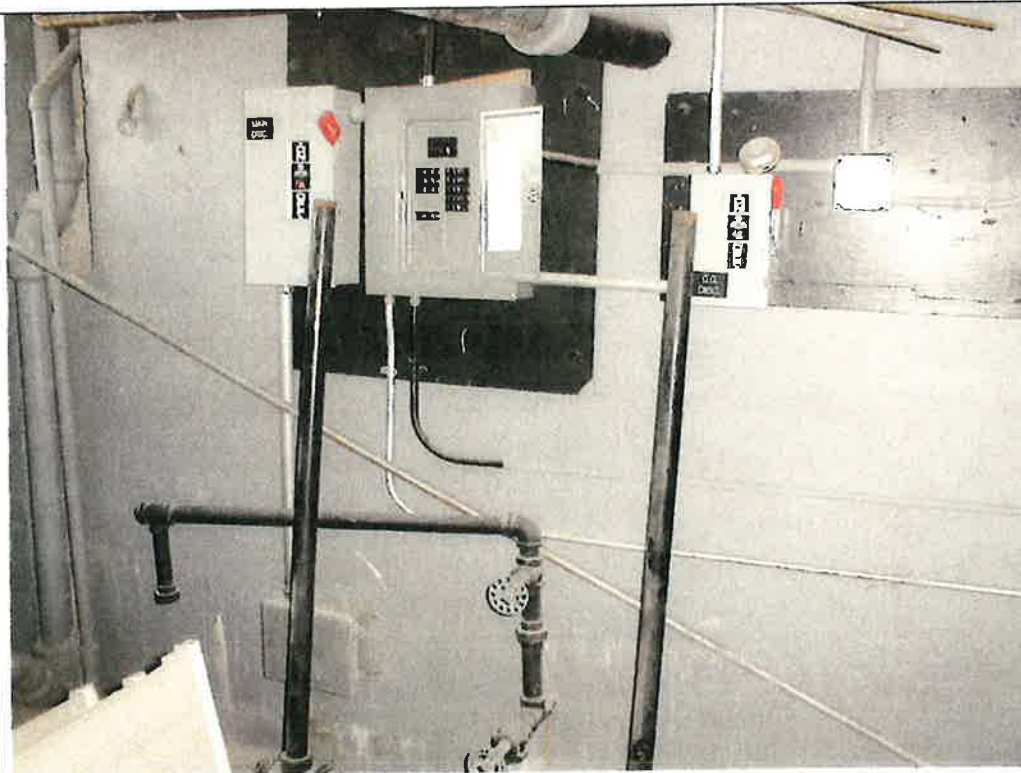
Existing electrical service – 100 amp panel and disconnect switch.

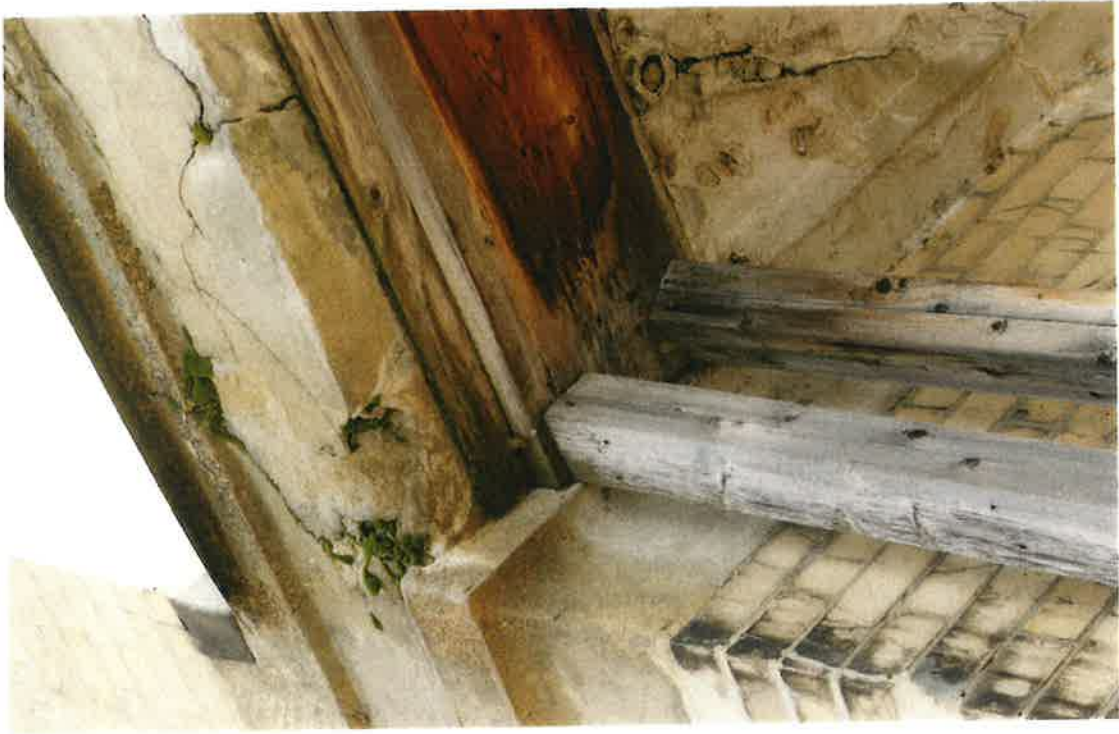
9

The concrete porch has been shored to prevent the accelerated cracking and spalling of the concrete structure. A temporary rubber roof was installed at the end of the previous construction campaign of roofing and window restoration. Water has infiltrated the cracks in the concrete slabs and is rusting the steel. The splitting brick piers show the signs of water infiltration behind the brick. Refer to the structural report (photos 7-16).

Recommendations: The structure needs immediate repair of the reinforced concrete structure while it is still in a condition that can be repaired. The brick piers need to be stripped of the brick that is not the size of the house brick; the concrete piers repaired and refaced with new brick. A new permanent roofing should be installed over the slab to protect the concrete surface. **Cost = \$18,000**

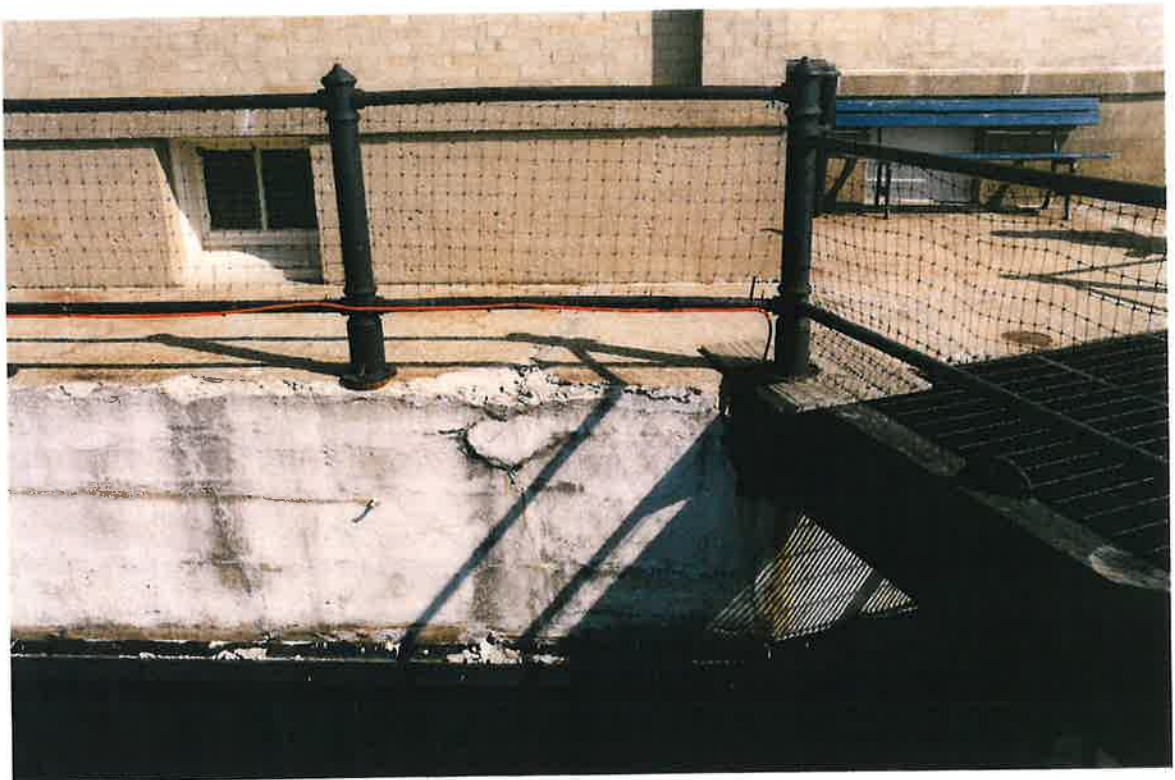
24

few signs of rusting of the thickness of the sheet iron, this condition indicates there are other hidden weak areas. The caisson steel cap has rusting and has rotted and fallen off in several sides. Refer to the structural report (photos 23-30).

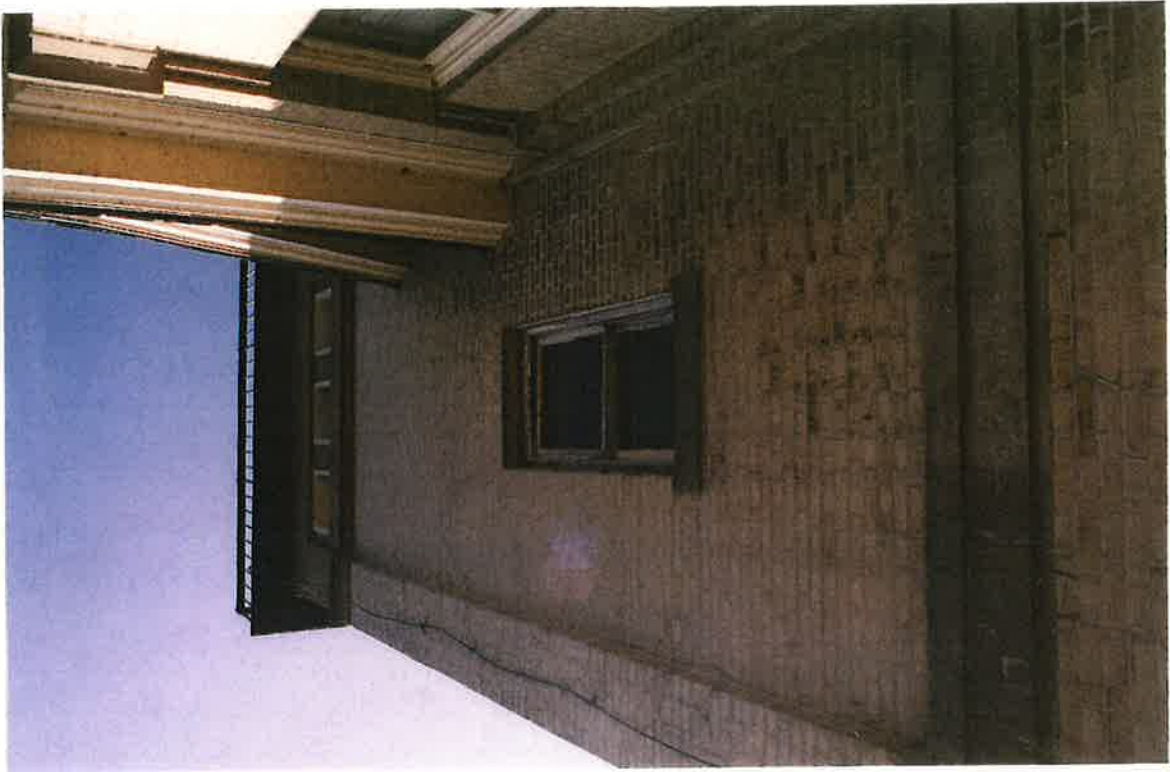
41

41. East side of tower: window that requires complete restoration.
42. Detail of east side of tower window that requires complete restoration.
43. East tower basement window requires complete restoration (west side window in similar condition)  
Note sump pump pipe thru sash
44. Tower top: porthole missing on east side.

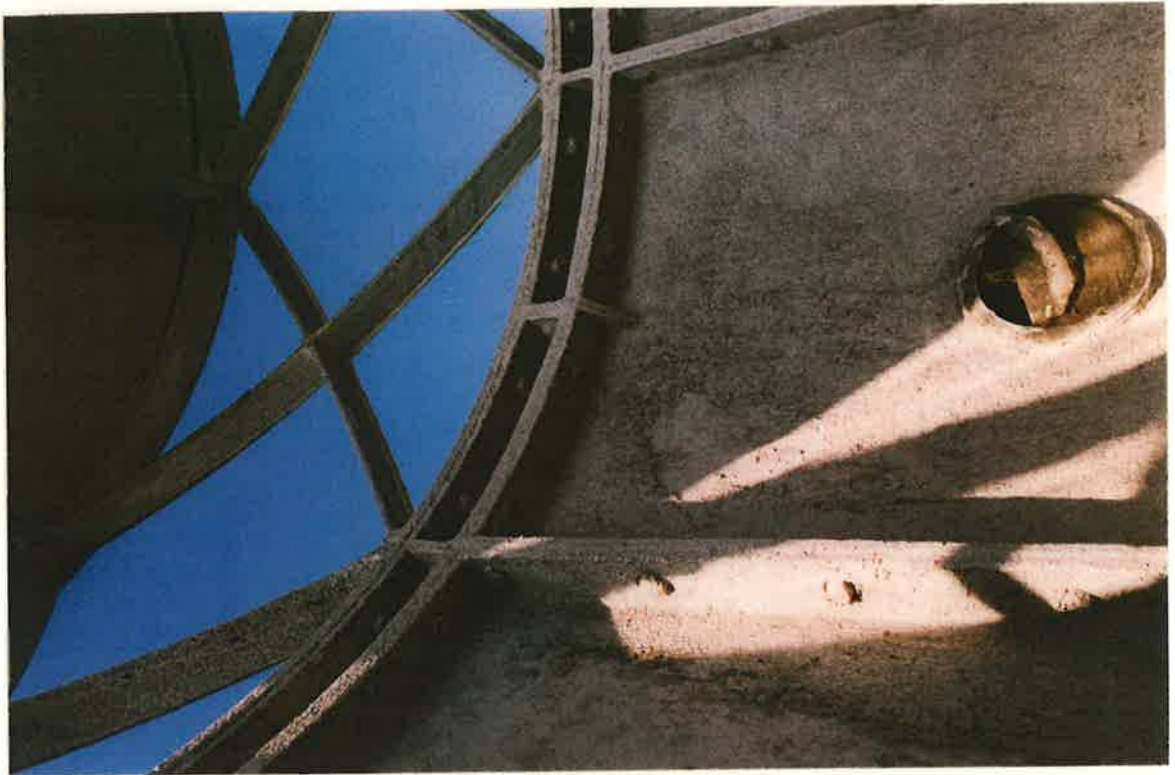
45

45. Interior deteriorated paint due to high levels of condensation.
46. Detail of interior deteriorated paint due to high levels of condensation.
47. Glazing bar repairs to exterior muntins
48. Glazing bar repairs to exterior muntins.

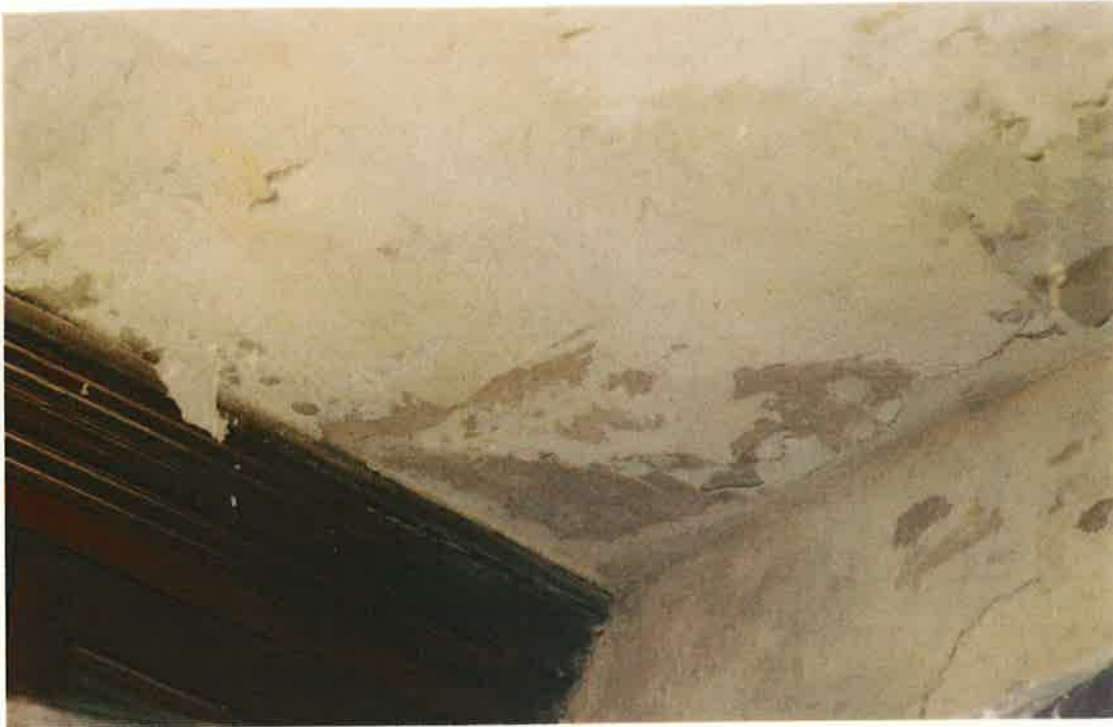
57

- 57. Typical condition of plaster ceiling and wall, worst condition.
- 58. Typical condition of plaster ceiling and wall, worst condition.
- 59. Spalling plaster from underside of floor construction.
- 60. Spalling glazed brick tile of tower.
- 61. Attic, third floor ceiling and walls: sheetrock covering of roof rafters and furred exterior wall.  
Note exposed roof ridge board and exposed clay tile to side of window jamb-side.
- 62. Attic, third floor ceiling and walls: stud kneewall framing at bottom of ceiling, roof finish.  
Note line of rafters beyond.

| • repair plaster and paint | |

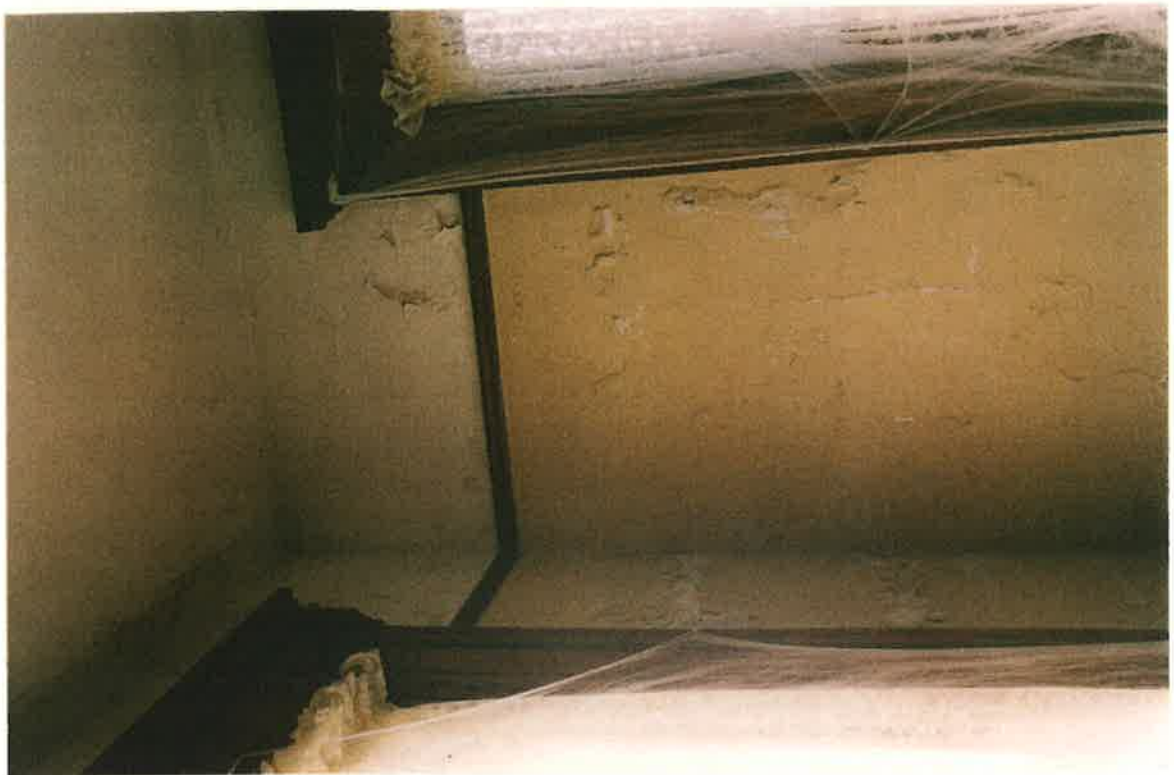
63

- 63. Typical window woodwork and picture molding.  
Note deteriorated wall and ceiling plaster. South house corner.
- 64. Kitchen interior door and wainscoting. Typical door.
- 65. Typical door and picture molding (first and second floors).
- 66. Typical condition of door frame, baseboard and flooring (first and second floors).
- 67. Basement: Rotted door frame due to flooding.
- 68. Basement: Rotted door frame due to flooding  
Note dropped door head and brick tile loss at head.

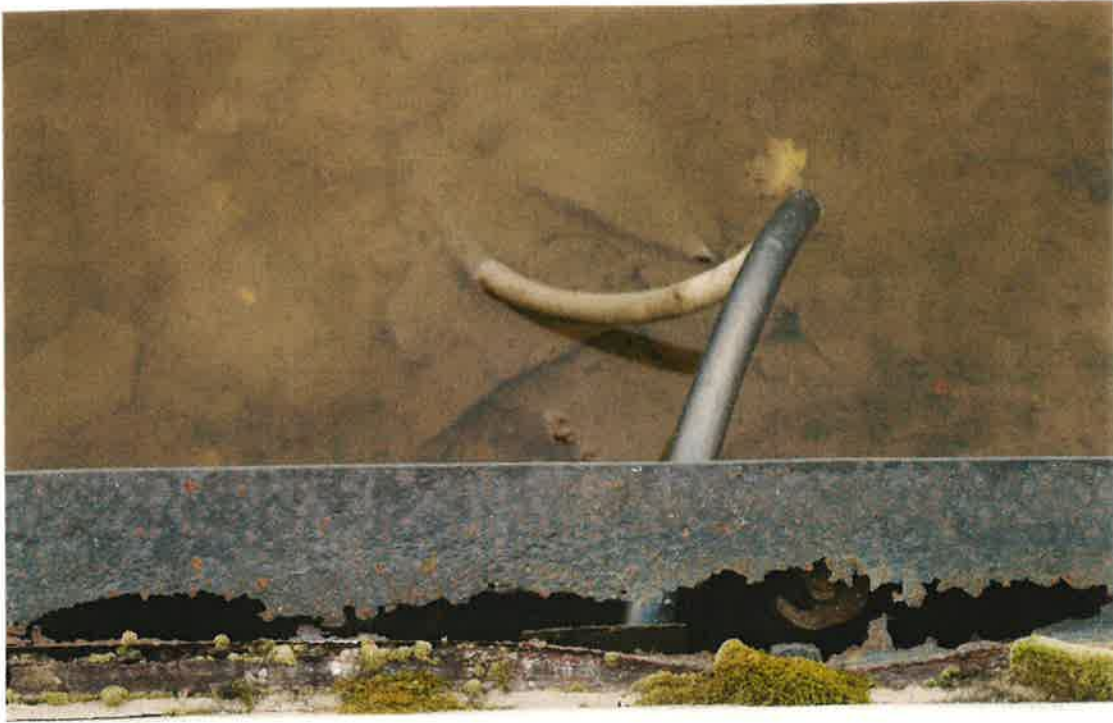
69

- 69. Electric service cable exposed on northwest side through cistern overflow pipe.
- 70. Lightning protection secured to cast iron lookout platform. View looking down toward concrete platform around house off east corner of tower.
- 71. Box gutter downspout entrance through concrete foundation wall to cistern in basement at north corner of house.
- 72. Sump pump for basement under porch.
- 73. Fresh air intake for original waste piping through northeast wall.
- 74. Original sanitary pipe outlet to river on northeast side through caisson wall.
