**INTENSIVE LEVEL
MIDTOWN EAST SURVEY
City of Kingston**

Intensive Level Building Survey of the Midtown East Study Area
City of Kingston, Ulster County, New York

Survey Methodology Statement

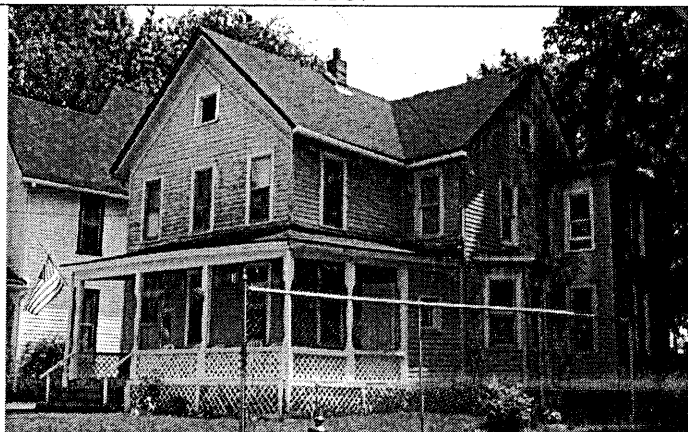
12. PHOTO:

8. BUILDING MATERIAL: a. clapboard ☒ b. stone c. brick d. board and batten
e. cobblestone f. shingles g. stucco f. other
9. STRUCTURAL SYSTEM: (if known) a. wood frame with interlocking joints ☐
b. wood frame with light members ☐
c. masonry load bearing walls ☐
d. metal (explain) ☐
e. other: (explain) ☐
10. CONIDITION: a. excellent b. good c. fair ☒ d. deteriorated
11. INTEGRITY: a. original site ☒ b. moved ☐ if so, when?
c. list major alterations and dates (if known): Porch rails replaced, gutters added

14. THREATS TO BUILDING:
a. none known b. zoning c. roads d. developers e. deterioration ☒
f. other: _____
15. RELATED OUTBUILDINGS AND PROPERTY:
a. barn b. carriage house c. garage d. privy e. shed f. greenhouse g. shop h. gardens
i. landscape features:
j. other: _____
16. SURROUNDINGS OF THE BUILDING (check more than one if necessary):
a. open land ☐ b. woodland ☐ c. scattered buildings ☐ d. densely built-up ☒ e. commercial ☐
f. industrial ☐ g. residential ☒ h. other: _____
17. INTERRELATIONSHIP OF BUILDING AND SURROUNDINGS: (Indicate if building or structure is in an historic district)
Not in an historic district
18. OTHER NOTABLE FEATURES OF BUILDING AND SITE (including interior features if known): A modest cross gabled roof victorian residence with projecting wing built circa 1900. Full width one story porch. Loss of detail.

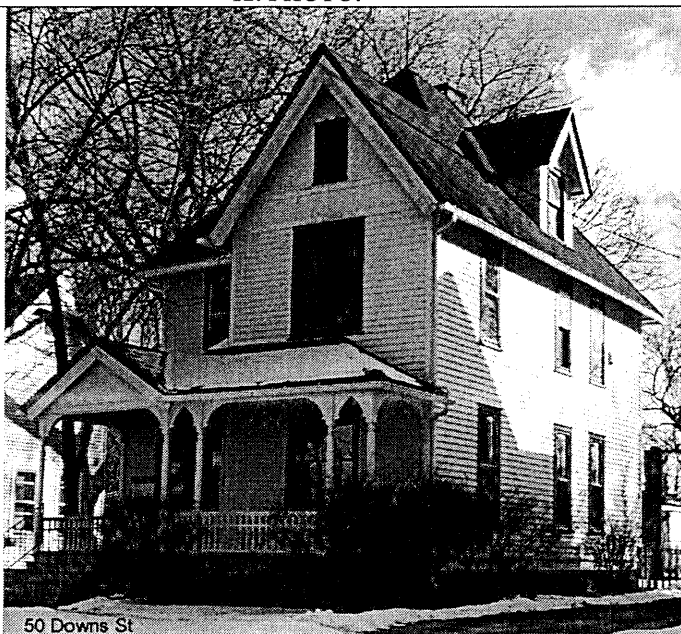
12. PHOTO:

8. BUILDING MATERIAL: f. other Vinyl siding
9. STRUCTURAL SYSTEM: (if known)
 - a. wood frame with interlocking joints ☒
 - b. wood frame with light members ☐
 - c. masonry load bearing walls ☐
 - d. metal (explain)
 - e. other: (explain) ☐
10. CONDITION: a. excellent b. good ☒ c. fair d. deteriorated
11. INTEGRITY: a. original site ☒ b. moved ☐ if so, when?
c. list major alterations and dates (if known):

18. OTHER NOTABLE FEATURES OF BUILDING AND SITE (including interior features if known): A two and one half story Queen Anne style frame residence with front and side facing gables, a full front one story porch with decorative posts and spindlework rail, vinyl siding. Building declared "Unsafe"**SIGNIFICANCE**

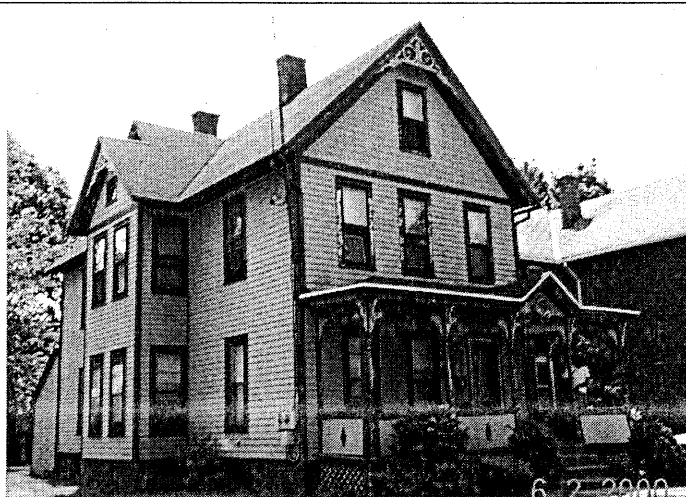
12. PHOTO:

8. BUILDING MATERIAL: a. clapboard ☒ b. stone ☐ c. brick ☐ d. board and batten ☐
e. cobblestone ☐ f. shingles ☐ g. stucco ☐ other (explain) ☐
9. STRUCTURAL SYSTEM: (if known) a. wood frame with interlocking joints ☐
b. wood frame with light members ☐
c. masonry load bearing walls ☐
d. metal (explain) ☐
e. other: (explain) ☐
10. CONDITION: a. excellent ☐ b. good ☐ c. fair ☒ d. deteriorated ☐
11. INTEGRITY: a. original site ☒ b. moved ☐ if so, when?
c. list major alterations and dates (if known): Addition in back, porch railing replaced, porch facint replaced

14. THREATS TO BUILDING: a. none known ☐ b. zoning ☐ c. roads ☐
 d. developers ☐ e. deterioration ☐
 f. other: Vinyl siding – painted badly needed

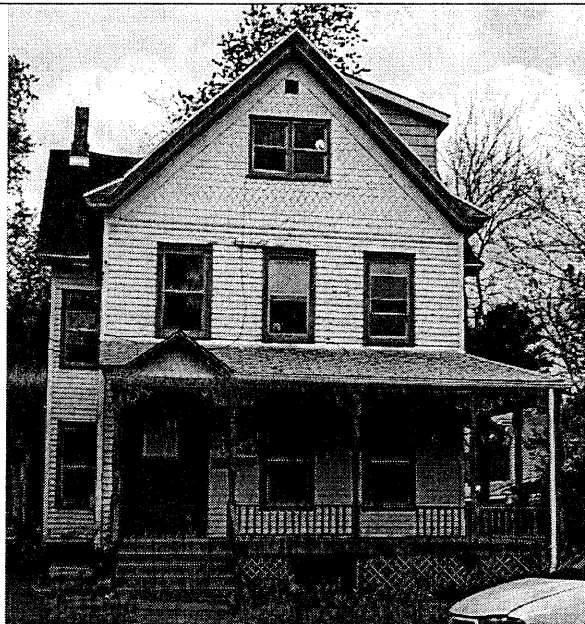
12. PHOTO:

8. BUILDING MATERIAL: a. clapboard b. stone c. brick d. board and batten
e. cobblestone f. shingles g. stucco f. other a
9. STRUCTURAL SYSTEM: (if known) a. wood frame with interlocking joints ☐
b. wood frame with light members ☐
c. masonry load bearing walls ☐
d. metal (explain) ☐
e. other: (explain) ☐
10. CONDITION: a. excellent b. good ☒ c. fair d. deteriorated
11. INTEGRITY: a. original site ☒ b. moved ☐ if so, when?
c. list major alterations and dates (if known): Steps to porch, dormer in attic (vinyl sided, blue)

- a. none known. b. zoning c. roads d. developers e. deterioration ☒
f. other: vacant, pigeons inside

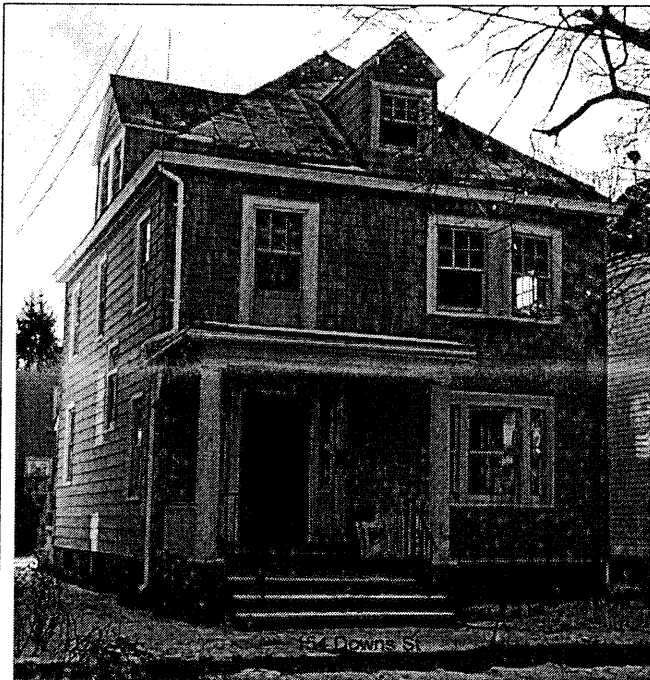
12. PHOTO:

10. CONDITION: a. excellent b. good c. fair ☒ d. deteriorated

11. INTEGRITY: a. original site ☒ b. moved ☐ if so, when?
c. list major alterations and dates (if known): Vinyl siding. Door on 2nd floor use to lead to a porch?. Front window was like 165 Downs St.?

f. other: vacant

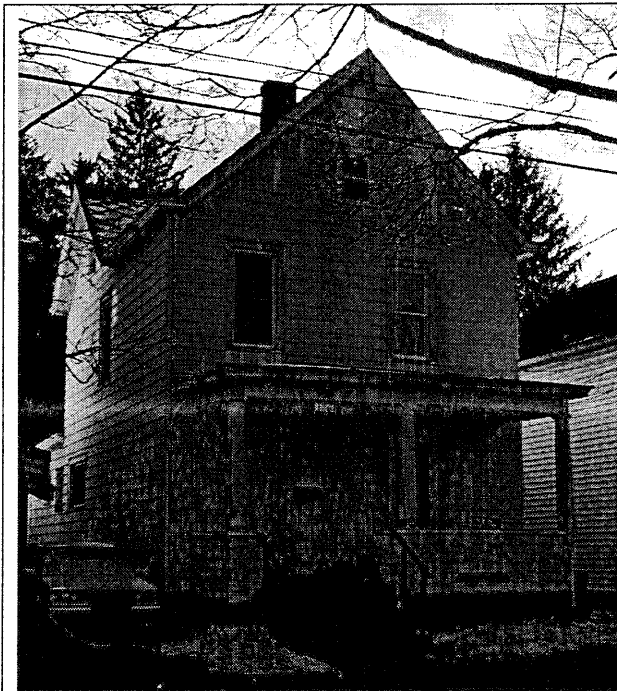
12. PHOTO:

8. BUILDING
MATERIAL: f. other Aluminum Siding
9. STRUCTURAL
SYSTEM: (if known) a. wood frame with interlocking joints ☒
b. wood frame with light members ☐
c. masonry load bearing walls ☐
d. metal (explain)
e. other: (explain) ☐
10. CONDITION: a. excellent b. good c. fair ☒ d. deteriorated
11. INTEGRITY: a. original site ☒ b. moved ☐ if so, when?
c. list major alterations and dates (if known):

- a. none known b. zoning c. roads d. developers e. deterioration :
f. other: House Vacant

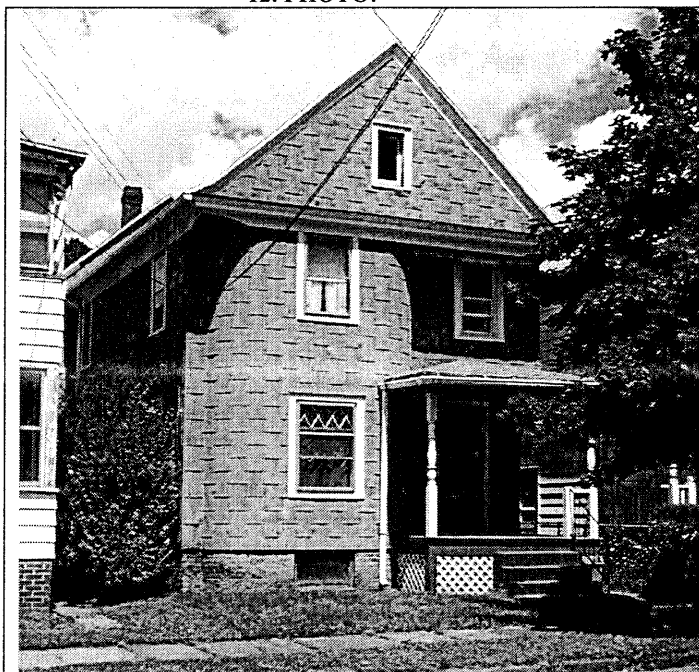
12. PHOTO:

8. BUILDING MATERIAL: a. clapboard b. stone c. brick d. board and batten
e. cobblestone f. shingles g. stucco f. other Asbestos
9. STRUCTURAL SYSTEM: (if known) a. wood frame with interlocking joints ☐
b. wood frame with light members ☐
c. masonry load bearing walls ☐
d. metal (explain) ☐
e. other: (explain) ☐
10. CONDITION: a. excellent b. good c. fair ☒ d. deteriorated
11. INTEGRITY: a. original site ☒ b. moved ☐ if so, when?
c. list major alterations and dates (if known): porch replaced, windows replaced, asbestos siding after 1955

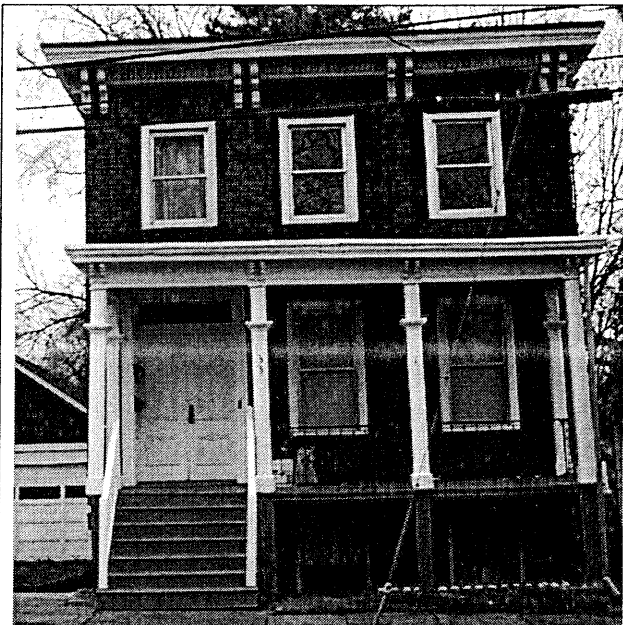
12. PHOTO:

8. BUILDING MATERIAL: a. clapboard b. stone c. brick d. board and batten
e. cobblestone ☒ f. shingles g. stucco f. other asphalt siding
9. STRUCTURAL SYSTEM: (if known) a. wood frame with interlocking joints ☐
b. wood frame with light members ☐
c. masonry load bearing walls ☐
d. metal (explain) ☐
e. other: (explain) ☐
10. CONDITION: a. excellent b. good c. fair ☒ d. deteriorated
11. INTEGRITY: a. original site ☒ b. moved ☐ if so, when?
c. list major alterations and dates (if known): asphalt siding, iron porch railings, porch detail taken off since 1956, use to have 2/2 windows now 1/1 replacements, aluminum wrapped window trim

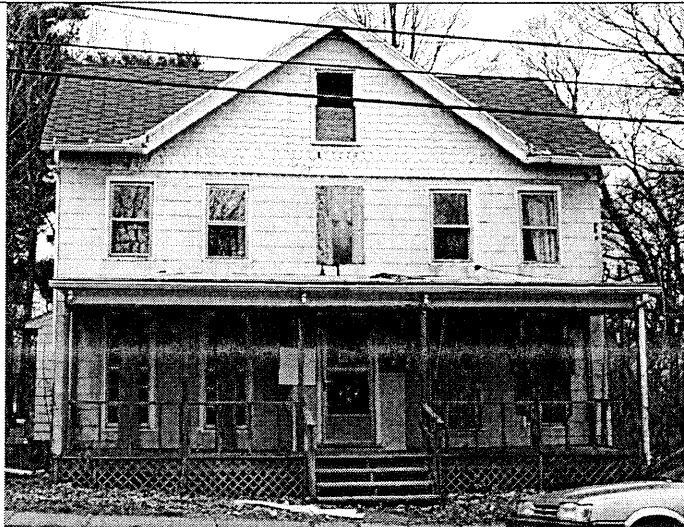
12. PHOTO:

8. BUILDING MATERIAL: a. clapboard b. stone c. brick d. board and batten
e. cobblestone ☐ f. shingles g. stucco f. other asbestos shingles
9. STRUCTURAL SYSTEM: (if known) a. wood frame with interlocking joints ☐
b. wood frame with light members ☐
c. masonry load bearing walls ☐
d. metal (explain)
e. other: (explain) ☐
10. CONDITION: a. excellent b. good c. fair d. deteriorated
11. INTEGRITY: a. original site ☒ b. moved ☐ if so, when?
c. list major alterations and dates (if known): Addition in back sometime between 58 and 88, asbestos shingle siding, 1956 better (orig?) porch w/ballustrade & columns, now pressure treated porch floor & 2x4 railing

- a. none known b. zoning c. roads d. developers e. deterioration : ☒
f. other: house vacant

18. OTHER NOTABLE FEATURES OF BUILDING AND SITE (including interior features if known): A modest circa 1910 front gable Queen Anne wooden residence with decorative fish tail shingle siding remaining at roof line; replacement windows, porch details.**SIGNIFICANCE**

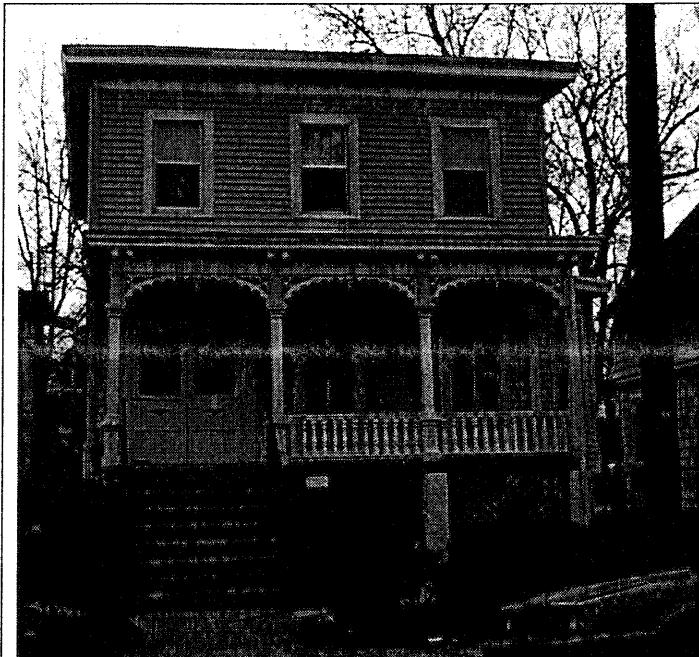
12. PHOTO:

8. BUILDING MATERIAL: a. clapboard b. stone c. brick d. board and batten
e. cobblestone ☐ f. shingles g. stucco f. other vinyl
9. STRUCTURAL SYSTEM: (if known) a. wood frame with interlocking joints ☐
b. wood frame with light members ☐
c. masonry load bearing walls ☐
d. metal (explain)
e. other: (explain) ☐
10. CONDITION: a. excellent b. good ☒ c. fair d. deteriorated
11. INTEGRITY: a. original site ☒ b. moved ☐ if so, when?
c. list major alterations and dates (if known): Soffits wrapped w/aluminum. Some spindles missing from porch replaced w/non conforming spindles

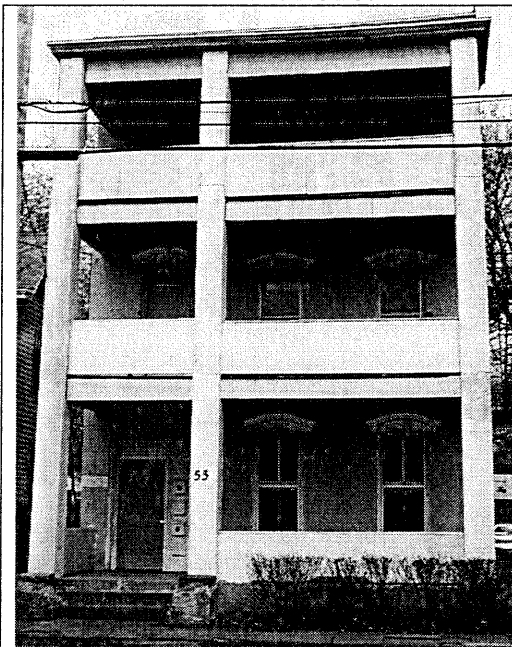
12. PHOTO:

8. BUILDING MATERIAL: a. clapboard b. stone c. brick ☒ d. board and batten
e. cobblestone f. shingles g. stucco f. other
9. STRUCTURAL SYSTEM: (if known) a. wood frame with interlocking joints ☐
b. wood frame with light members ☐
c. masonry load bearing walls ☐
d. metal (explain) ☐
e. other: (explain) ☐
10. CONDITION: a. excellent b. good c. fair ☒ d. deteriorated
11. INTEGRITY: a. original site ☒ b. moved ☐ if so, when?
c. list major alterations and dates (if known): Ugly porch 3 level of plywood & particle board, metal fire escape, painted prick

14. THREATS TO BUILDING:
a. none known ☒ b. zoning c. roads d. developers e. deterioration
f. other: painful ugliness
15. RELATED OUTBUILDINGS AND PROPERTY:

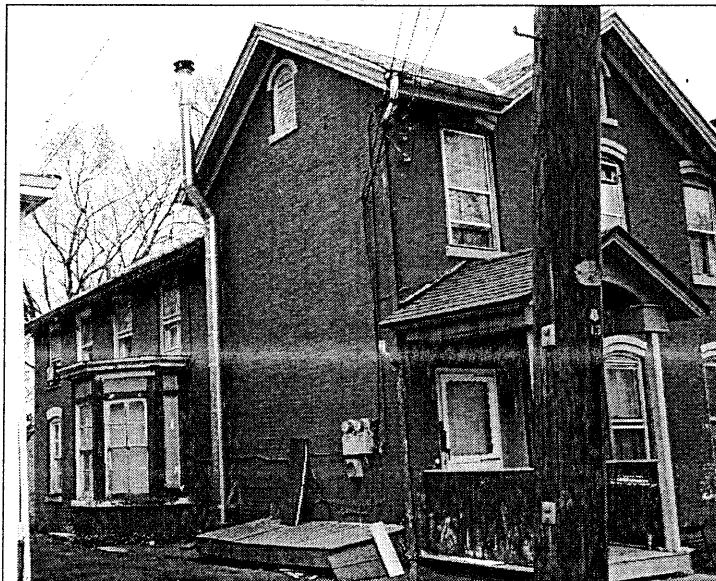
12. PHOTO:

8. BUILDING MATERIAL: a. clapboard b. stone c. brick ☒ d. board and batten
e. cobblestone f. shingles g. stucco h. other
9. STRUCTURAL SYSTEM: (if known) a. wood frame with interlocking joints ☐
b. wood frame with light members ☐
c. masonry load bearing walls ☐
d. metal (explain) ☐
e. other: (explain) ☐
10. CONDITION: a. excellent b. good c. fair d. deteriorated
11. INTEGRITY: a. original site ☒ b. moved ☐ if so, when?
c. list major alterations and dates (if known): Addition, lean-to in back, entrance to basement, porch replaced w/T-1-11

18. OTHER NOTABLE FEATURES OF BUILDING AND SITE (including interior features if known): A modest brick cross gabled Queen Anne residence built circa 1905 with replacement front entrance portico; arched window cornices and gable vents.**SIGNIFICANCE**19. DATE OF INITIAL CONSTRUCTION: Circa 1905

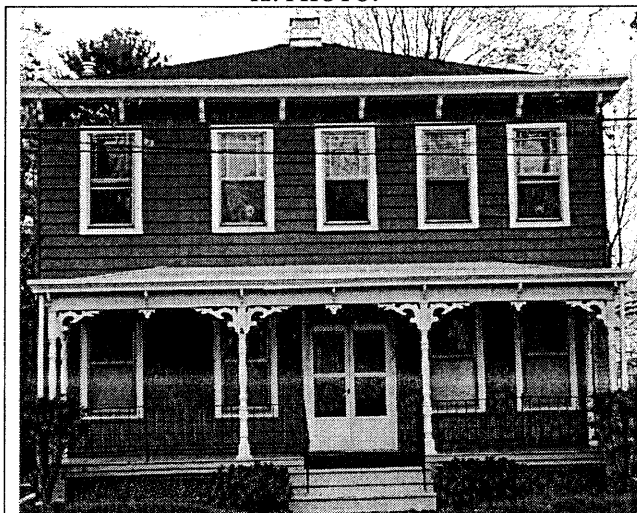
12. PHOTO:

8. BUILDING MATERIAL: a. clapboard b. stone c. brick d. board and batten
e. cobblestone ☒ f. shingles g. stucco f. other aluminum siding
9. STRUCTURAL SYSTEM: (if known) a. wood frame with interlocking joints ☐
b. wood frame with light members ☐
c. masonry load bearing walls ☐
d. metal (explain) ☐
e. other: (explain) ☐
10. CONDITION: a. excellent b. good ☒ c. fair d. deteriorated
11. INTEGRITY: a. original site ☒ b. moved ☐ if so, when?
c. list major alterations and dates (if known): Metal balusters on porch, small porch in back

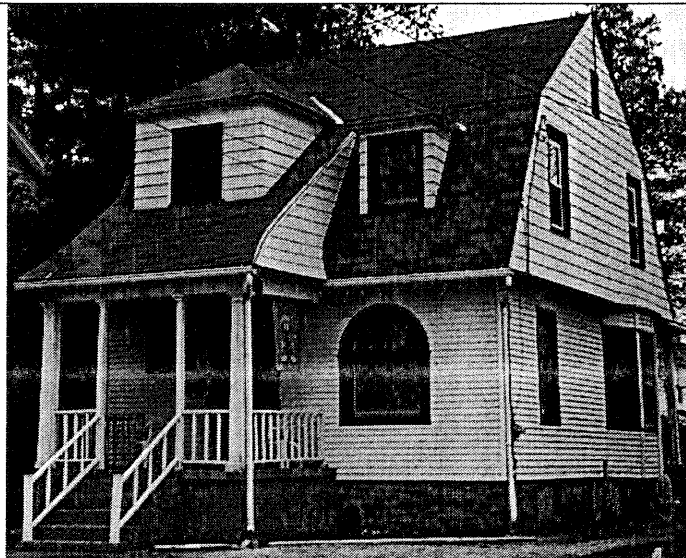
12. PHOTO:

8. BUILDING MATERIAL: a. clapboard b. stone c. brick d. board and batten
e. cobblestone ☐ f. shingles g. stucco f. other Aluminum and vinyl
9. STRUCTURAL SYSTEM: (if known) a. wood frame with interlocking joints ☐
b. wood frame with light members ☐
c. masonry load bearing walls ☐
d. metal (explain)
e. other: (explain) ☐
10. CONDITION: a. excellent b. good ☒ c. fair d. deteriorated
11. INTEGRITY: a. original site ☒ b. moved ☐ if so, when?
c. list major alterations and dates (if known): Aluminum siding on top, vinyl siding on bottom

18. OTHER NOTABLE FEATURES OF BUILDING AND SITE (including interior features if known): A single family early 20th century Dutch Colonial Revival residence with a side gambrel roof shape and projecting front portico; bloodstone foundation; arched front windows; a replacement front porch retained the exterior columns.

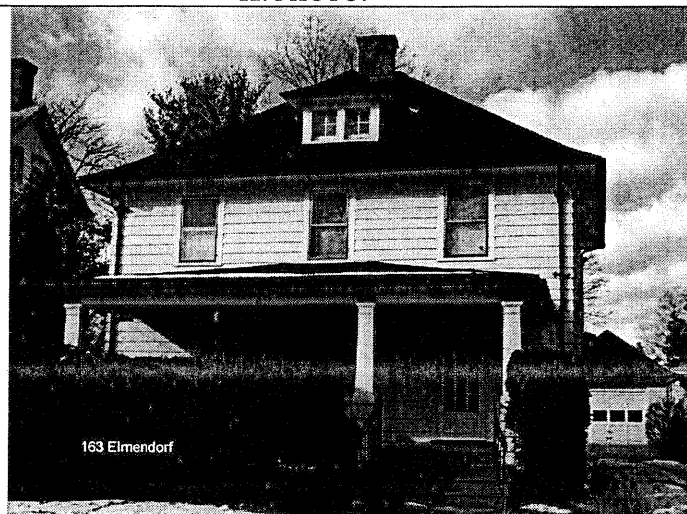
12. PHOTO:

8. BUILDING MATERIAL: a. clapboard ☒ b. stone c. brick d. board and batten
e. cobblestone f. shingles g. stucco f. other
9. STRUCTURAL SYSTEM: (if known) a. wood frame with interlocking joints ☒
b. wood frame with light members ☐
c. masonry load bearing walls ☐
d. metal (explain)
e. other: (explain) ☐
10. CONDITION: a. excellent b. good ☒ c. fair d. deteriorated
11. INTEGRITY: a. original site ☒ b. moved ☐ if so, when?
c. list major alterations and dates (if known):

i. landscape features:
j. other: Gargage 1 car, 1 story hipped roof, mirrors house
16. SURROUNDINGS OF THE BUILDING (check more than one if necessary):
a. open land ☐ b. woodland ☐ c. scattered buildings ☐ d. densely built-up ☒ e. commercial ☐

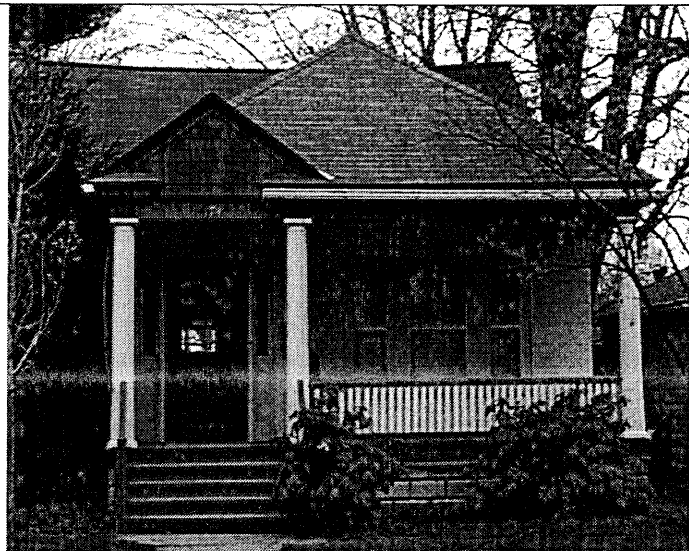
12. PHOTO:

8. BUILDING MATERIAL: a. clapboard b. stone c. brick d. board and batten
e. cobblestone ☒ f. shingles g. stucco f. other Asbestos
9. STRUCTURAL SYSTEM: (if known) a. wood frame with interlocking joints ☐
b. wood frame with light members ☐
c. masonry load bearing walls ☐
d. metal (explain) ☐
e. other: (explain) ☐
10. CONDITION: a. excellent b. good ☒ c. fair d. deteriorated
11. INTEGRITY: a. original site ☒ b. moved ☐ if so, when?
c. list major alterations and dates (if known): New roof

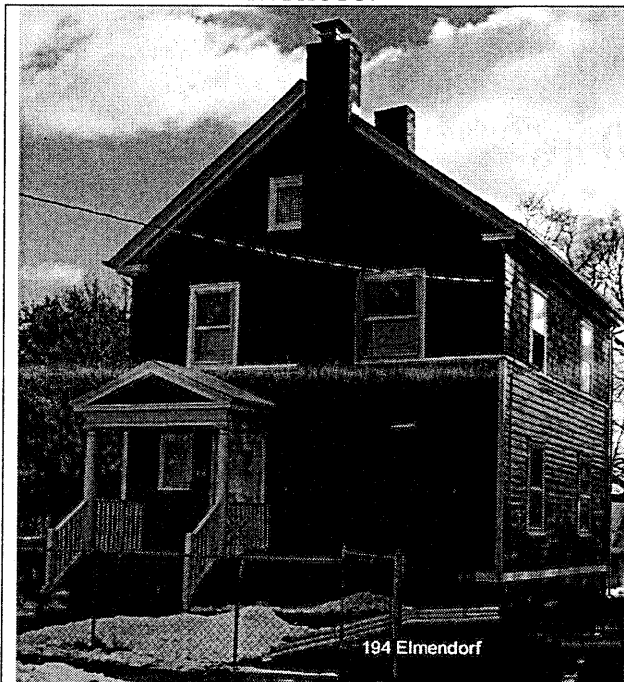
12. PHOTO:

8. BUILDING MATERIAL: a. clapboard ☒ b. stone c. brick d. board and batten
e. cobblestone f. shingles g. stucco f. other shingles
9. STRUCTURAL SYSTEM: (if known) a. wood frame with interlocking joints ☒
b. wood frame with light members ☐
c. masonry load bearing walls ☐
d. metal (explain)
e. other: (explain) ☐
10. CONDITION: a. excellent b. good ☒ c. fair d. deteriorated
11. INTEGRITY: a. original site ☒ b. moved ☐ if so, when?
c. list major alterations and dates (if known): Fireplace in front

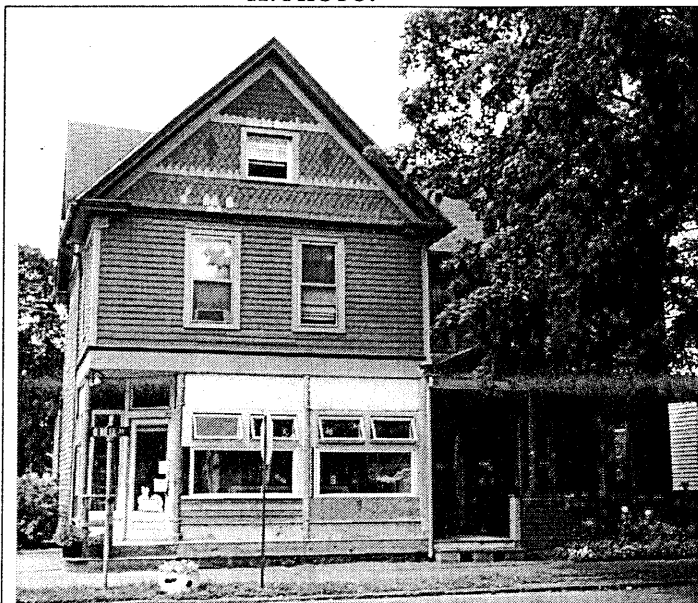
12. PHOTO:

8. BUILDING MATERIAL: a. clapboard ☒ b. stone c. brick d. board and batten
e. cobblestone f. shingles g. stucco f. other
9. STRUCTURAL SYSTEM: (if known) a. wood frame with interlocking joints ☒
b. wood frame with light members ☐
c. masonry load bearing walls ☐
d. metal (explain) ☐
e. other: (explain) ☐
10. CONIDITION: a. excellent b. good ☒ c. fair d. deteriorated
11. INTEGRITY: a. original site ☒ b. moved ☐ if so, when?
c. list major alterations and dates (if known): Top Floor front windows repalced

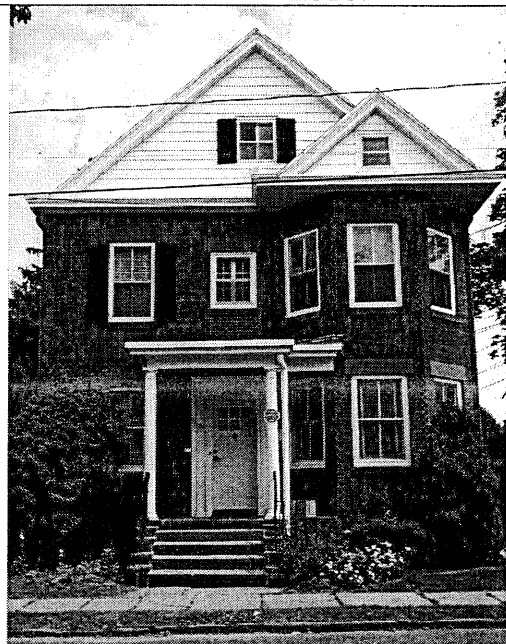
12. PHOTO:

10. CONDITION: a. excellent b. good ☒ c. fair d. deteriorated

11. INTEGRITY: a. original site ☒ b. moved ☐ if so, when?
c. list major alterations and dates (if known): Major addition of office space

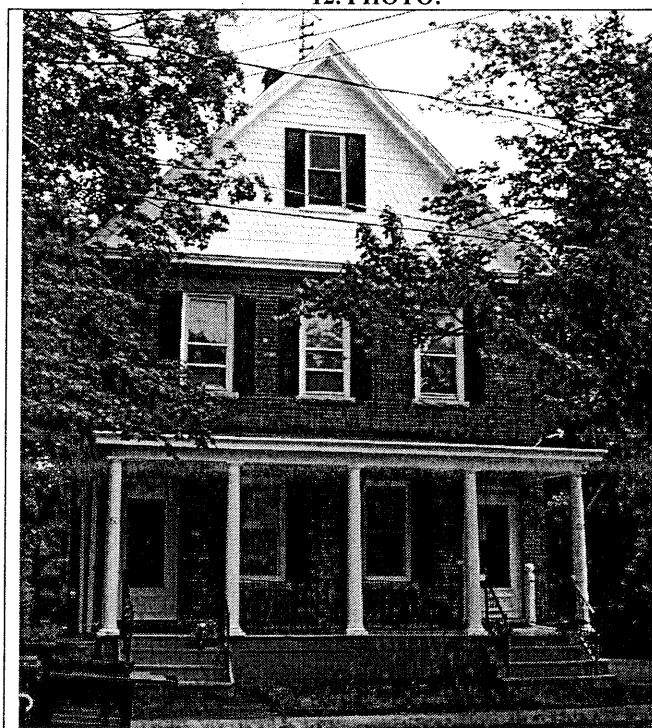
12. PHOTO:

8. BUILDING MATERIAL: a. clapboard ☐ b. stone ☐ c. brick ☒ d. board and batten ☐
e. cobblestone ☐ f. shingles ☐ g. stucco ☐ other (explain) ☐
9. STRUCTURAL SYSTEM: (if known) a. wood frame with interlocking joints ☐
b. wood frame with light members ☐
c. masonry load bearing walls ☐
d. metal (explain) ☐
e. other: (explain) ☐
10. CONDITION: a. excellent ☐ b. good ☒ c. fair ☐ d. deteriorated ☐
11. INTEGRITY: a. original site ☒ b. moved ☐ if so, when?
c. list major alterations and dates (if known): Vinyl shutters, porch rails, new windows

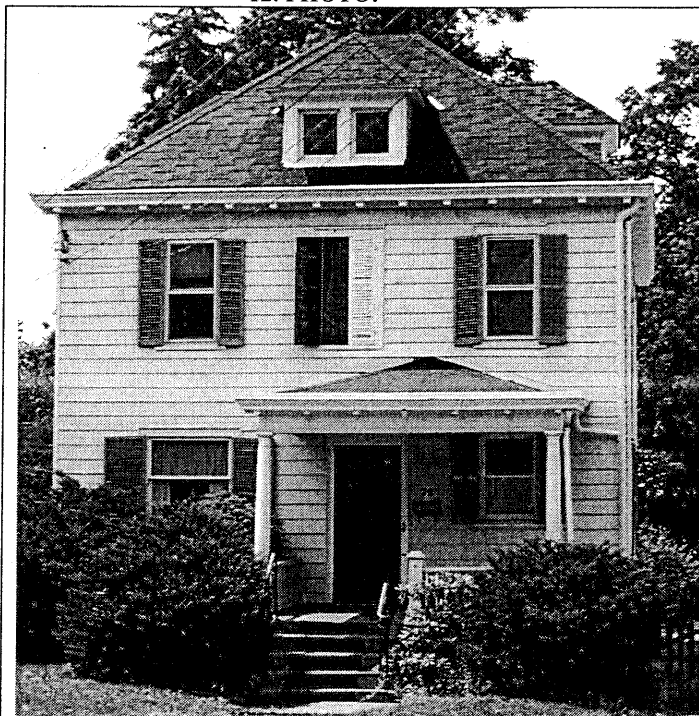
12. PHOTO:

8. BUILDING MATERIAL: a. clapboard b. stone c. brick d. board and batten
e. cobblestone ☒ f. shingles g. stucco f. other Aluminum siding
9. STRUCTURAL SYSTEM: (if known) a. wood frame with interlocking joints ☐
b. wood frame with light members ☐
c. masonry load bearing walls ☐
d. metal (explain) ☐
e. other: (explain) ☐
10. CONDITION: a. excellent b. good ☒ c. fair d. deteriorated
11. INTEGRITY: a. original site ☒ b. moved ☐ if so, when?
c. list major alterations and dates (if known): porch stair rails

14. THREATS TO BUILDING:
a. none known b. zoning c. roads d. developers e. deterioration ☒
f. other: ..
15. RELATED OUTBUILDINGS AND PROPERTY:
a. barn b. carriage house c. garage d. privy e. shed f. greenhouse g. shop h. gardens
i. landscape features: little
j. other:
16. SURROUNDINGS OF THE BUILDING (check more than one if necessary):
a. open land ☐ b. woodland ☐ c. scattered buildings ☐ d. densely built-up ☒ e. commercial ☐
f. industrial ☐ g. residential ☒ h. other:
17. INTERRELATIONSHIP OF BUILDING AND SURROUNDINGS: (Indicate if building or structure is in an historic district)
Not in an historic district
18. OTHER NOTABLE FEATURES OF BUILDING AND SITE (including interior features if known): A circa 1900 'American Four Square' hipped roof with attic dormers; exposed roof rafter beams; single entry portico with classic column supports and curved balustrade.

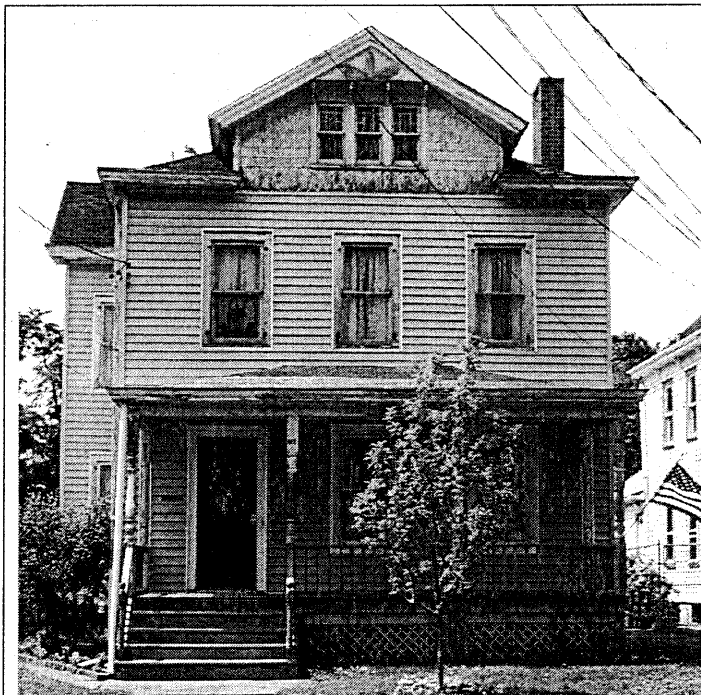
12. PHOTO:

8. BUILDING MATERIAL: a. clapboard b. stone c. brick d. board and batten
e. cobblestone ☐ f. shingles g. stucco f. other Vinyl
9. STRUCTURAL SYSTEM: (if known) a. wood frame with interlocking joints ☐
b. wood frame with light members ☐
c. masonry load bearing walls ☐
d. metal (explain)
e. other: (explain) ☐
10. CONDITION: a. excellent b. good c. fair ☒ d. deteriorated
11. INTEGRITY: a. original site ☒ b. moved ☐ if so, when?
c. list major alterations and dates (if known): Siding, new porch rails, shutters removed, porch detail removed

- a. none known b. zoning c. roads d. developers e. deterioration ☒
f. other: .

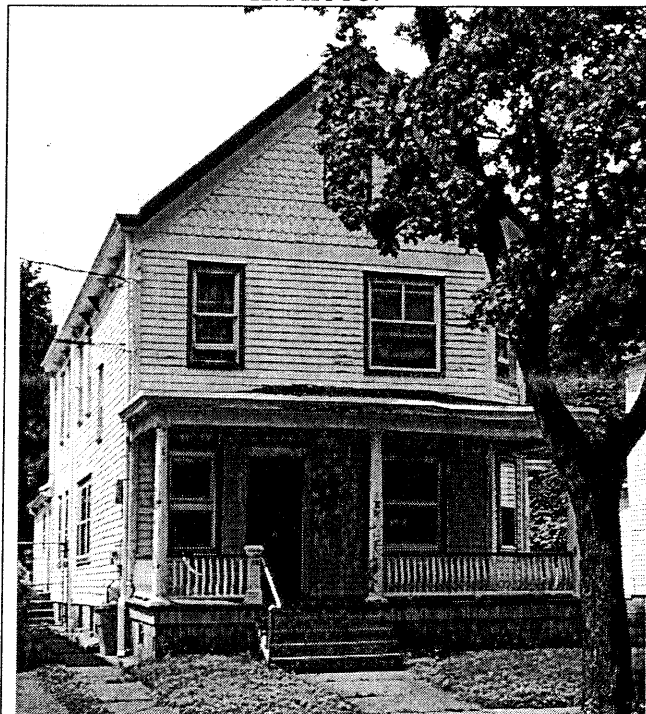
12. PHOTO:

8. BUILDING MATERIAL: a. clapboard ☒ b. stone c. brick d. board and batten
e. cobblestone f. shingles g. stucco f. other
9. STRUCTURAL SYSTEM: (if known) a. wood frame with interlocking joints ☐
b. wood frame with light members ☐
c. masonry load bearing walls ☐
d. metal (explain) ☐
e. other: (explain) ☐
10. CONIDITION: a. excellent b. good c. fair ☒ d. deteriorated
11. INTEGRITY: a. original site ☒ b. moved ☐ if so, when?
c. list major alterations and dates (if known): rail to porch steps, converted to multi family, back addition - 1980

14. THREATS TO BUILDING:
a. none known b. zoning c. roads d. developers e. deterioration ☒
f. other: Vinyl siding!
15. RELATED OUTBUILDINGS AND PROPERTY:
a. barn b. carriage house c. garage ☒ d. privy e. shed f. greenhouse g. shop h. gardens

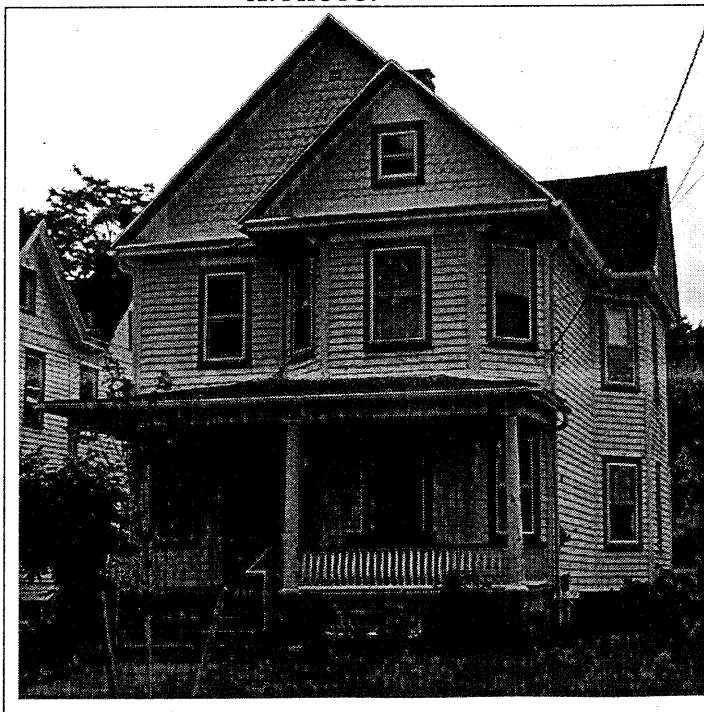
12. PHOTO:

8. BUILDING MATERIAL: a. clapboard ☒ b. stone c. brick d. board and batten
e. cobblestone f. shingles g. stucco f. other
9. STRUCTURAL SYSTEM: (if known) a. wood frame with interlocking joints ☐
b. wood frame with light members ☐
c. masonry load bearing walls ☐
d. metal (explain) ☐
e. other: (explain) ☐
10. CONDITION: a. excellent b. good c. fair ☒ d. deteriorated
11. INTEGRITY: a. original site ☒ b. moved ☐ if so, when?
c. list major alterations and dates (if known):

- a. none known b. zoning c. roads d. developers e. deterioration ☒
f. other: ..

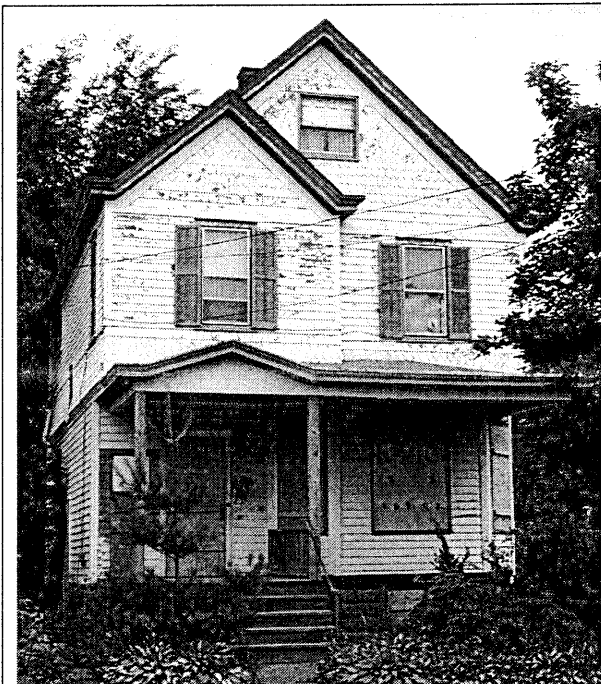
12. PHOTO:

8. BUILDING MATERIAL: a. clapboard ☒ b. stone c. brick d. board and batten
e. cobblestone f. shingles g. stucco f. other
9. STRUCTURAL SYSTEM: (if known) a. wood frame with interlocking joints ☐
b. wood frame with light members ☐
c. masonry load bearing walls ☐
d. metal (explain)
e. other: (explain) ☐
10. CONDITION: a. excellent b. good c. fair ☒ d. deteriorated
11. INTEGRITY: a. original site ☒ b. moved ☐ if so, when?
c. list major alterations and dates (if known): Porch torn down

14. THREATS TO BUILDING:
a. none known b. zoning c. roads d. developers e. deterioration ☒
f. other: House vacant
15. RELATED OUTBUILDINGS AND PROPERTY:
a. barn b. carriage house c. garage d. privy e. shed f. greenhouse g. shop h. gardens
i. landscape features: Jungle in the backyard
j. other:
16. SURROUNDINGS OF THE BUILDING (check more than one if necessary):
a. open land ☐ b. woodland ☐ c. scattered buildings ☐ d. densely built-up ☒ e. commercial ☐
f. industrial ☐ g. residential ☒ h. other:
17. INTERRELATIONSHIP OF BUILDING AND SURROUNDINGS: (Indicate if building or structure is in an historic district)
Not in an historic district
18. OTHER NOTABLE FEATURES OF BUILDING AND SITE (including interior features if known): A simple Queen Anne residence built circa 1910 with decorative fishtail shingles at gable ends and second story level course. Porch remodeled 20th century.

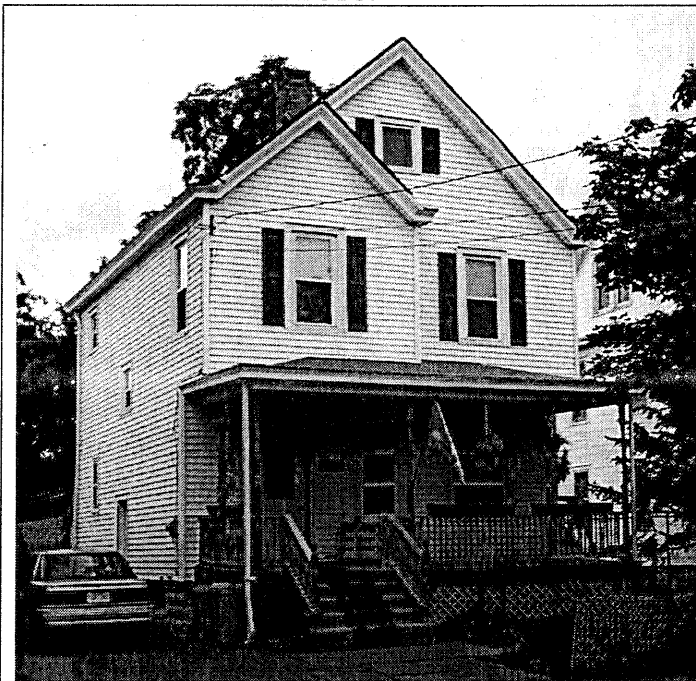
12. PHOTO:

8. BUILDING MATERIAL: a. clapboard b. stone c. brick d. board and batten
e. cobblestone ☐ f. shingles g. stucco f. other Vinyl
9. STRUCTURAL SYSTEM: (if known) a. wood frame with interlocking joints ☐
b. wood frame with light members ☐
c. masonry load bearing walls ☐
d. metal (explain) ☐
e. other: (explain) ☐
10. CONDITION: a. excellent b. good ☒ c. fair d. deteriorated
11. INTEGRITY: a. original site ☒ b. moved ☐ if so, when?
c. list major alterations and dates (if known): Siding, Front door replaced, porch rails replaced

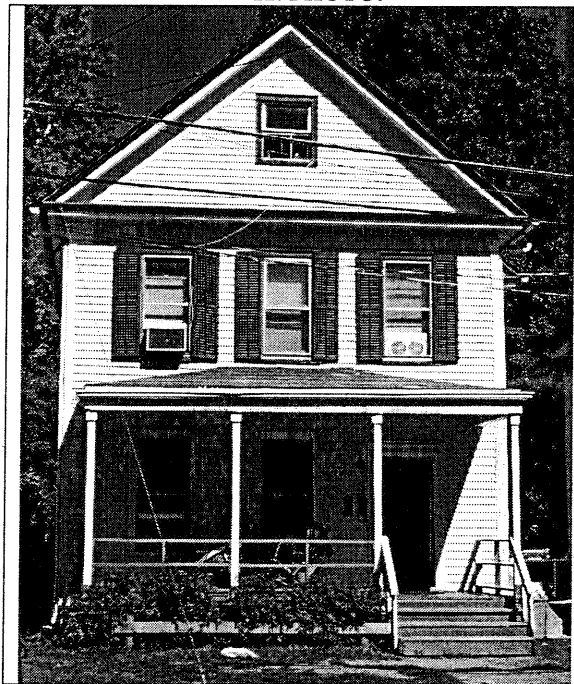
12. PHOTO:

8. BUILDING MATERIAL: a. clapboard b. stone c. brick d. board and batten
e. cobblestone ☒ f. shingles g. stucco f. other Vinyl siding
9. STRUCTURAL SYSTEM: (if known) a. wood frame with interlocking joints ☐
b. wood frame with light members ☐
c. masonry load bearing walls ☐
d. metal (explain) ☐
e. other: (explain) ☐
10. CONDITION: a. excellent b. good ☒ c. fair d. deteriorated
11. INTEGRITY: a. original site ☒ b. moved ☐ if so, when?
c. list major alterations and dates (if known): Porch replaced, vinyl siding, vinyl shutters added

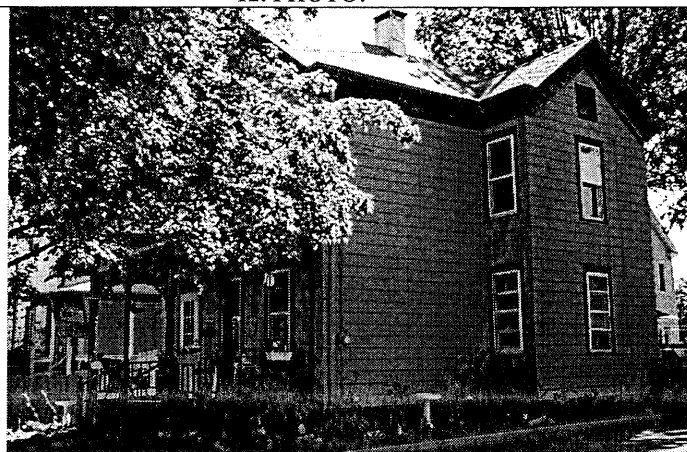
12. PHOTO:

8. BUILDING MATERIAL: a. clapboard ☐ b. stone ☐ c. brick ☐ d. board and batten ☐
e. cobblestone ☐ f. shingles ☐ g. stucco ☐ other (explain) ☒ Aluminum Siding
9. STRUCTURAL SYSTEM: (if known) a. wood frame with interlocking joints ☐
b. wood frame with light members ☐
c. masonry load bearing walls ☐
d. metal (explain) ☐
e. other: (explain) ☐
10. CONDITION: a. excellent ☐ b. good ☒ c. fair ☐ d. deteriorated ☐
11. INTEGRITY: a. original site ☒ b. moved ☐ if so, when?
c. list major alterations and dates (if known): Aluminum siding (c. 1960). porch siding is T1-11. porch rails have been replaced

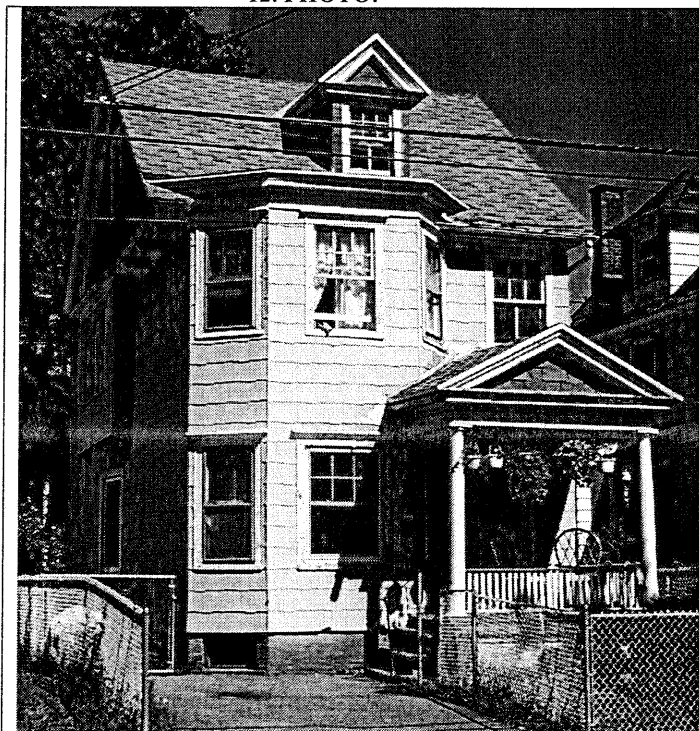
12. PHOTO:

- a. excellent b. good c. fair ☒ d. deteriorated

- a. original site ☒ b. moved ☐ if so, when?
c. list major alterations and dates (if known): Rebuilt front porch

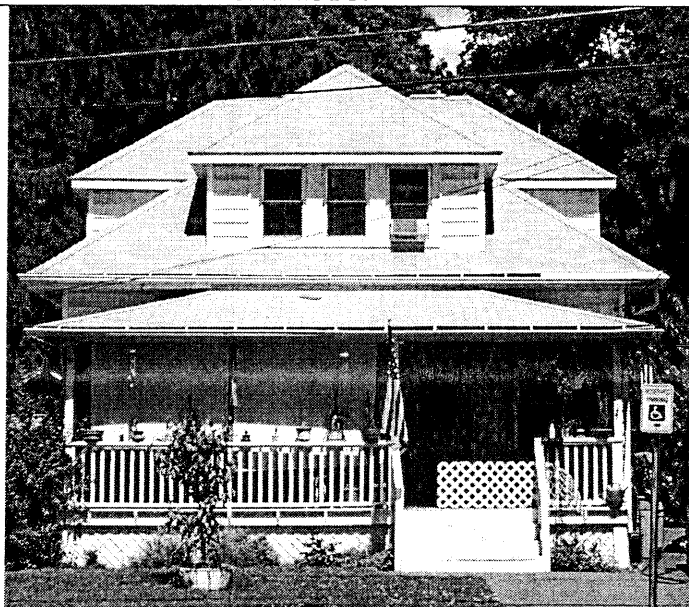
12. PHOTO:

8. BUILDING MATERIAL: a. clapboard b. stone c. brick d. board and batten
e. cobblestone f. shingles g. stucco f. other Aluminum Siding
9. STRUCTURAL SYSTEM: (if known) a. wood frame with interlocking joints ☐
b. wood frame with light members ☐
c. masonry load bearing walls ☐
d. metal (explain) ☐
e. other: (explain) ☐
10. CONIDITION: a. excellent b. good ☒ c. fair d. deteriorated
11. INTEGRITY: a. original site ☒ b. moved ☐ if so, when?
c. list major alterations and dates (if known): Replacement windows, porch rails, front step rails, porch pillars

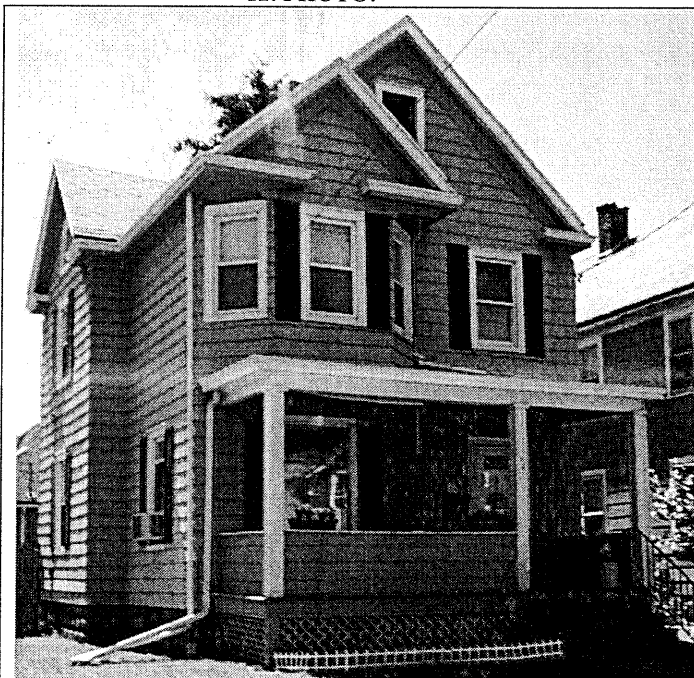
12. PHOTO:

8. BUILDING MATERIAL:
a. clapboard b. stone c. brick d. board and batten
e. cobblestone f. shingles ☒ g. stucco a. clapboard b. stone c. brick
d. board and batten e. cobblestone f. shingles g. stucco f. other
9. STRUCTURAL SYSTEM: (if known)
a. wood frame with interlocking joints ☐
b. wood frame with light members ☐
c. masonry load bearing walls ☐
d. metal (explain) ☐
e. other: (explain) ☐
10. CONDITION: a. excellent b. good ☒ c. fair d. deteriorated
11. INTEGRITY: a. original site ☒ b. moved ☐ if so, when?
c. list major alterations and dates (if known): Vinyl shutters, front step rails replaced, new front door, new windows (except front, 1st floor)

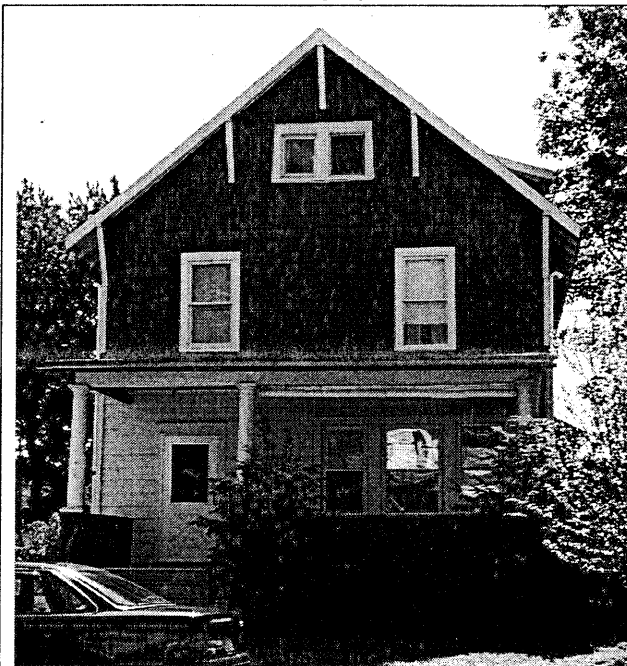
12. PHOTO:

8. BUILDING MATERIAL: a. clapboard ☒ b. stone c. brick d. board and batten
e. cobblestone f. shingles g. stucco f. other Shingles
9. STRUCTURAL SYSTEM: (if known) a. wood frame with interlocking joints ☐
b. wood frame with light members ☐
c. masonry load bearing walls ☐
d. metal (explain) ☐
e. other: (explain) ☐
10. CONDITION: a. excellent b. good ☒ c. fair d. deteriorated
11. INTEGRITY: a. original site ☒ b. moved ☐ if so, when?
c. list major alterations and dates (if known): Shed/garage addition in back, 1952, replacement windows, step railings

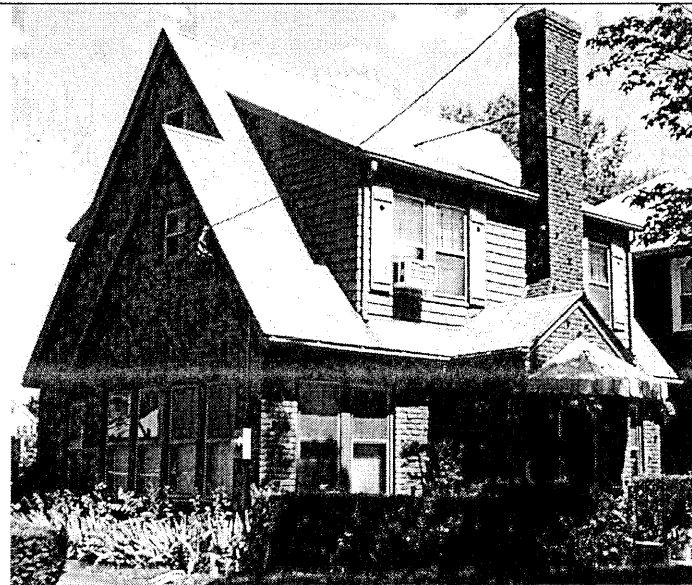
12. PHOTO:

8. BUILDING MATERIAL: a. clapboard b. stone c. brick ☒ d. board and batten
e. cobblestone f. shingles g. stucco h. other
9. STRUCTURAL SYSTEM: (if known) a. wood frame with interlocking joints ☐
b. wood frame with light members ☐
c. masonry load bearing walls ☐
d. metal (explain) ☐
e. other: (explain) ☐
10. CONDITION: a. excellent b. good ☒ c. fair d. deteriorated
11. INTEGRITY: a. original site ☒ b. moved ☐ if so, when?
c. list major alterations and dates (if known): aluminum awning

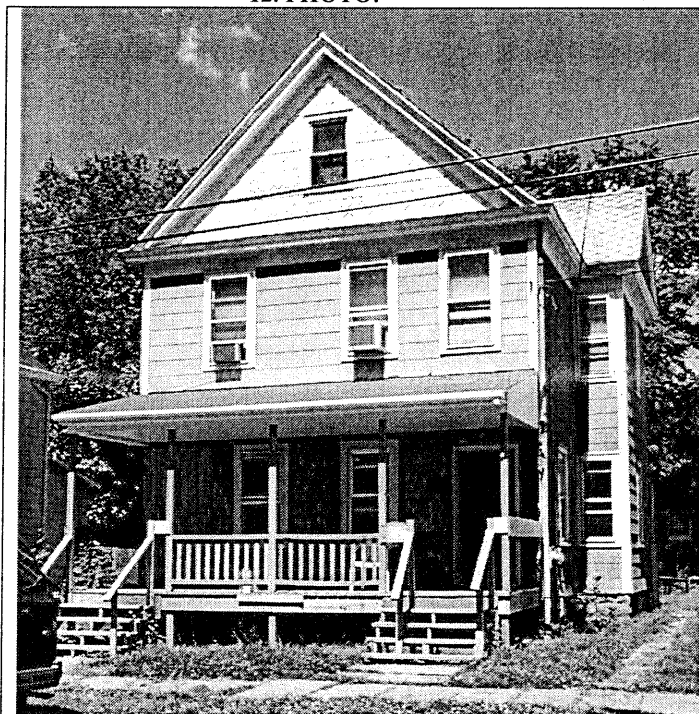
12. PHOTO:

8. BUILDING MATERIAL: a. clapboard b. stone c. brick d. board and batten
e. cobblestone f. shingles g. stucco f. other renovation in progress - vinyl?
9. STRUCTURAL SYSTEM: (if known) a. wood frame with interlocking joints ☒
b. wood frame with light members ☐
c. masonry load bearing walls ☐
d. metal (explain)
e. other: (explain) ☐
10. CONDITION: a. excellent b. good c. fair ☒ d. deteriorated
11. INTEGRITY: a. original site ☒ b. moved ☐ if so, when?
c. list major alterations and dates (if known): Porch rebuilt, replacement windows

f. other: Renovation

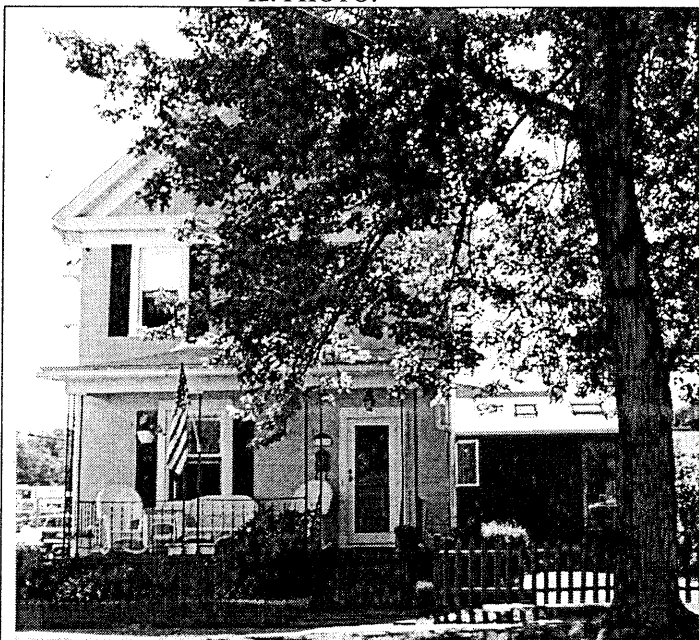
12. PHOTO:

8. BUILDING MATERIAL: a. clapboard b. stone c. brick d. board and batten
e. cobblestone f. shingles ☒ g. stucco a. clapboard b. stone c. brick
d. board and batten e. cobblestone f. shingles g. stucco f. other
9. STRUCTURAL SYSTEM: (if known) a. wood frame with interlocking joints ☐
b. wood frame with light members ☐
c. masonry load bearing walls ☐
d. metal (explain) ☐
e. other: (explain) ☐
10. CONDITION: a. excellent b. good ☒ c. fair d. deteriorated
11. INTEGRITY: a. original site ☒ b. moved ☐ if so, when?
c. list major alterations and dates (if known): additional attached room - 1987, concrete block porch, wrapped soffit - vinyl, fake wrought iron porch rails, attached concrete garage - 1987

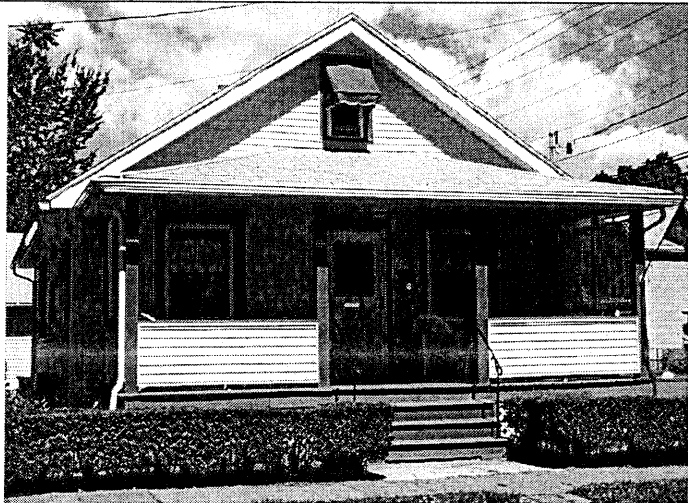
12. PHOTO:

8. BUILDING MATERIAL: a. clapboard b. stone c. brick d. board and batten
e. cobblestone ☒ f. shingles g. stucco f. other Vinyl
9. STRUCTURAL SYSTEM: (if known) a. wood frame with interlocking joints ☐
b. wood frame with light members ☐
c. masonry load bearing walls ☐
d. metal (explain) ☐
e. other: (explain) ☐
10. CONDITION: a. excellent b. good ☒ c. fair d. deteriorated
11. INTEGRITY: a. original site ☒ b. moved ☐ if so, when?
c. list major alterations and dates (if known): Vinyl siding, porch rails replaced, porch column replaced, replacement windows, covered soffits, windows not sized correctly, new roof - 1998

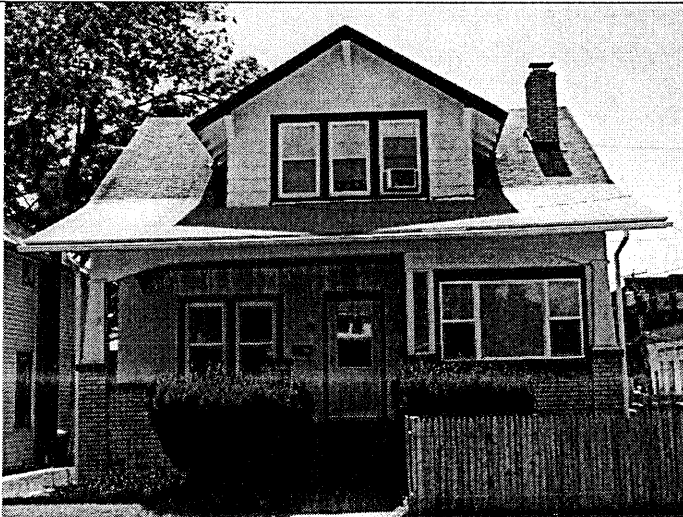
12. PHOTO:

8. BUILDING MATERIAL: a. clapboard b. stone c. brick d. board and batten
e. cobblestone ☒ f. shingles g. stucco f. other Aluminum
9. STRUCTURAL SYSTEM: (if known) a. wood frame with interlocking joints ☐
b. wood frame with light members ☐
c. masonry load bearing walls ☐
d. metal (explain) ☐
e. other: (explain) ☐
10. CONDITION: a. excellent b. good ☒ c. fair d. deteriorated
11. INTEGRITY: a. original site ☒ b. moved ☐ if so, when?
c. list major alterations and dates (if known): replacement windows, brick facing on porch

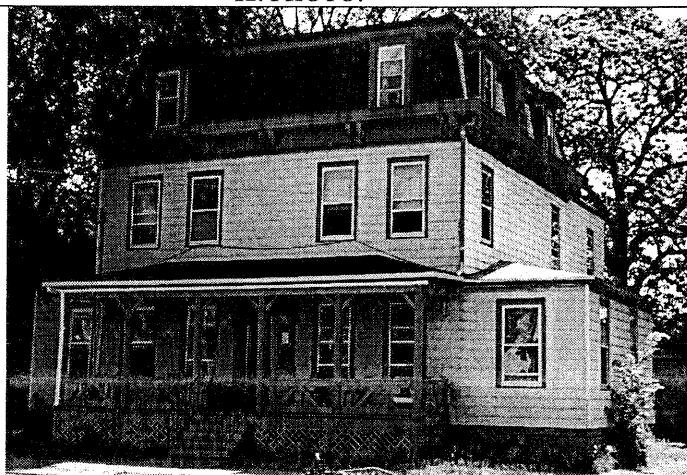
12. PHOTO:

8. BUILDING MATERIAL: a. clapboard b. stone c. brick d. board and batten
e. cobblestone ☒ f. shingles g. stucco f. other Aluminum
9. STRUCTURAL SYSTEM: (if known) a. wood frame with interlocking joints ☐
b. wood frame with light members ☐
c. masonry load bearing walls ☐
d. metal (explain) ☐
e. other: (explain) ☐
10. CONDITION: a. excellent b. good ☒ c. fair d. deteriorated
11. INTEGRITY: a. original site ☒ b. moved ☐ if so, when?
c. list major alterations and dates (if known): Some replacement windows, rebuilt porch, addition to side?

- a. none known b. zoning c. roads d. developers e. deterioration ☒
f. other: _____
