**INTENSIVE LEVEL
MIDTOWN EAST SURVEY
City of Kingston**

Intensive Level Building Survey of the Midtown East Study Area
City of Kingston, Ulster County, New York

Survey Methodology Statement

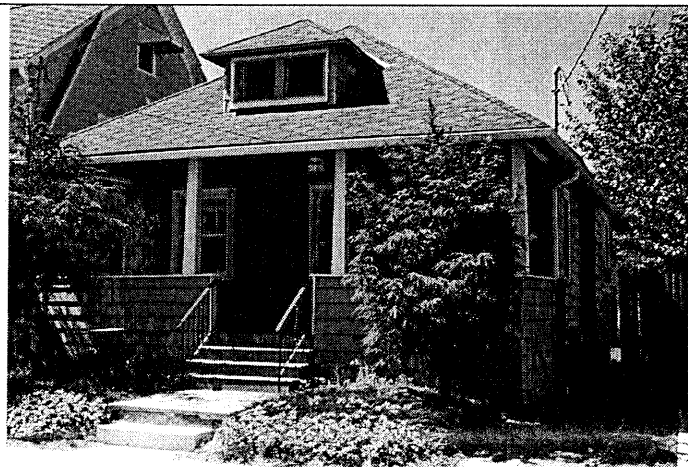
12. PHOTO:

8. BUILDING MATERIAL:
 - a. clapboard ☐ b. stone ☐ c. brick ☐ d. board and batten ☐
 - e. cobblestone ☐ f. shingles ☒ g. stucco ☐ other (explain) ☐
9. STRUCTURAL SYSTEM: (if known)
 - a. wood frame with interlocking joints ☒
 - b. wood frame with light members ☐
 - c. masonry load bearing walls ☐
 - d. metal (explain) ☐
 - e. other: (explain) ☐
10. CONDITION:
 - a. excellent ☐ b. good ☒ c. fair ☐ d. deteriorated ☐
11. INTEGRITY:
 - a. original site ☒ b. moved ☐ if so, when?
 - c. list major alterations and dates (if known): front step rails

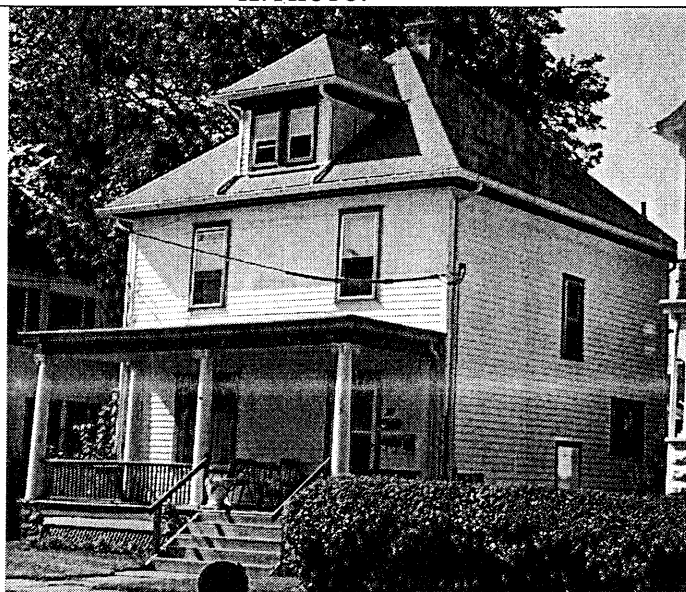
12. PHOTO:

8. BUILDING MATERIAL: a. clapboard ☒ b. stone c. brick d. board and batten
e. cobblestone f. shingles g. stucco f. other
9. STRUCTURAL SYSTEM: (if known) a. wood frame with interlocking joints ☐
b. wood frame with light members ☐
c. masonry load bearing walls ☐
d. metal (explain) ☐
e. other: (explain) ☐
10. CONDITION: a. excellent b. good ☒ c. fair d. deteriorated
11. INTEGRITY: a. original site ☒ b. moved ☐ if so, when?
c. list major alterations and dates (if known): Porch steps rebuilt, some vinyl windows

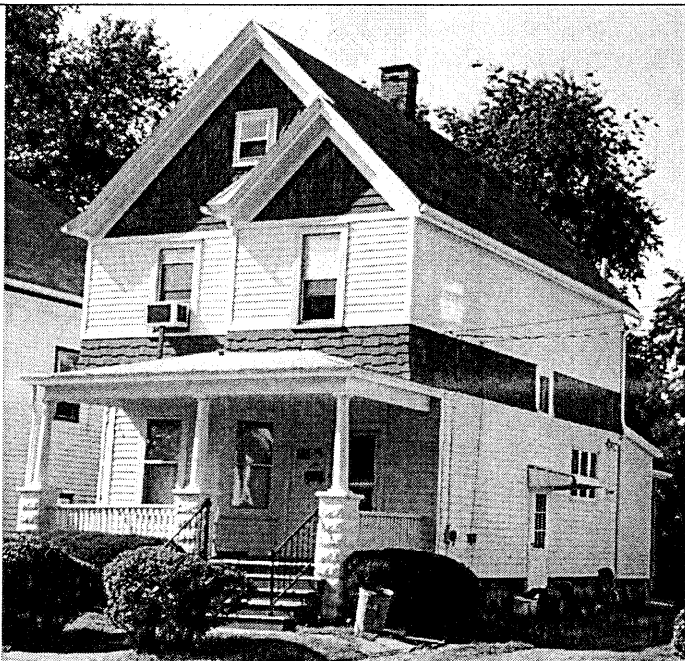
12. PHOTO:

8. BUILDING MATERIAL: a. clapboard ☒ b. stone c. brick d. board and batten
e. cobblestone f. shingles g. stucco f. other
9. STRUCTURAL SYSTEM: (if known) a. wood frame with interlocking joints ☐
b. wood frame with light members ☐
c. masonry load bearing walls ☐
d. metal (explain)
e. other: (explain) ☐
10. CONDITION: a. excellent b. good ☒ c. fair d. deteriorated
11. INTEGRITY: a. original site ☒ b. moved ☐ if so, when?
c. list major alterations and dates (if known): Replacement windows, porch steps, addition in back

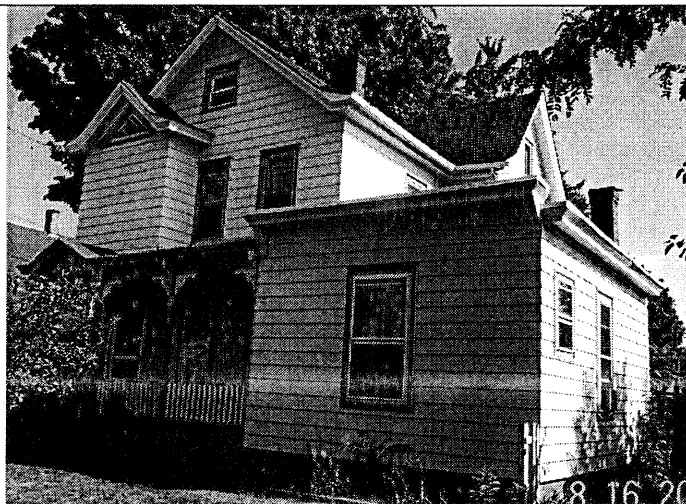
12. PHOTO:

88. BUILDING MATERIAL: a. clapboard ☐ b. stone c. brick d. board and batten
e. cobblestone f. shingles g. stucco f. other aluminum
9. STRUCTURAL SYSTEM: (if known) a. wood frame with interlocking joints ☐
b. wood frame with light members ☐
c. masonry load bearing walls ☐
d. metal (explain)
e. other: (explain) ☐
10. CONDITION: a. excellent b. good c. fair ☒ d. deteriorated
11. INTEGRITY: a. original site ☒ b. moved ☐ if so, when?
c. list major alterations and dates (if known): Addition to side

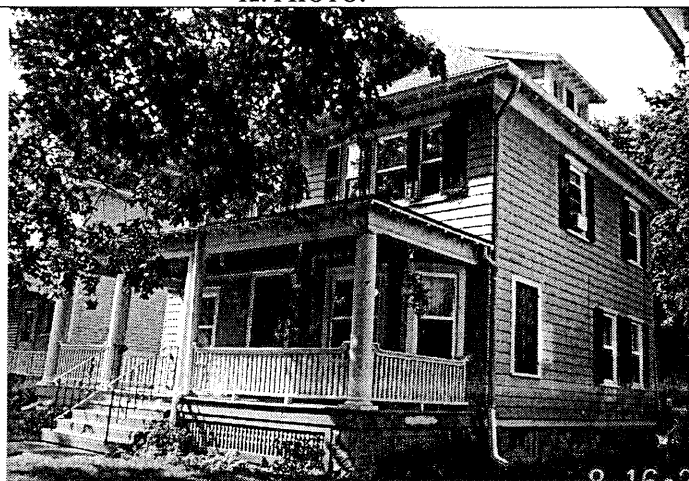
12. PHOTO:

8. BUILDING MATERIAL: a. clapboard ☒ b. stone c. brick d. board and batten
e. cobblestone f. shingles g. stucco f. other
9. STRUCTURAL SYSTEM: (if known) a. wood frame with interlocking joints ☐
b. wood frame with light members ☐
c. masonry load bearing walls ☐
d. metal (explain) ☐
e. other: (explain) ☐
10. CONDITION: a. excellent b. good ☒ c. fair d. deteriorated
11. INTEGRITY: a. original site ☒ b. moved ☐ if so, when?
c. list major alterations and dates (if known): Replacement windows

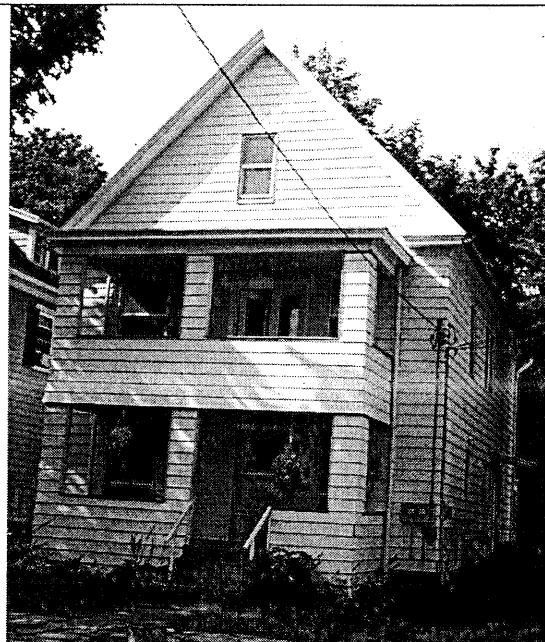
12. PHOTO:

8. BUILDING MATERIAL: a. clapboard ☐ b. stone c. brick d. board and batten
e. cobblestone f. shingles g. stucco f f. other Aluminum siding
9. STRUCTURAL SYSTEM: (if known) a. wood frame with interlocking joints ☐
b. wood frame with light members ☐
c. masonry load bearing walls ☐
d. metal (explain)
e. other: (explain) ☐
10. CONDITION: a. excellent b. good ☒ c. fair d. deteriorated
11. INTEGRITY: a. original site ☒ b. moved ☐ if so, when?
c. list major alterations and dates (if known): 2 story porch

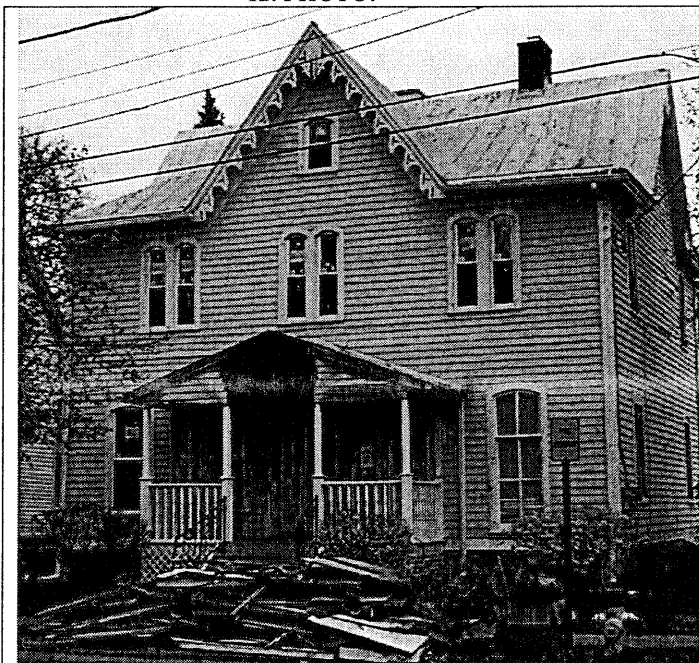
12. PHOTO:

8. BUILDING MATERIAL: a. clapboard ☒ b. stone c. brick d. board and batten
e. cobblestone f. shingles g. stucco f. other
9. STRUCTURAL SYSTEM: (if known) a. wood frame with interlocking joints ☐
b. wood frame with light members ☐
c. masonry load bearing walls ☐
d. metal (explain) ☐
e. other: (explain) ☐
10. CONIDITION: a. excellent b. good c. fair d. deteriorated
11. INTEGRITY: a. original site ☒ b. moved ☐ if so, when?
c. list major alterations and dates (if known): Fire damage, addition in back

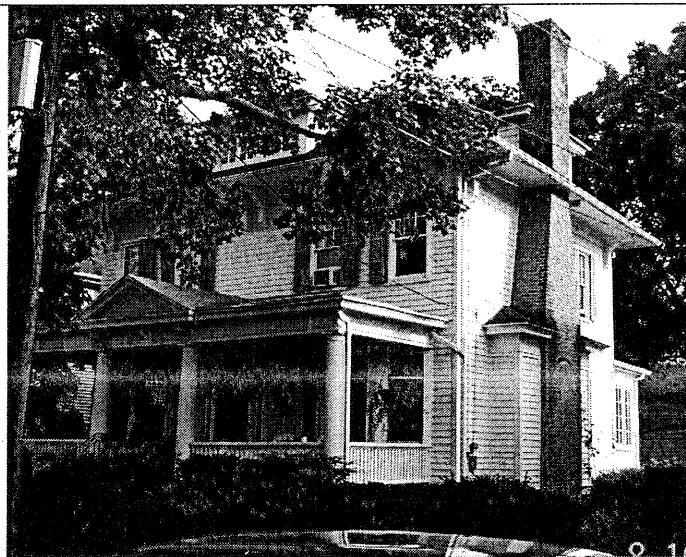
12. PHOTO:

8. BUILDING MATERIAL: a. clapboard ☒ b. stone c. brick d. board and batten
e. cobblestone f. shingles g. stucco f. other
9. STRUCTURAL SYSTEM: (if known) a. wood frame with interlocking joints ☐
b. wood frame with light members ☐
c. masonry load bearing walls ☐
d. metal (explain) ☐
e. other: (explain) ☐
10. CONDITION: a. excellent b. good ☒ c. fair d. deteriorated
11. INTEGRITY: a. original site ☒ b. moved ☐ if so, when?
c. list major alterations and dates (if known):

- a. barn b. carriage house c. garage ☒ d. privy e. shed f. greenhouse g. shop h. gardens
i. landscape features:
j. other: garage & shed in poor condition

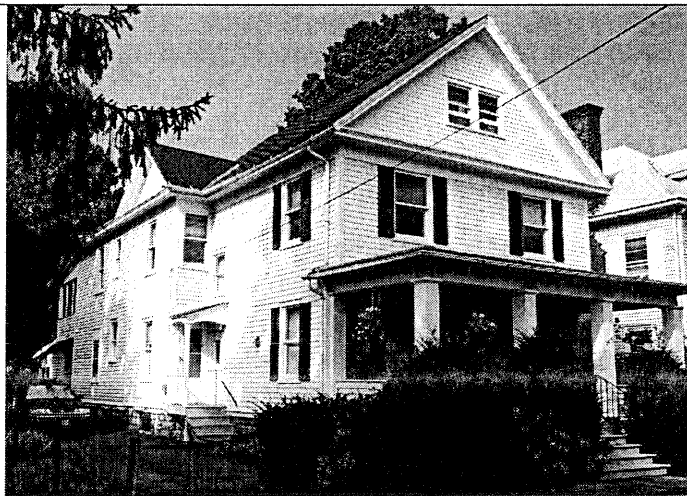
12. PHOTO:

8. BUILDING MATERIAL: a. clapboard ☒ b. stone c. brick d. board and batten
e. cobblestone f. shingles g. stucco f. other
9. STRUCTURAL SYSTEM: (if known) a. wood frame with interlocking joints ☐
b. wood frame with light members ☐
c. masonry load bearing walls ☐
d. metal (explain) ☐
e. other: (explain) ☐
10. CONDITION: a. excellent b. good ☒ c. fair d. deteriorated
11. INTEGRITY: a. original site ☒ b. moved ☐ if so, when?
c. list major alterations and dates (if known): Addition to back

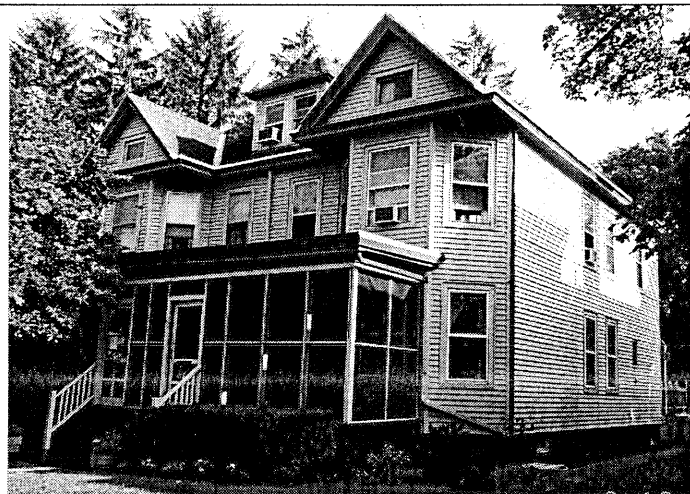
12. PHOTO:

8. BUILDING MATERIAL: a. clapboard ☒ b. stone c. brick d. board and batten
e. cobblestone f. shingles g. stucco f. other Aluminum
9. STRUCTURAL SYSTEM: (if known) a. wood frame with interlocking joints ☐
b. wood frame with light members ☐
c. masonry load bearing walls ☐
d. metal (explain)
e. other: (explain) ☐
10. CONDITION: a. excellent b. good ☒ c. fair d. deteriorated
11. INTEGRITY: a. original site ☒ b. moved ☐ if so, when?
c. list major alterations and dates (if known): Aluminum siding, porch replaced, new porch in back

18. OTHER NOTABLE FEATURES OF BUILDING AND SITE (including interior features if known): A modest Victorian wooden double house built circa 1900, with hipped roof and pair of pedimented gables flanking a central hipped attic dormer. Replacement one story full width porch obscures original detailing of entryway.**SIGNIFICANCE**19. DATE OF INITIAL CONSTRUCTION: Circa 1900

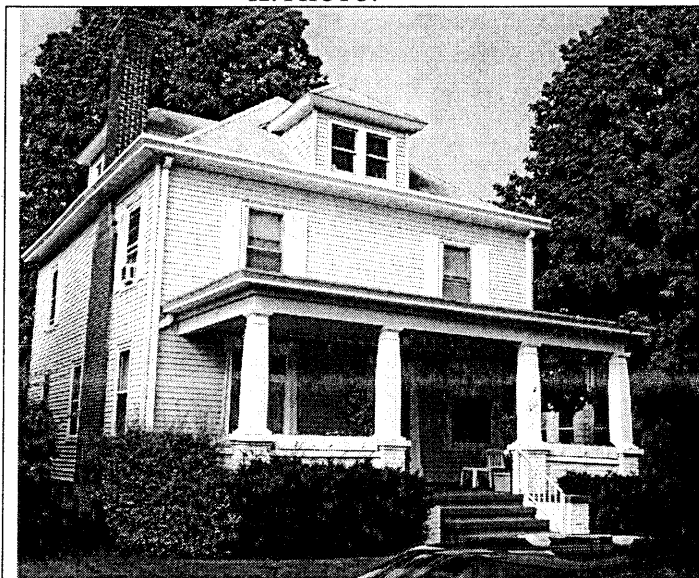
12. PHOTO:

8. BUILDING MATERIAL: a. clapboard b. stone c. brick d. board and batten
e. cobblestone f. shingles g. stucco f. other Aluminum
9. STRUCTURAL SYSTEM: (if known) a. wood frame with interlocking joints ☐
b. wood frame with light members ☐
c. masonry load bearing walls ☐
d. metal (explain) ☐
e. other: (explain) ☐
10. CONDITION: a. excellent b. good ☒ c. fair d. deteriorated
11. INTEGRITY: a. original site ☒ b. moved ☐ if so, when?
c. list major alterations and dates (if known): Aluminum Siding

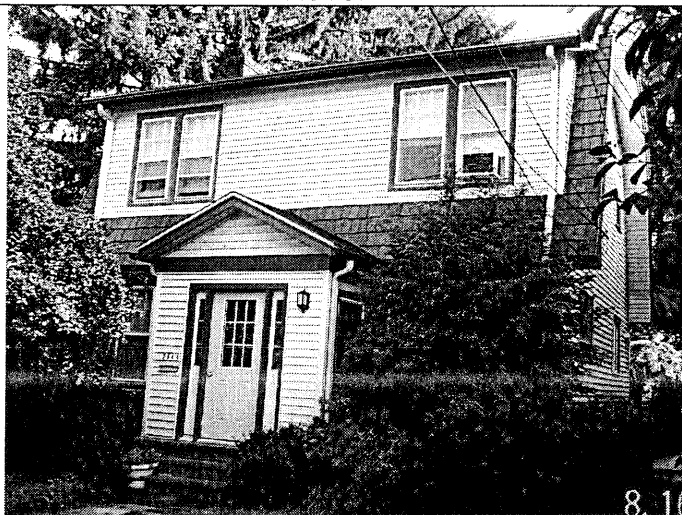
12. PHOTO:

8. BUILDING MATERIAL: f. other Vinyl
9. STRUCTURAL SYSTEM: (if known)
 - a. wood frame with interlocking joints ☒
 - b. wood frame with light members ☐
 - c. masonry load bearing walls ☐
 - d. metal (explain)
 - e. other: (explain) ☐
10. CONDITION: a. excellent b. good ☒ c. fair d. deteriorated
11. INTEGRITY: a. original site ☒ b. moved ☐ if so, when?
c. list major alterations and dates (if known): Entrance way, vinyl siding, addition to back, office building in back

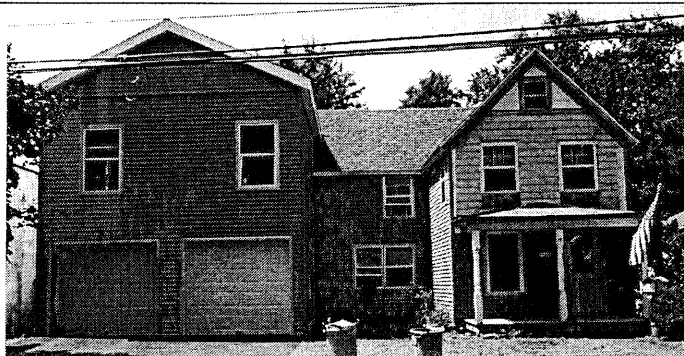
12. PHOTO:

8. BUILDING MATERIAL: a. clapboard b. stone c. brick d. board and batten
e. cobblestone f. shingles g. stucco f. other Vinyl
9. STRUCTURAL SYSTEM: (if known) a. wood frame with interlocking joints ☐
b. wood frame with light members ☐
c. masonry load bearing walls ☐
d. metal (explain) ☐
e. other: (explain) ☐
10. CONDITION: a. excellent b. good c. fair ☒ d. deteriorated
11. INTEGRITY: a. original site ☒ b. moved ☐ if so, when?
c. list major alterations and dates (if known): Siding, replacement widows

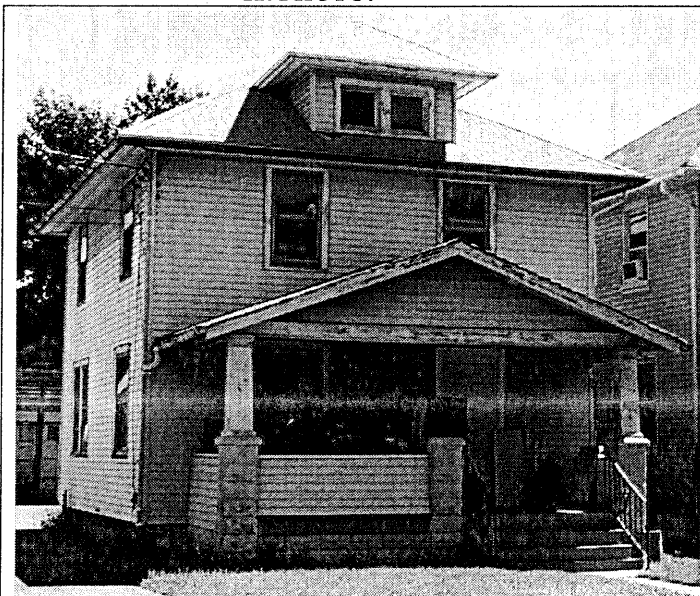
12. PHOTO:

8. BUILDING MATERIAL: a. clapboard ☐ b. stone ☐ c. brick ☐ d. board and batten ☐
e. cobblestone ☐ f. shingles ☐ g. stucco ☐ other (explain) ☒ vinyl
9. STRUCTURAL SYSTEM: (if known) a. wood frame with interlocking joints ☒
b. wood frame with light members ☐
c. masonry load bearing walls ☐
d. metal (explain) ☐
e. other: (explain) ☐
10. CONDITION: a. excellent ☐ b. good ☐ c. fair ☐ d. deteriorated ☐
11. INTEGRITY: a. original site ☒ b. moved ☐ if so, when?
c. list major alterations and dates (if known): vinyl siding, front door replaced, porch railings replaced with vinyl siding

14. THREATS TO BUILDING: a. none known ☐ b. zoning ☐ c. roads ☐
 d. developers ☐ e. deterioration ☒
 f. other:
15. RELATED OUTBUILDINGS AND PROPERTY:
 a. barn ☐ b. carriage house ☐ c. garage ☒ 2 car. clabord deteriorating
 d. privy ☐ e. shed ☐ f. greenhouse ☐
 g. shop ☐ h. gardens ☐
 i. landscape features:
 j. other:
16. SURROUNDINGS OF THE BUILDING (check more than one if necessary):
 a. open land ☐ b. woodland ☐
 c. scattered buildings ☐
 d. densely built-up ☒ e. commercial ☐
 f. industrial ☐ g. residential ☒ h. other:

18. OTHER NOTABLE FEATURES OF BUILDING AND SITE (including interior features if known): A 'four square' hipped roof with double window attic dormers; residence built circa 1919. Front gable porch with solid poured concrete supports. Replacement doors and windows.

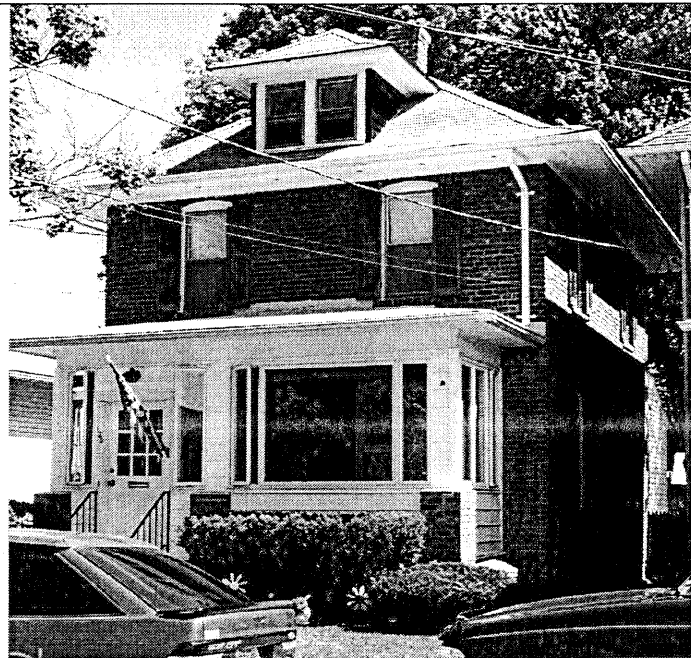
12. PHOTO:

8. BUILDING MATERIAL: a. clapboard ☐ b. stone ☐ c. brick ☒ d. board and batten ☐
e. cobblestone ☐ f. shingles ☐ g. stucco ☐ other (explain) ☐
9. STRUCTURAL SYSTEM: (if known) a. wood frame with interlocking joints ☐
b. wood frame with light members ☐
c. masonry load bearing walls ☐
d. metal (explain) ☐
e. other: (explain) ☐
10. CONDITION: a. excellent ☐ b. good ☐ c. fair ☐ d. deteriorated ☐
11. INTEGRITY: a. original site ☒ b. moved ☐ if so, when?
c. list major alterations and dates (if known): enclosed front porch

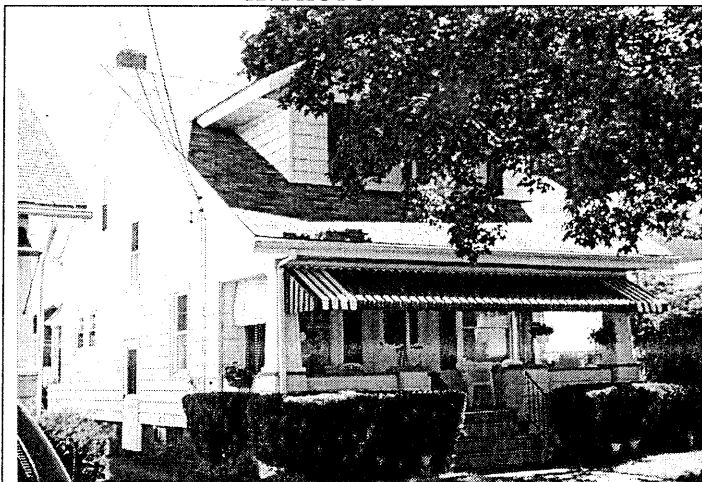
12. PHOTO:

8. BUILDING MATERIAL: a. clapboard b. stone c. brick d. board and batten
e. cobblestone f. shingles g. stucco h. other Aluminum
9. STRUCTURAL SYSTEM: (if known) a. wood frame with interlocking joints ☒
b. wood frame with light members ☐
c. masonry load bearing walls ☐
d. metal (explain) ☐
e. other: (explain) ☐
10. CONDITION: a. excellent b. good ☒ c. fair d. deteriorated
11. INTEGRITY: a. original site ☒ b. moved ☐ if so, when?
c. list major alterations and dates (if known): Aluminum siding & awnings, vinyl shutters, soffits covered w/aluminum, porch railings replaced

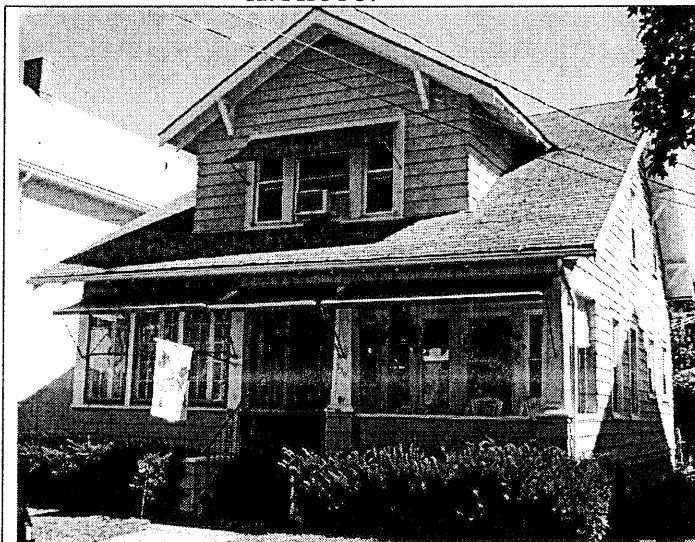
12. PHOTO:

8. BUILDING MATERIAL: a. clapboard b. stone c. brick d. board and batten
e. cobblestone f. shingles g. stucco f. other Aluminum
9. STRUCTURAL SYSTEM: (if known) a. wood frame with interlocking joints ☒
b. wood frame with light members ☐
c. masonry load bearing walls ☐
d. metal (explain) ☐
e. other: (explain) ☐
10. CONIDITION: a. excellent b. good ☒ c. fair d. deteriorated
11. INTEGRITY: a. original site ☒ b. moved ☐ if so, when?
c. list major alterations and dates (if known): Vinyl replacement windows, vinyl awnings, porch enclosed

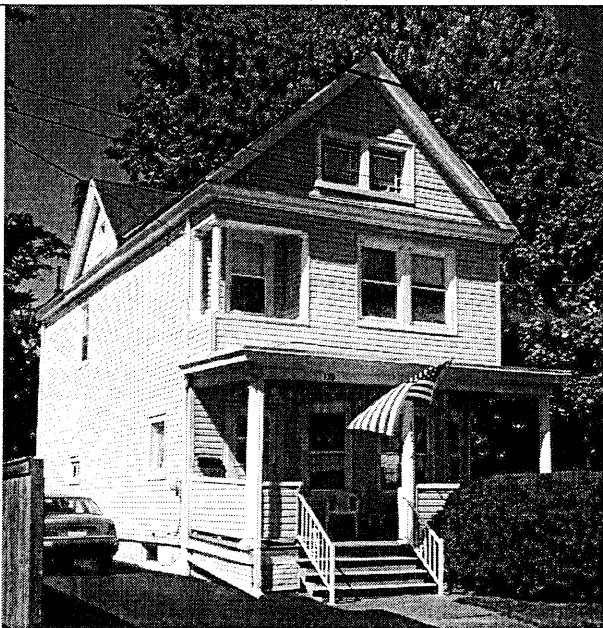
12. PHOTO:

8. BUILDING MATERIAL: a. clapboard b. stone c. brick d. board and batten
e. cobblestone f. shingles g. stucco f. other Vinyl Siding
9. STRUCTURAL SYSTEM: (if known) a. wood frame with interlocking joints ☒
b. wood frame with light members ☐
c. masonry load bearing walls ☐
d. metal (explain) ☐
e. other: (explain) ☐
10. CONIDITION: a. excellent b. good ☒ c. fair d. deteriorated
11. INTEGRITY: a. original site ☒ b. moved ☐ if so, when?
c. list major alterations and dates (if known): Vinyl replacement windows, porch rails sided, iron rails, Owner proud of the vinyl & replacement windows but also proud that she kept the stain glass window at the side of the house

18. OTHER NOTABLE FEATURES OF BUILDING AND SITE (including interior features if known): A two and one half story Queen Anne style residence with replacement vinyl siding and windows; a cross gabled roof with paired attic Queen Anne pane of colored glass surrounding clear square pane; replacemtn porch and rails.

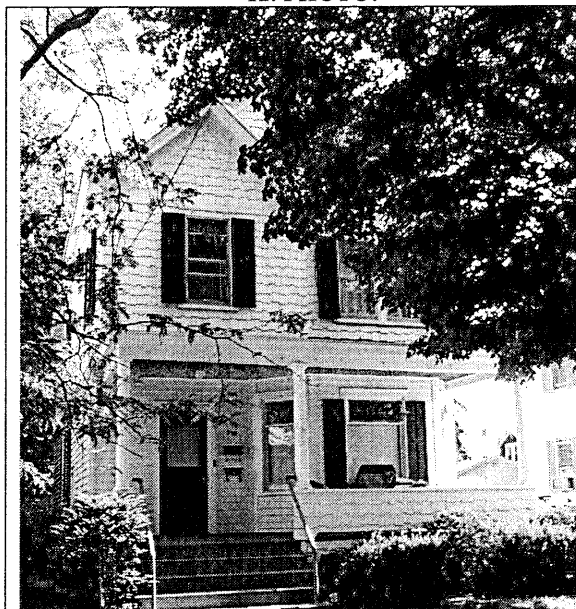
12. PHOTO:

8. BUILDING MATERIAL: a. clapboard ☒ b. stone c. brick d. board and batten
e. cobblestone f. shingles g. stucco f. other & shingles
9. STRUCTURAL SYSTEM: (if known) a. wood frame with interlocking joints ☐
b. wood frame with light members ☐
c. masonry load bearing walls ☐
d. metal (explain) ☐
e. other: (explain) ☐
10. CONIDITION: a. excellent b. good ☒ c. fair d. deteriorated
11. INTEGRITY: a. original site ☒ b. moved ☐ if so, when?
c. list major alterations and dates (if known): 2nd Floor sun room & deck, replacement attic window

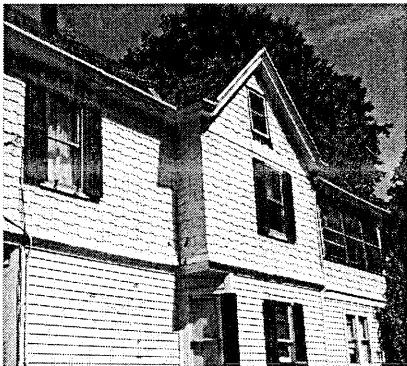
Sunroom addition in back 2nd floor

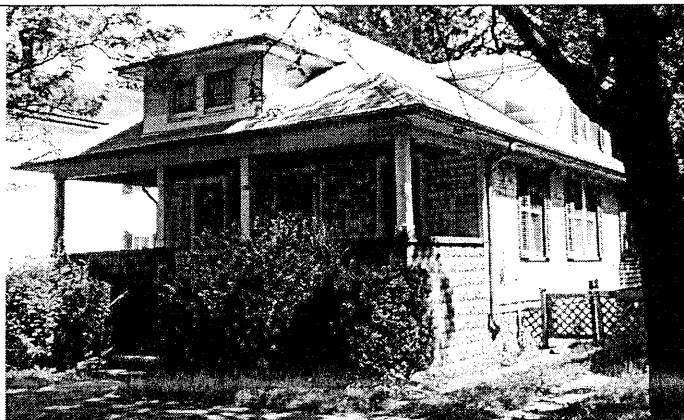
12. PHOTO:

8. BUILDING MATERIAL: a. clapboard ☒ b. stone c. brick d. board and batten
e. cobblestone f. shingles g. stucco f. other
9. STRUCTURAL SYSTEM: (if known) a. wood frame with interlocking joints ☐
b. wood frame with light members ☐
c. masonry load bearing walls ☐
d. metal (explain) ☐
e. other: (explain) ☐
10. CONIDITION: a. excellent b. good c. fair ☒ d. deteriorated
11. INTEGRITY: a. original site ☒ b. moved ☐ if so, when?
c. list major alterations and dates (if known): Cement porch, dormers (?) front step railings in fake wrought iron

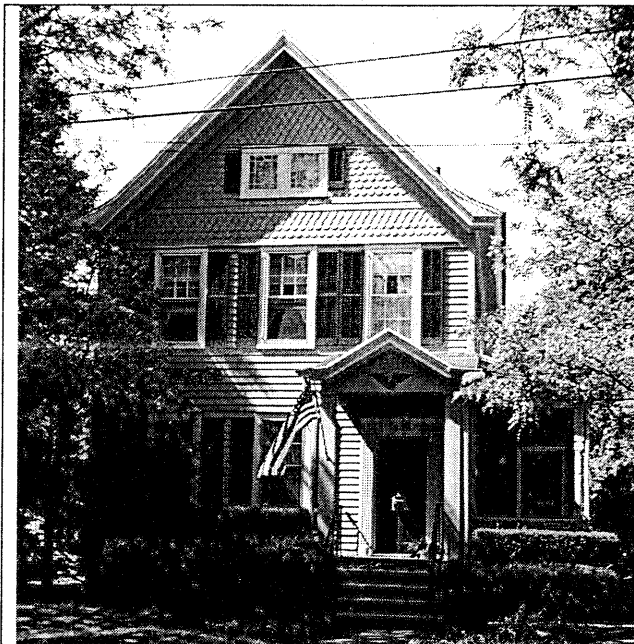
12. PHOTO:

8. BUILDING MATERIAL: a. clapboard ☒ b. stone c. brick d. board and batten
e. cobblestone f. shingles g. stucco f. other
9. STRUCTURAL SYSTEM: (if known) a. wood frame with interlocking joints ☐
b. wood frame with light members ☐
c. masonry load bearing walls ☐
d. metal (explain) ☐
e. other: (explain) ☐
10. CONDITION: a. excellent b. good ☒ c. fair d. deteriorated
11. INTEGRITY: a. original site ☒ b. moved ☐ if so, when?
c. list major alterations and dates (if known): Addition to side porch circa 1972, addition to back, rebuilt stone front steps (well done)

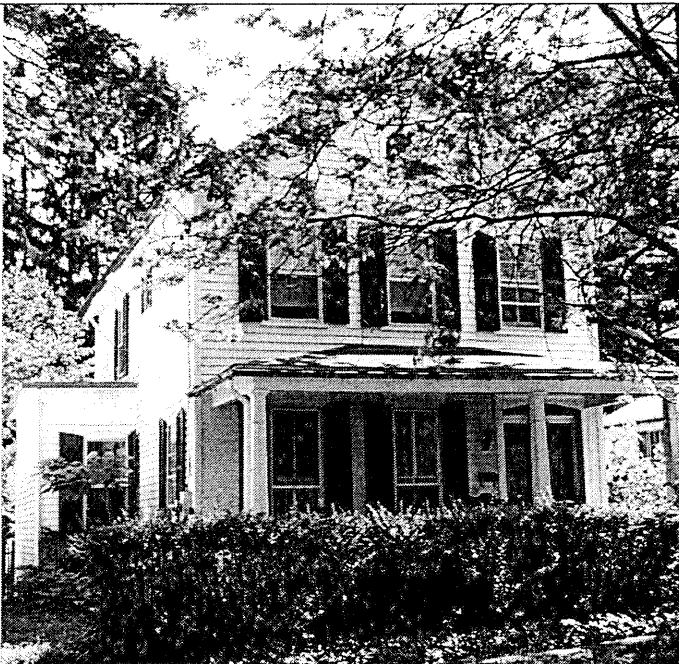
12. PHOTO:

8. BUILDING MATERIAL: a. clapboard ☒ b. stone c. brick d. board and batten
e. cobblestone f. shingles g. stucco f. other
9. STRUCTURAL SYSTEM: (if known) a. wood frame with interlocking joints ☐
b. wood frame with light members ☐
c. masonry load bearing walls ☐
d. metal (explain) ☐
e. other: (explain) ☐
10. CONIDITION: a. excellent b. good ☒ c. fair d. deteriorated
11. INTEGRITY: a. original site ☒ b. moved ☐ if so, when?
c. list major alterations and dates (if known): Additional room to side

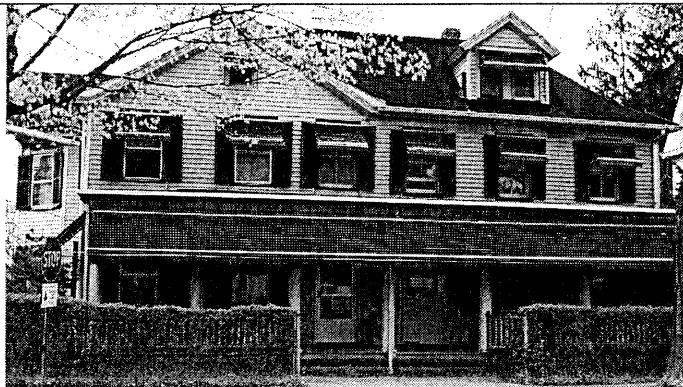
12. PHOTO:

8. BUILDING MATERIAL: a. clapboard b. stone c. brick d. board and batten
e. cobblestone f. shingles g. stucco f. other Vinyl
9. STRUCTURAL SYSTEM: (if known) a. wood frame with interlocking joints ☐
b. wood frame with light members ☐
c. masonry load bearing walls ☐
d. metal (explain) ☐
e. other: (explain) ☐
10. CONDITION: a. excellent b. good c. fair ☒ d. deteriorated
11. INTEGRITY: a. original site ☒ b. moved ☐ if so, when?
c. list major alterations and dates (if known): Aluminum awnings, chain link fence

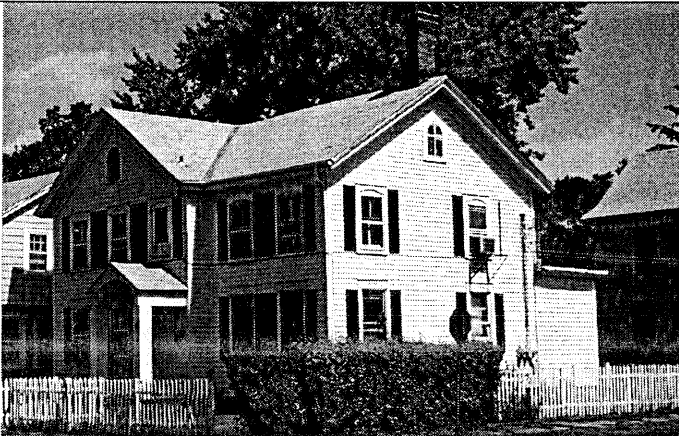
12. PHOTO:

8. BUILDING MATERIAL: a. clapboard ☒ b. stone c. brick d. board and batten
e. cobblestone f. shingles g. stucco f. other
9. STRUCTURAL SYSTEM: (if known) a. wood frame with interlocking joints ☐
b. wood frame with light members ☐
c. masonry load bearing walls ☐
d. metal (explain) ☐
e. other: (explain) ☐
10. CONDITION: a. excellent b. good c. fair ☒ d. deteriorated
11. INTEGRITY: a. original site ☒ b. moved ☐ if so, when?
c. list major alterations and dates (if known): Addition to back, replacement windows and floor, vinyl shutters, vinyl windows 1st floor porch columns replaced, front door replaced

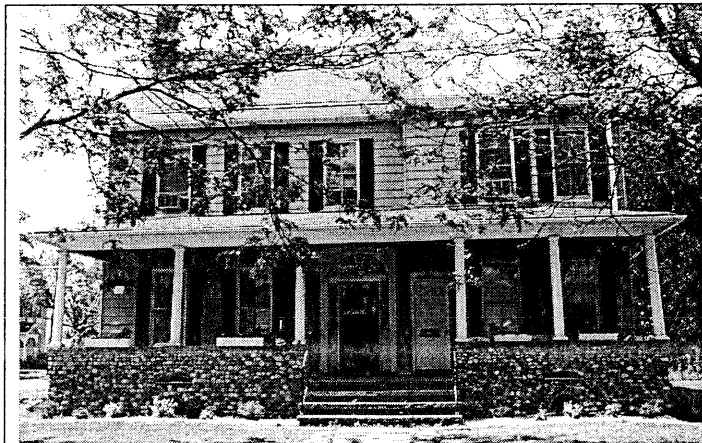
12. PHOTO:

8. BUILDING MATERIAL: a. clapboard b. stone c. brick d. board and batten
e. cobblestone f. shingles g. stucco f. other Aluminum
9. STRUCTURAL SYSTEM: (if known) a. wood frame with interlocking joints ☐
b. wood frame with light members ☐
c. masonry load bearing walls ☐
d. metal (explain) ☐
e. other: (explain) ☐
10. CONIDITION: a. excellent b. good ☒ c. fair d. deteriorated
11. INTEGRITY: a. original site ☒ b. moved ☐ if so, when?
c. list major alterations and dates (if known): Additional door in front. Aluminum siding. vinyl shutters. addition in back

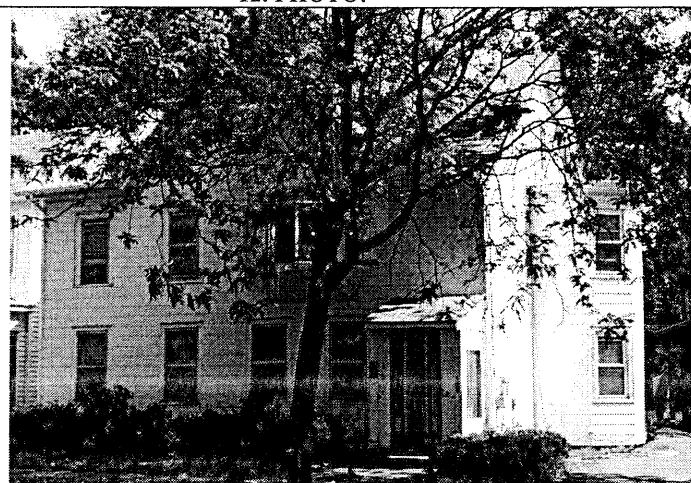
12. PHOTO:

8. BUILDING MATERIAL: a. clapboard b. stone c. brick d. board and batten
e. cobblestone f. shingles g. stucco f. other asbestos
9. STRUCTURAL SYSTEM: (if known) a. wood frame with interlocking joints ☐
b. wood frame with light members ☐
c. masonry load bearing walls ☐
d. metal (explain) ☐
e. other: (explain) ☐
10. CONDITION: a. excellent b. good c. fair ☒ d. deteriorated
11. INTEGRITY: a. original site ☒ b. moved ☐ if so, when?
c. list major alterations and dates (if known): Side addition, asbestos siding, enclosed front porch

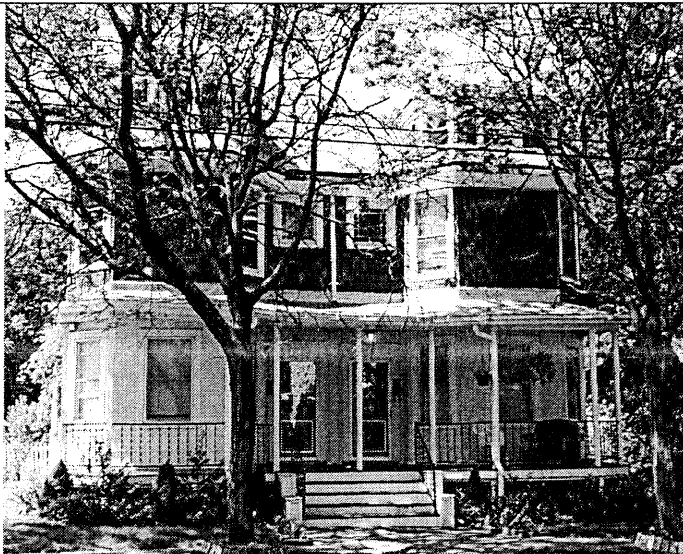
12. PHOTO:

8. BUILDING MATERIAL: a. clapboard b. stone c. brick d. board and batten
e. cobblestone f. shingles g. stucco f. other Asbestos
9. STRUCTURAL SYSTEM: (if known) a. wood frame with interlocking joints ☐
b. wood frame with light members ☐
c. masonry load bearing walls ☐
d. metal (explain)
e. other: (explain) ☐
10. CONDITION: a. excellent b. good ☒ c. fair d. deteriorated
11. INTEGRITY: a. original site ☒ b. moved ☐ if so, when?
c. list major alterations and dates (if known): Rebuilt porch, new railings, columns, porch ceiling covered in aluminum

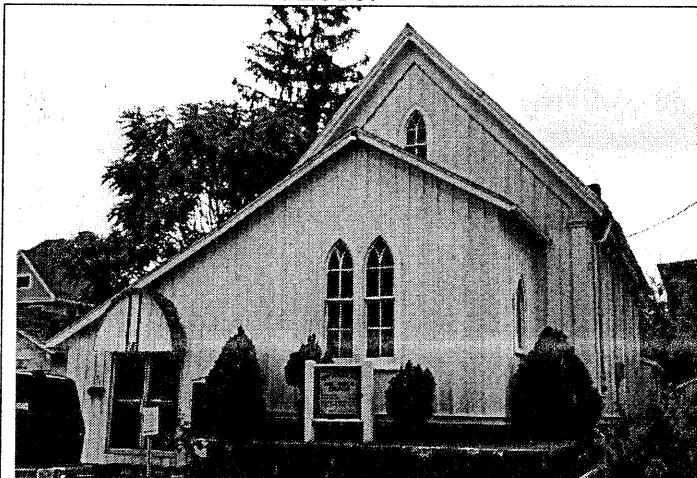
12. PHOTO:

8. BUILDING MATERIAL: a. clapboard b. stone c. brick d. board and batten ☒
e. cobblestone f. shingles g. stucco h. other
9. STRUCTURAL SYSTEM: (if known) a. wood frame with interlocking joints ☐
b. wood frame with light members ☐
c. masonry load bearing walls ☐
d. metal (explain) ☐
e. other: (explain) ☐
10. CONDITION: a. excellent b. good ☒ c. fair d. deteriorated
11. INTEGRITY: a. original site ☒ b. moved ☐ if so, when?
c. list major alterations and dates (if known): Addition to side, front re-sided to accommodate addition post 1956

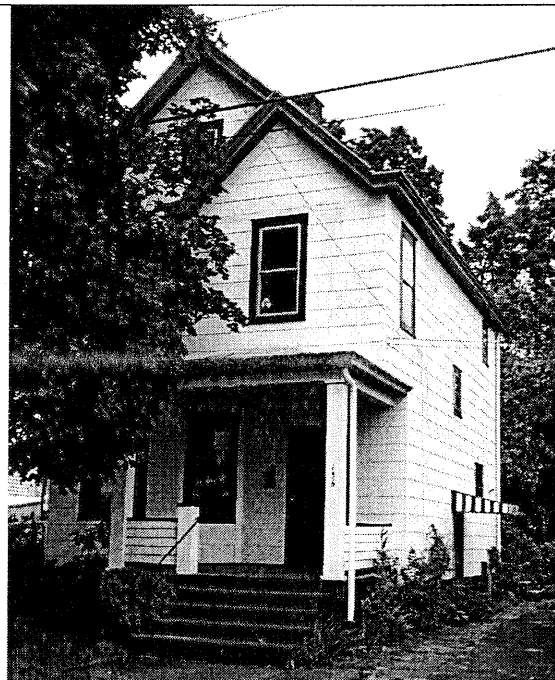
12. PHOTO:

8. BUILDING MATERIAL: a. clapboard b. stone c. brick d. board and batten ☐
e. cobblestone f. shingles g. stucco f. other asbestos
9. STRUCTURAL SYSTEM: (if known) a. wood frame with interlocking joints ☐
b. wood frame with light members ☐
c. masonry load bearing walls ☐
d. metal (explain)
e. other: (explain) ☐
10. CONDITION: a. excellent b. good ☒ c. fair d. deteriorated
11. INTEGRITY: a. original site ☒ b. moved ☐ if so, when?
c. list major alterations and dates (if known): Siding, porch chairs, back porch columns, porch rails

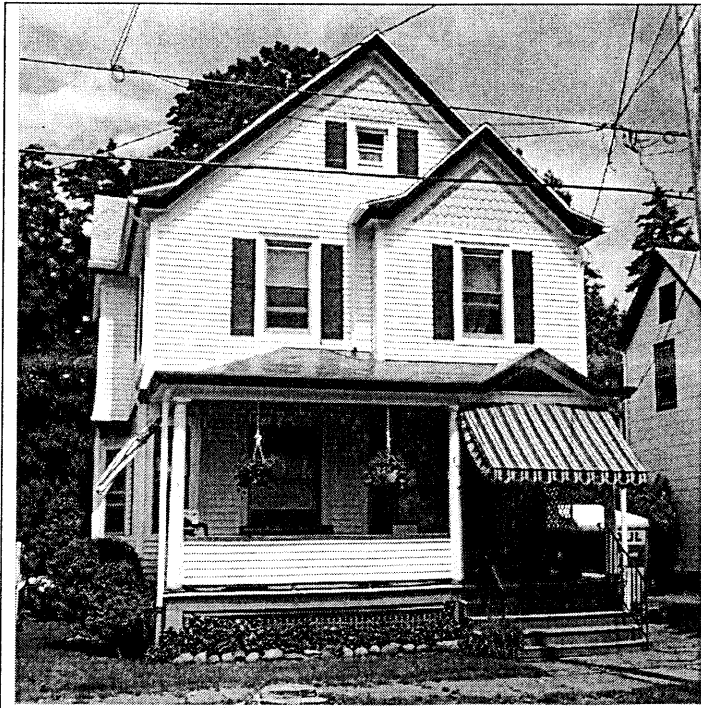
12. PHOTO:

c. list major alterations and dates (if known): New front steps, back porch, vinyl siding

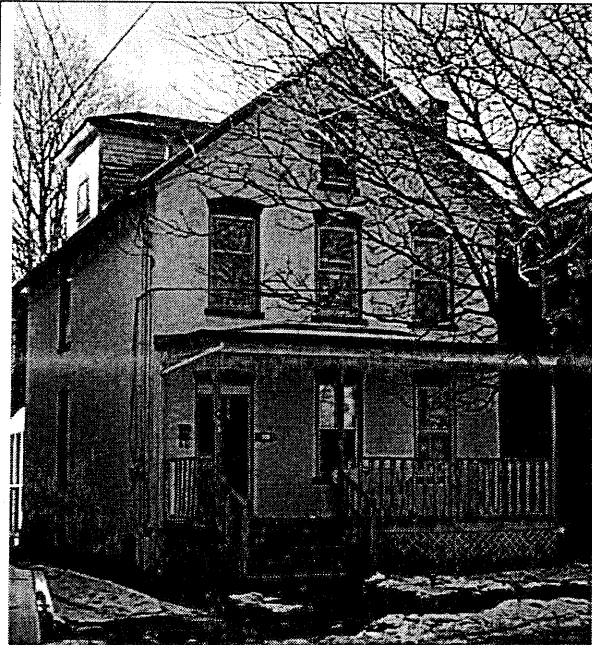
12. PHOTO:

8. BUILDING MATERIAL: a. clapboard b. stone c. brick ☒ d. board and batten
e. cobblestone f. shingles g. stucco f. other
9. STRUCTURAL SYSTEM: (if known) a. wood frame with interlocking joints ☒
b. wood frame with light members ☐
c. masonry load bearing walls ☐
d. metal (explain)
e. other: (explain) ☐
10. CONDITION: a. excellent b. good c. fair ☒ d. deteriorated
11. INTEGRITY: a. original site ☒ b. moved ☐ if so, when?
c. list major alterations and dates (if known): New Porch

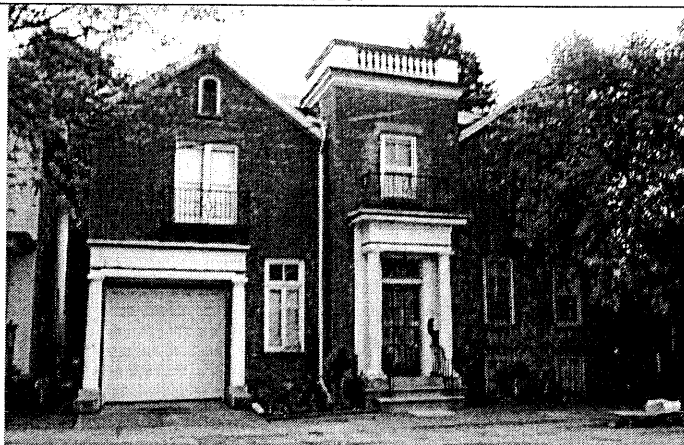
12. PHOTO:

8. BUILDING MATERIAL: a. clapboard ☐ b. stone ☐ c. brick ☒ d. board and batten ☐
e. cobblestone ☐ f. shingles ☐ g. stucco ☐ other (explain) ☐
9. STRUCTURAL SYSTEM: (if known) a. wood frame with interlocking joints ☐
b. wood frame with light members ☐
c. masonry load bearing walls ☐
d. metal (explain) ☐
e. other: (explain) ☐
10. CONDITION: a. excellent ☐ b. good ☒ c. fair ☐ d. deteriorated ☐
11. INTEGRITY: a. original site ☒ b. moved ☐ if so, when?
c. list major alterations and dates (if known): garage door, addition to back

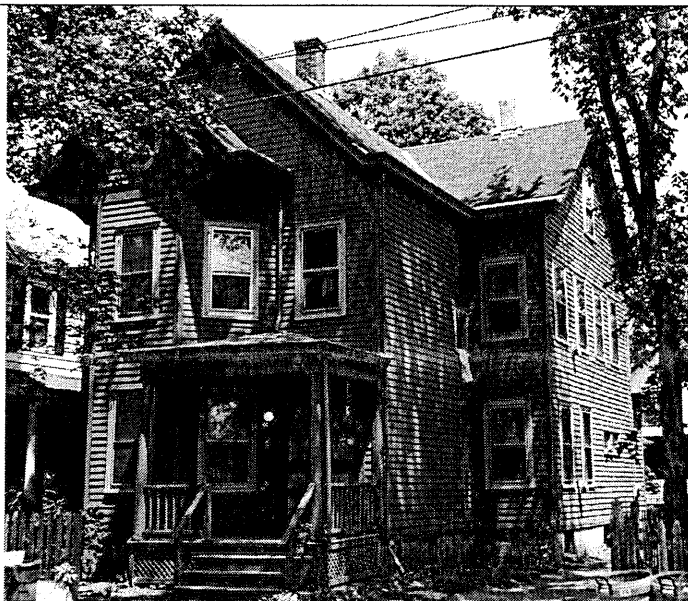
12. PHOTO:

8. BUILDING MATERIAL: a. clapboard ☒ b. stone c. brick d. board and batten
e. cobblestone f. shingles g. stucco f. other
9. STRUCTURAL SYSTEM: (if known) a. wood frame with interlocking joints ☐
b. wood frame with light members ☐
c. masonry load bearing walls ☐
d. metal (explain)
e. other: (explain) ☐
10. CONDITION: a. excellent b. good ☒ c. fair d. deteriorated
11. INTEGRITY: a. original site ☒ b. moved ☐ if so, when?
c. list major alterations and dates (if known): Glass on front door replaced, porch railings replaced

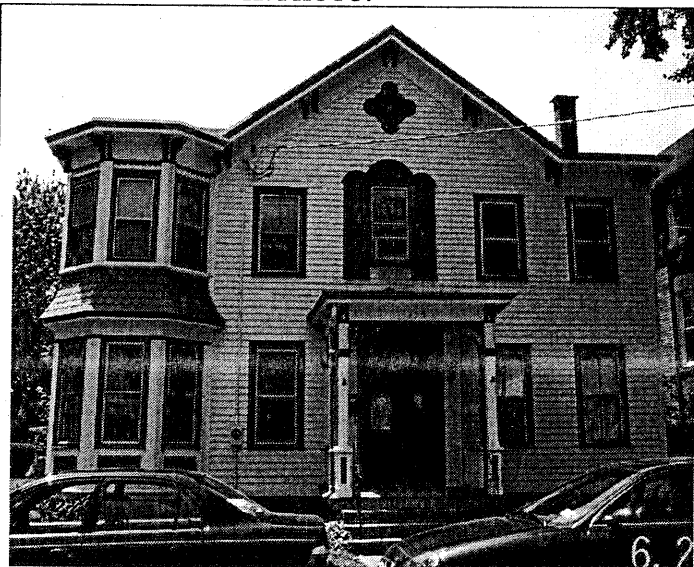
12. PHOTO:

8. BUILDING MATERIAL: a. clapboard ☒ b. stone c. brick d. board and batten
e. cobblestone f. shingles g. stucco f. other
9. STRUCTURAL SYSTEM: (if known) a. wood frame with interlocking joints ☐
b. wood frame with light members ☐
c. masonry load bearing walls ☐
d. metal (explain)
e. other: (explain) ☐
10. CONDITION: a. excellent b. good ☒ c. fair d. deteriorated
11. INTEGRITY: a. original site ☒ b. moved ☐ if so, when?
c. list major alterations and dates (if known): Porch steps rebuilt w/pressure treated lumber

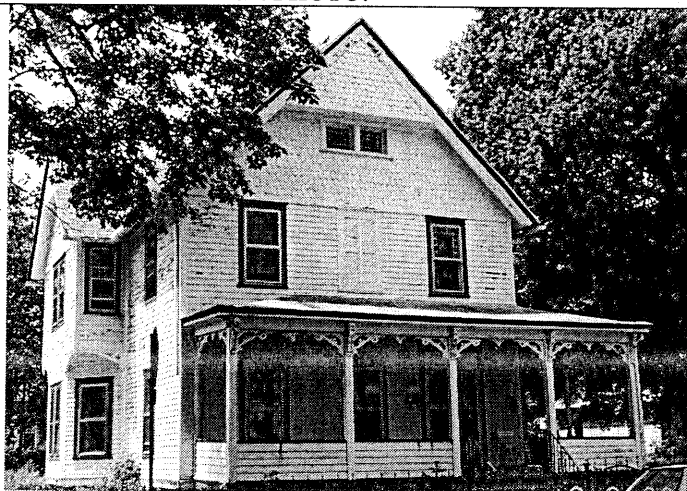
12. PHOTO:

- a. none known b. zoning c. roads d. developers e. deterioration ☒ :
f. other:

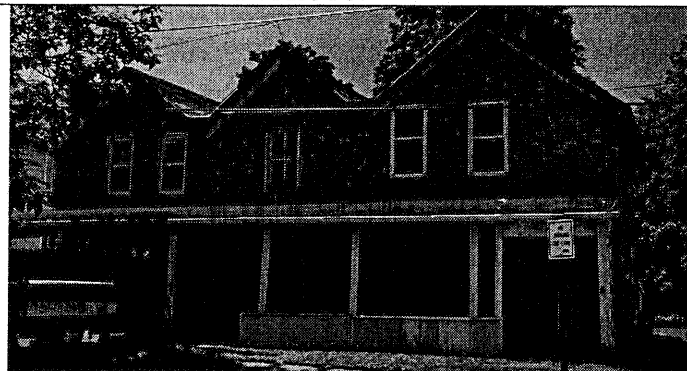
12. PHOTO:

8. BUILDING MATERIAL: a. clapboard ☐ b. stone ☐ c. brick ☐ d. board and batten ☐
e. cobblestone ☐ f. shingles ☐ g. stucco ☐ other (explain) ☒ asbestos
9. STRUCTURAL SYSTEM: (if known) a. wood frame with interlocking joints ☐
b. wood frame with light members ☐
c. masonry load bearing walls ☐
d. metal (explain) ☐
e. other: (explain) ☐
10. CONDITION: a. excellent ☐ b. good ☐ c. fair ☒ d. deteriorated ☒
11. INTEGRITY: a. original site ☒ b. moved ☐ if so, when?
c. list major alterations and dates (if known): porch replaced, some replacement windows

14. THREATS TO BUILDING: a. none known ☐ b. zoning ☐ c. roads ☐
 d. developers ☐ e. deterioration ☒
 f. other:

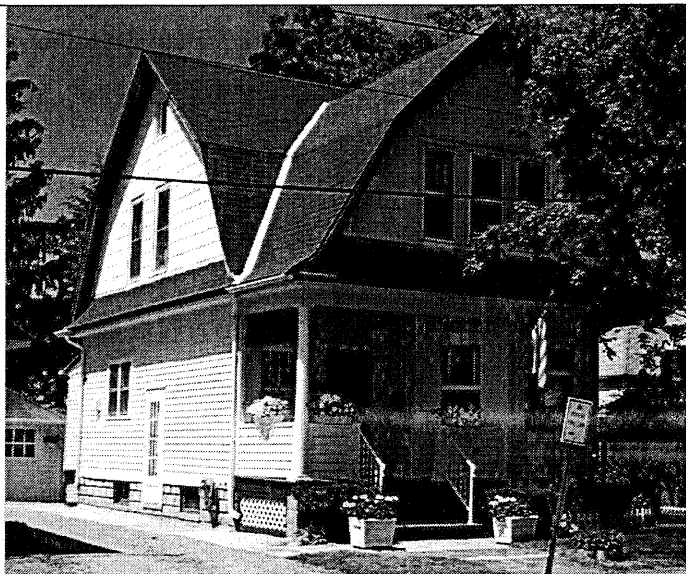
12. PHOTO:

8. BUILDING MATERIAL: a. clapboard ☒ b. stone ☐ c. brick ☐ d. board and batten ☐
e. cobblestone ☐ f. shingles ☒ g. stucco ☐ other (explain) ☐
9. STRUCTURAL SYSTEM: (if known) a. wood frame with interlocking joints ☐
b. wood frame with light members ☐
c. masonry load bearing walls ☐
d. metal (explain) ☐
e. other: (explain) ☐
10. CONDITION: a. excellent ☐ b. good ☒ c. fair ☐ d. deteriorated ☐
11. INTEGRITY: a. original site ☒ b. moved ☐ if so, when?
c. list major alterations and dates (if known): porch rails replaced
